March 24, 2016

Subject: 100 Moody Court, Thousand Oaks, CA
Seismic Screening Report
JLA Job no. 11630-01

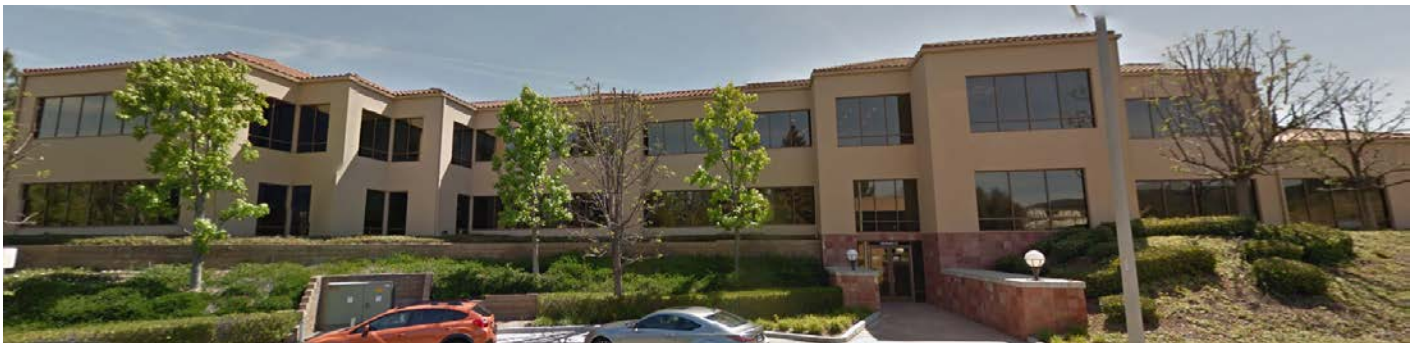
Figure 1 – Partial west elevation of 100 Moody Court in Thousand Oaks, CA
