UCLA Seismic Rating Study

11075 Santa Monica Boulevard

September 8, 2017

Job No. 17-G132

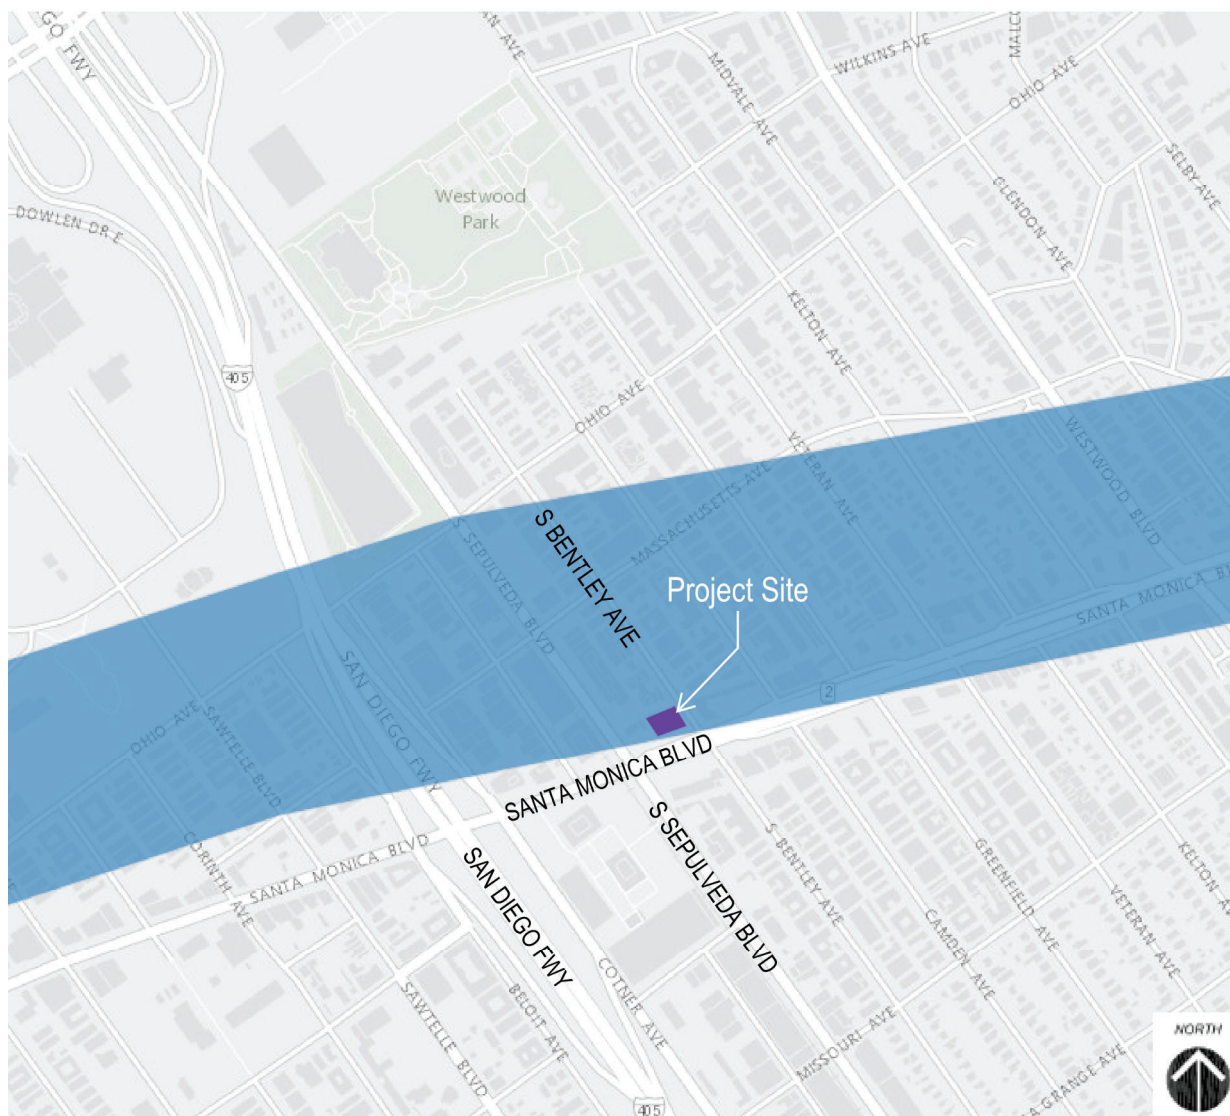
Figure 4.2 Beverly Hills Preliminary Fault Rupture Study Zone

The State of California has issued a set of regulatory maps detailing regions of potential liquefaction, landslide and ground fault rupture. Landslide and ground fault rupture have not been identified as potential hazards at the site; however, in 2015 the California Geological Survey published a map identifying the Beverly Hills Preliminary Fault Rupture Study Area, the southern boundary of which just includes the subject building, as shown in Figure 4.2. Although the map has not been finalized, the City of Los Angeles currently requires that proposed development projects within this zone perform a fault rupture study.

The building is in a preliminary fault rupture study zone, albeit at the very southern edge. No geotechnical report for the project has been located, although it is unlikely that in the early 1980s a fault rupture study would have been undertaken. Public records do not report evidence of faulting discovered during the excavation of the subterranean parking. A search of public records for a high-rise building with a basement, constructed one block away from the subject building in the mid-1980s (11111 Santa Monica Blvd.), also does not reveal evidence of faulting discovered during the excavation of the basement. Based on the location of the subject building relative to the southern boundary of the preliminary fault rupture study zone and the lack of evidence of reported faulting discovered during excavation activities at this and an adjacent site, it appears unlikely that the building will be subject to significant effects of ground rupture.

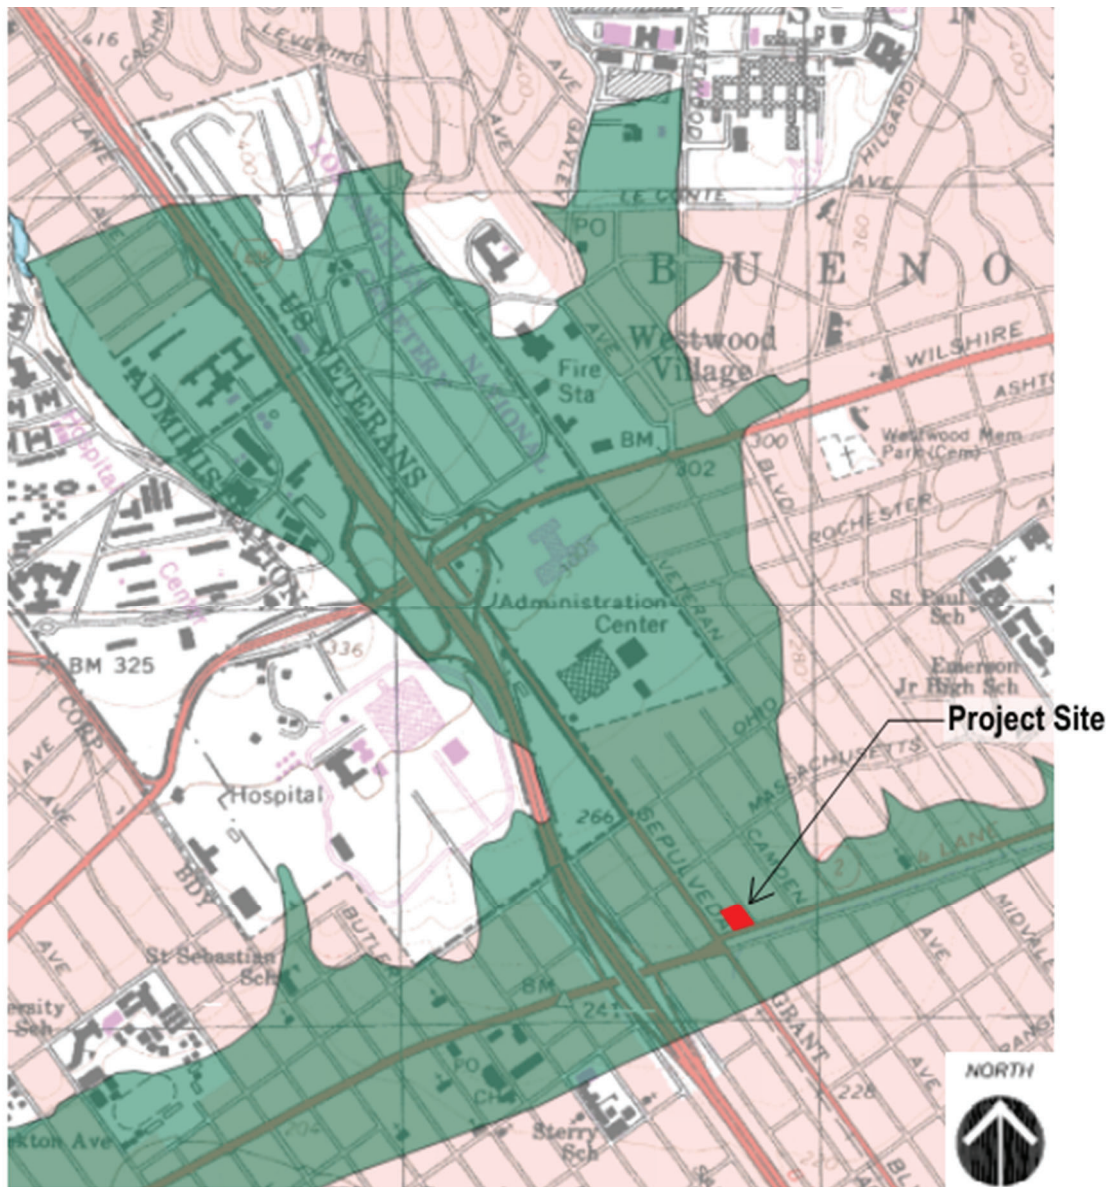
Figure 4.3 - California Geological Survey – Earthquake Zones of Required Investigation (Beverly Hills Quadrangle)

The building falls in a liquefaction study zone identified by the *California Geological Survey – Earthquake Zones of Required Investigation (Beverly Hills Quadrangle)*. A portion of this map is shown in Figure 4.3. The significance of both potential hazards is discussed in Section 5.

Although the building is in a liquefaction study zone, it is one block to the southern edge of the study zone. A review of other foundation systems in the general vicinity did not suggest the presence of liquefiable soils based on foundation type, and no liquefaction was reported during the 1994 Northridge Earthquake. In addition, while liquefaction may increase the amount of structural damage, it is not believed to represent a life-safety hazard for this building.

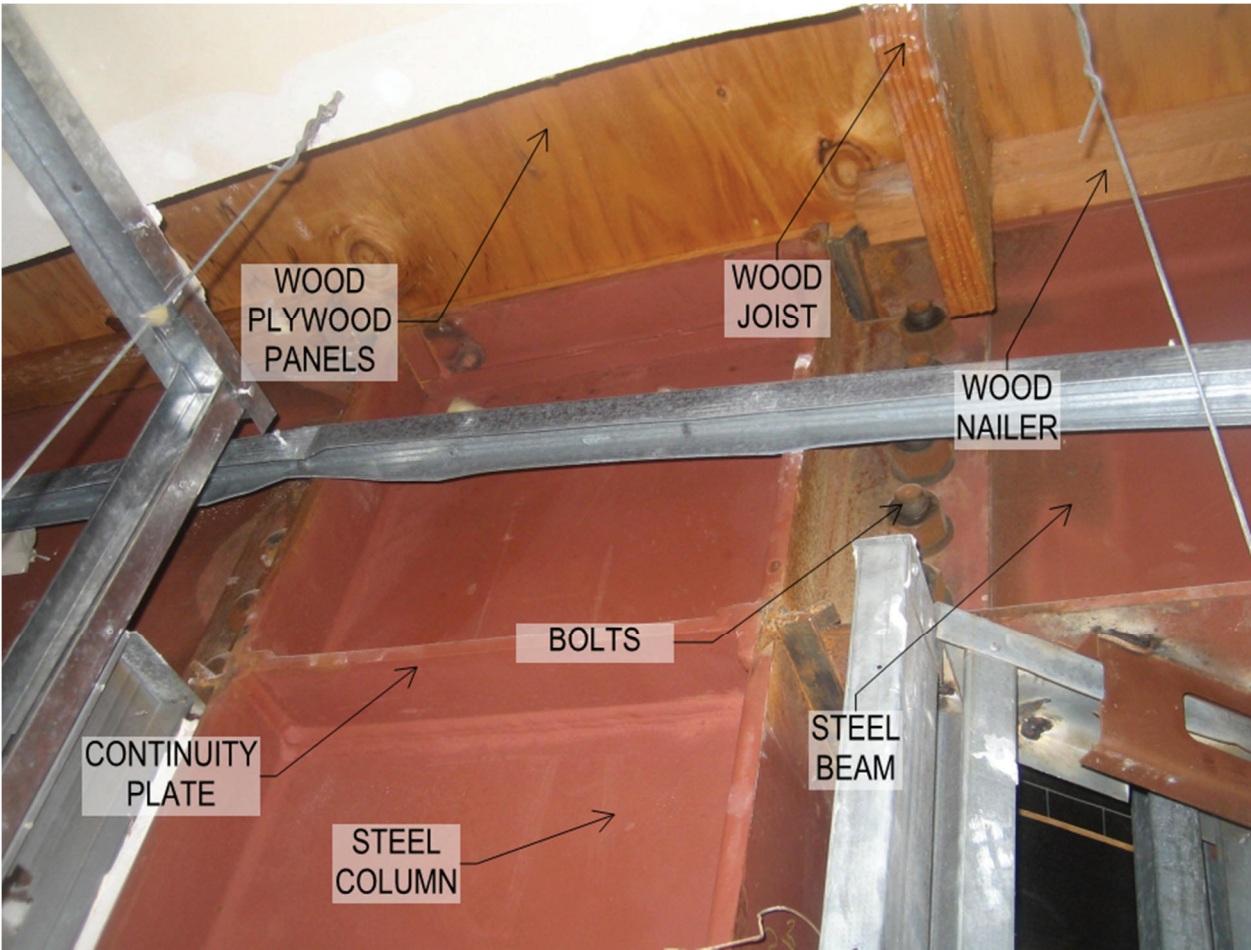
Figure 5.1 - Steel Moment Frame Beam-Column Connection

Moment-Resisting Connections: Structural models were developed using the structural analysis software package SAP2000 to study the steel moment frame connections that predate the 1994 Northridge Earthquake, a potential deficiency of the building. Site observations permitted classification of the building's steel beam-column connections as *welded unreinforced flange (WUF)* per ASCE 41-13 Table 9-5, described as “*full-penetration welds between beams and columns flanges, bolted or welded web, designed before code changes that followed the Northridge Earthquake.*”

Per ASCE 41-13 Section 9.4.2.4, fully restrained (FR) beam-column connections, such as the ones present in the building, are considered deformation-controlled, and the connection acceptance criteria are dependent on the detailing of continuity plates, the strength of the panel zone, the beam span-to-depth ratio, and the slenderness of the beam and web flanges. A typical beam-column connection for the building is shown in Figure 5.1. A typical elevation of a perimeter moment frame based on field measurements and interpolation assumptions is shown in Figure 5.2.

m-factors for the indicated connections were obtained from ASCE 41-13 Table 9-6 and modified based upon detailing observed on the site using the criteria in ASCE 41-13 Section 9.4.2.4. Connection components were evaluated following the acceptance criteria shown in Section 5.2.1 of this report, and the Tier 2 analysis verified acceptable performance of the steel moment frame beam-column connections under the BSE-R hazard, with demand-over-capacity ratios less than unity for critical limit states.

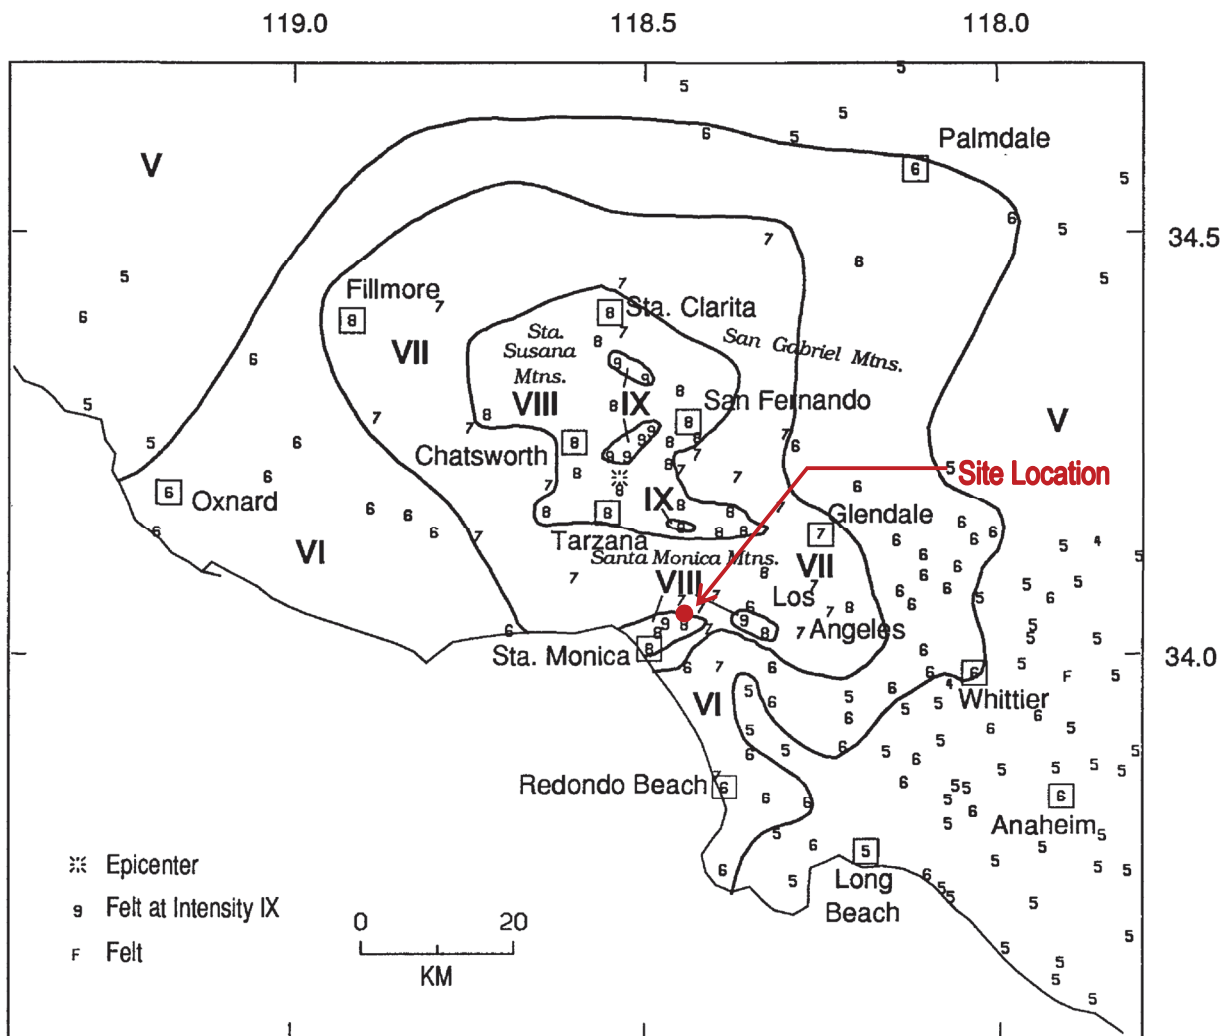
Figure 5.3 – Distribution of Modified Mercalli intensities in the epicentral region. Roman numerals give average intensities within isoseismals. Arabic numerals represent intensities at specific locations. Squares denote towns labeled in the figure.

The building is in the general vicinity of high levels of shaking as well as other steel frame and concrete buildings that sustained significant structural damage during the 1994 Northridge Earthquake (e.g., Olympic Boulevard and Sepulveda, Olympic Boulevard and Barrington Avenue). The USGS classified the Modified Mercalli Intensity at the site on the border between VII and VIII, as shown in Figure 5.3. The site was within the minimum 0.2g ground acceleration region within which a 1995 City of Los Angeles ordinance required earthquake inspection of steel frame buildings following the Northridge Earthquake. A search of public records showed no permit issued for repair of the steel frame, although many building permits were issued for tenant improvements in the years following the Northridge Earthquake. Based on the lack of observable repair work on the building exterior and the lack of a building permit for steel frame damage repair, it appears that no damage to the steel frame was found following the Northridge Earthquake.
