**Re: *University of California Seismic Rating for 1149 South Hill Street, Los Angeles***

Nabih Youssef Associates (NYA) have performed an Independent Review of the 11-story office building located at 1149 South Hill Street in Los Angeles. The review consisted of a site visit to observe the existing condition of the exposed structural elements, identification of potential falling hazards that pose a significant life or safety risk to occupants, a review of structural drawings and an ASCE 41-13 Tier 2 evaluation, including dynamic analyses.

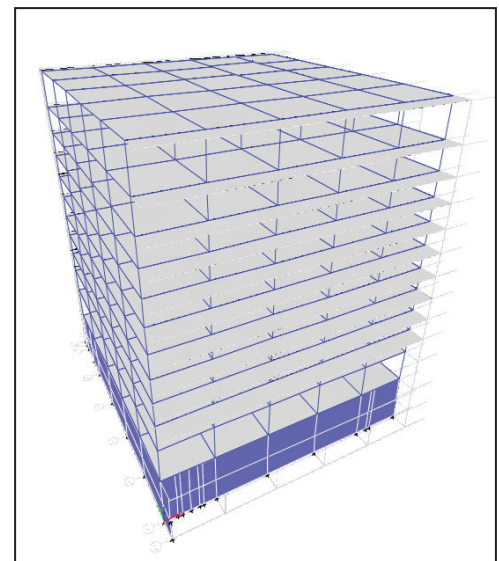
Figure 1 – ETABS Model

The model included all elements that significantly contribute to the lateral force resistance of the building, roof and floor diaphragms, steel moment frames and basement concrete walls. The roof and floor diaphragms were modeled as rigid. The partially restrained double split-tee connections were modeled using rotational springs at the beam-to-column joints as per ASCE 41-13. Figure 1 shows a plot of the ETABS model.

The results indicate that some connections (approximately 5% in either direction) are overstressed at the life safety and

collapse prevention performance levels. However, the average demand-to-capacity ratios of the connections are less than 0.5 at the life safety and collapse prevention performance levels. In addition, three columns at the 11<sup>th</sup> floor and four columns at the 10<sup>th</sup> floor were overstressed at the life safety and collapse prevention performance levels. Given that every frame bay participates in resisting lateral forces, there is adequate reserve capacity and redundancy to provide acceptable performance.

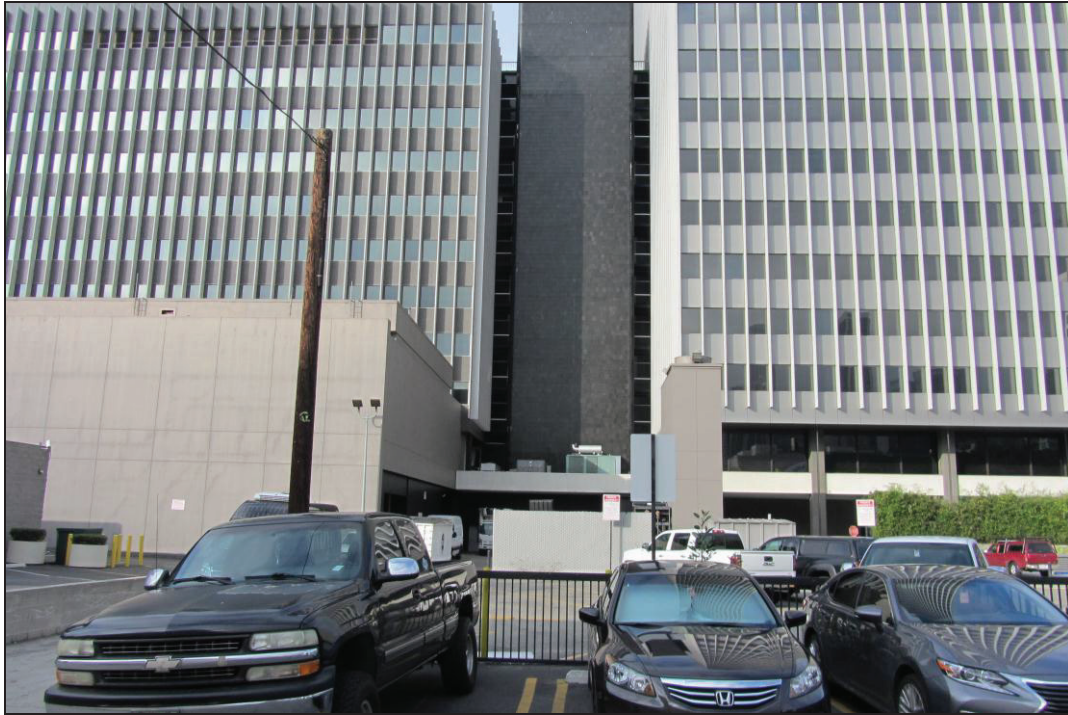
Photo 1 – Bridge Building

A bridge building connects the 1149 South Hill building to the 32-story 1150 South Olive building. The seismic separation between buildings varies over the height of the building and is 8" at the 11<sup>th</sup> floor. A pedestrian bridge connects the 1149 South Hill building to the Public Works building at 212 West 12<sup>th</sup> Street. A 3" seismic joint separates the building and the bridge. There is also an adjacent 2-story auditorium building to the north with a separation joint of unknown width.

The results of the analysis also indicate that the provided seismic joints separating the 1149 South Hill building from the adjacent buildings and pedestrian bridge are not adequate. However, the floors and roof of the adjacent buildings and pedestrian bridge are vertically aligned with the floors of the 1149 South Hill building, thus any potential impact/pounding during an earthquake will result in localized damage to the floor slabs.

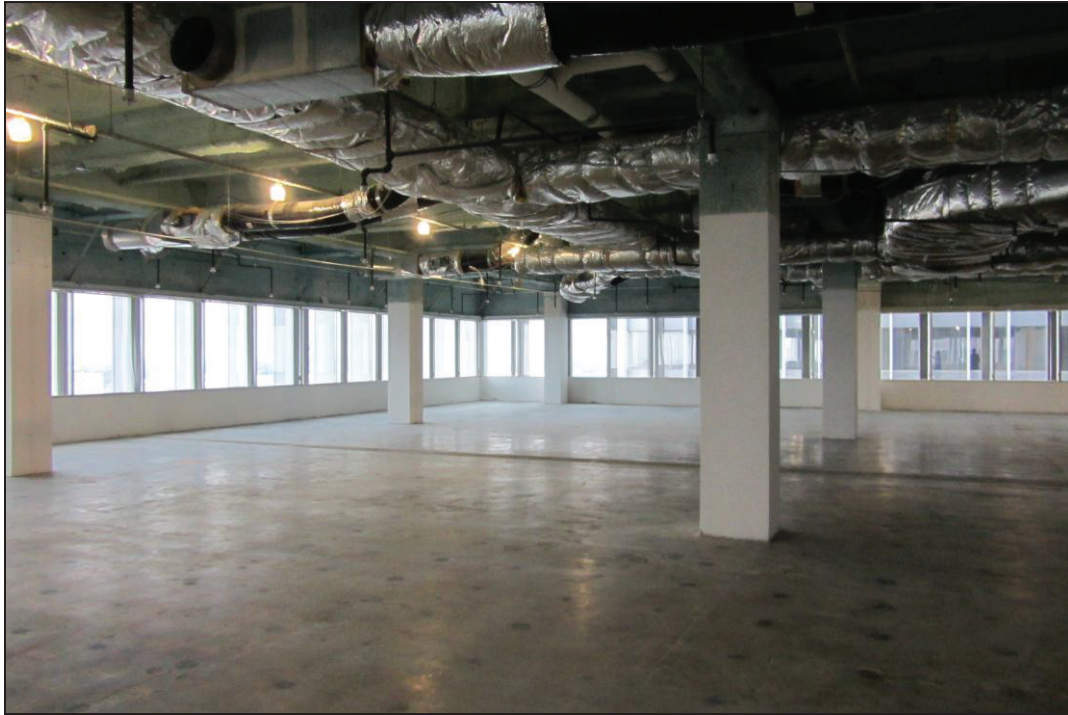
Photo 3 – Typical Steel Framing

The roof and 11<sup>th</sup> floor are constructed of 4½" light weight concrete slabs spanning to wide flange steel beams and girders. The typical floor are constructed of metal deck with 2½" light weight concrete fill spanning to wide flange steel beams and girders. The steel beams and girders are supported by wide flange steel columns that are spliced at every other floor and are continuous to the foundation. The foundation system consists of shallow concrete spread footings supporting columns and walls. Concrete piles support the south retaining wall.

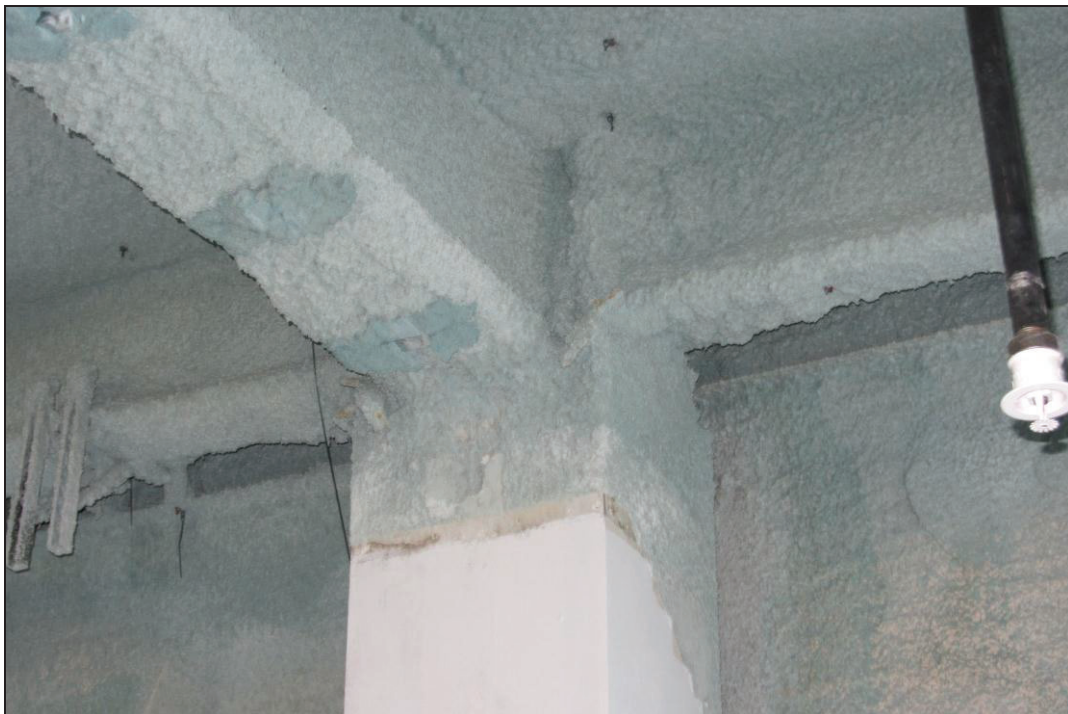
Photo 4 – Typical Beam to Column Connection

The lateral-force-resisting system consists of the metal deck and concrete fill roof and floors acting as structural diaphragms to transfer seismic inertial forces to the distributed steel moment frames, where each frame bay in both directions of the building is a moment frame. The moment frames have partially restrained double split-tee connections along the strong axis of the columns and bolted flange plate connections along the weak axis of the columns.

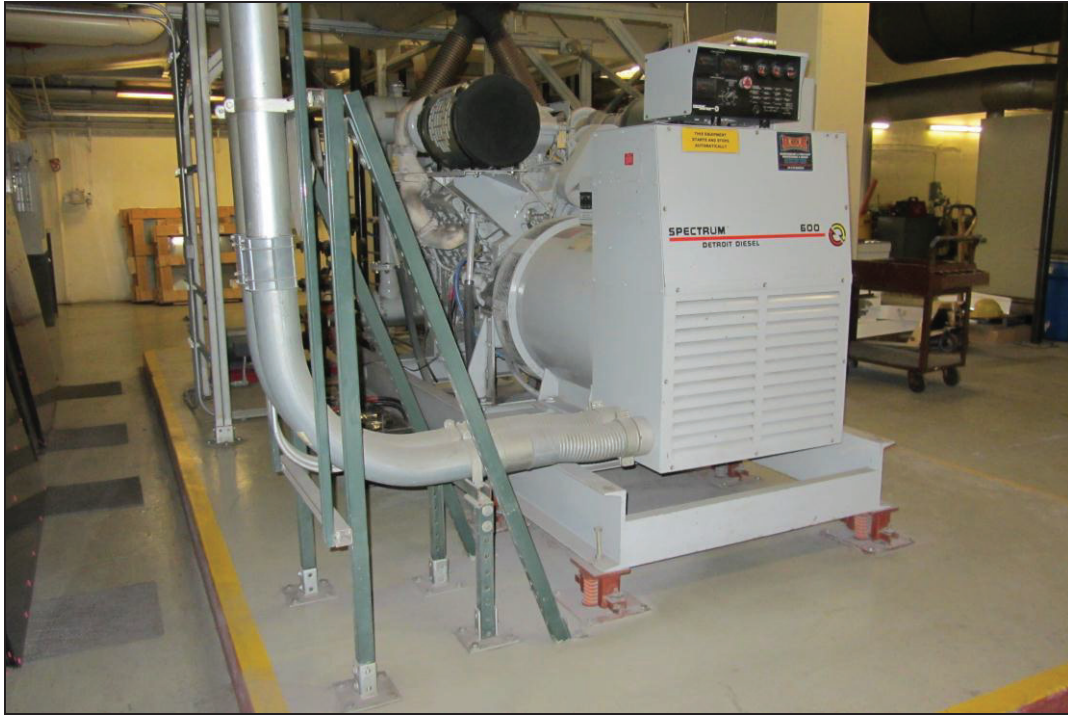
Photo 5 – Emergency Generator

Mechanical and electrical equipment were observed to be generally anchored and piping systems generally braced. The curtain wall system of the building consists of an aluminum mullion system with laminated glass. There is canopy at the ground floor along the Hill Street elevation that is cantilevered from the building. No falling hazards were observed on the exterior of the building.
