BUILDING REPORT REQUIREMENTS
ASCE 41-17 TIER 1 SEISMIC EVALUATIONS

BUILDING REPORT

- 1) UC Campus: Los Angeles
2) Building Name: 16th Street Apartments
3) Building CAAN ID: 4914
4) Auxiliary Building ID:
5) Date of Evaluation: 6/30/2020
6) Evaluation by: Englekirk, TAS
7) Seismic Performance Rating and Basis of Rating: V, ASCE 41-17 Tier 1

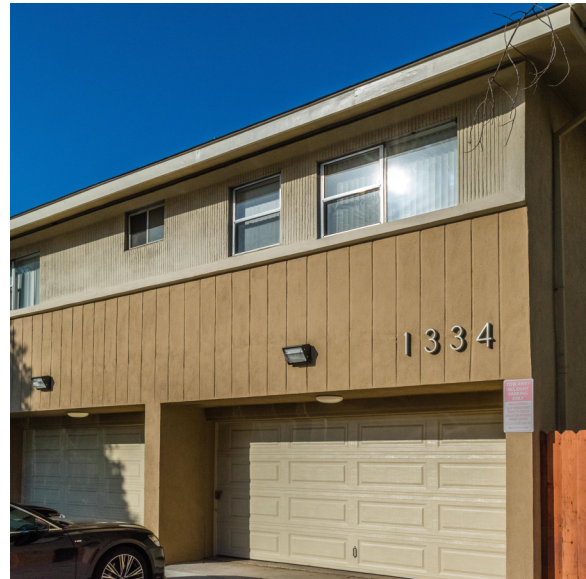
9) Exterior Elevation Photo

Comments: Building acquired by UCLA. No permit information provided and search for permit and drawings in Santa Monica archives was unsuccessful . Soft-story tuck-under parking. No record of seismic upgrade.

Provide lateral bracing of open garage front using moment frames or cantilevered columns. Add shear walls. Add plywood to roof diaphragm. Add diaphragm ties and anchorage of roof diaphragm to exterior walls.
