May 8, 2017

Re: *University of California Seismic Rating for 1821 Wilshire Boulevard, Santa Monica*

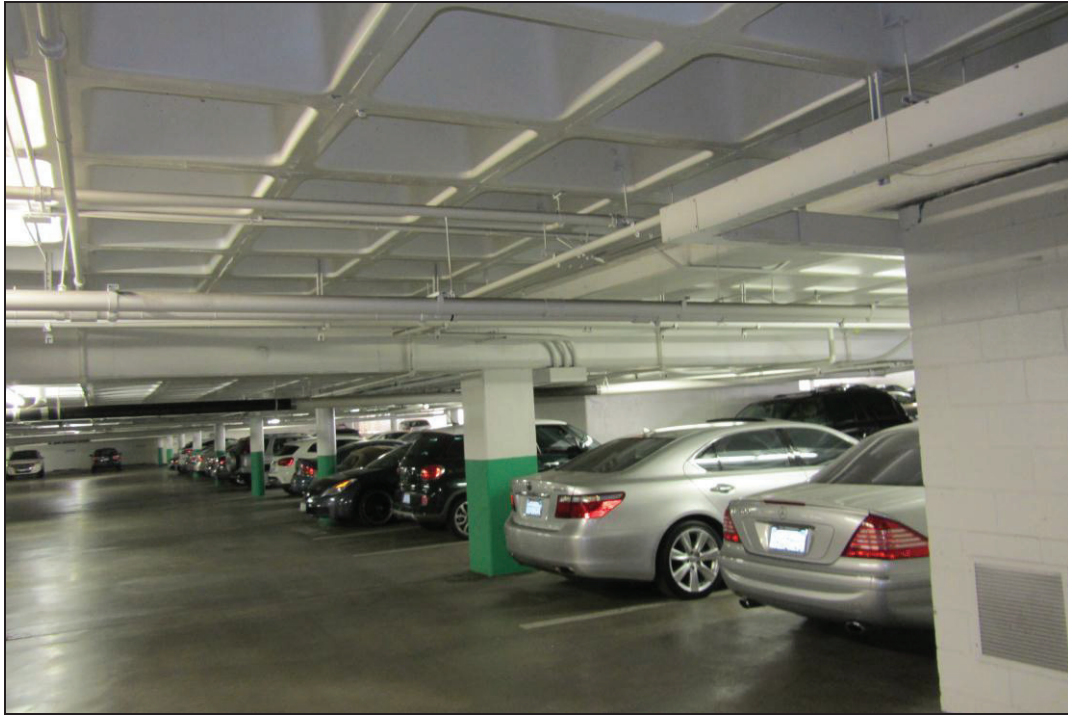
Photo 3 – Typical First Floor Framing

The roof and floors are constructed of metal deck with light weight concrete fill that span to steel beams. The steel beams are supported by steel girders and columns that are continuous to the foundation. The first floor is constructed of two-way concrete joists supported by concrete encased steel columns at the interior and 8" thick perimeter reinforced masonry walls. The foundation system consists of shallow isolated concrete spread footings under columns, continuous concrete strip footings supporting the masonry walls and a 4" reinforced concrete slab on grade.

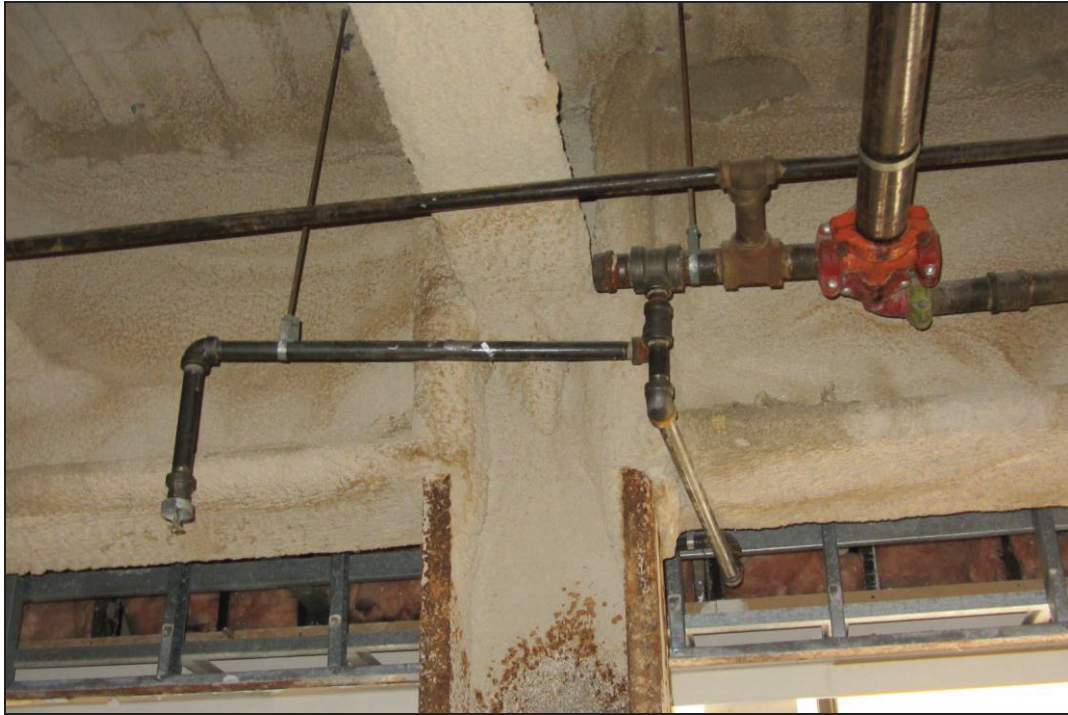
Photo 5 – Typical Moment Connection

- Moment Resisting Connections – The connections are not able to develop the strength of the adjoining members or panel zones. This is common for pre-Northridge connections.
- Panel Zones – Panel zones have inadequate shear capacity to develop the flexural strength of the girders framing into the column. This is common for buildings of this vintage, as panel zone shear strength was not a design requirement.
- Strong Column/Weak Beam – Calculations indicate that the moment frames do not meet the strong column/weak beam condition. This is common for buildings of this vintage, as strong column/weak beam was not a design requirement.
- Compact Members – Not all members meet compact section requirements. This is common for buildings of this vintage, as compactness was not a design requirement.

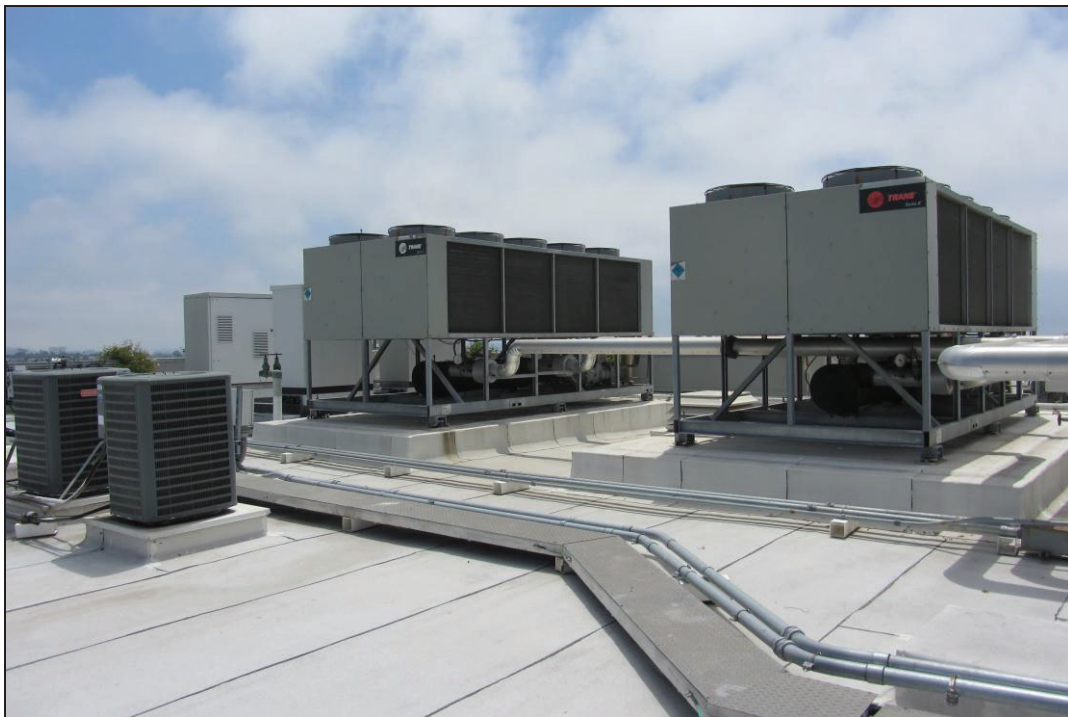
Photo 6 – Rooftop Cooling Towers

Mechanical and electrical equipment were observed to be generally anchored and piping systems generally braced. The building exterior consists of stucco finish with windows. No significant falling hazards were observed on the exterior of the building.
