Seismic Evaluation

Lake Arrowhead Conference Center Facility 1

Lake Arrowhead, California

October 23, 2020

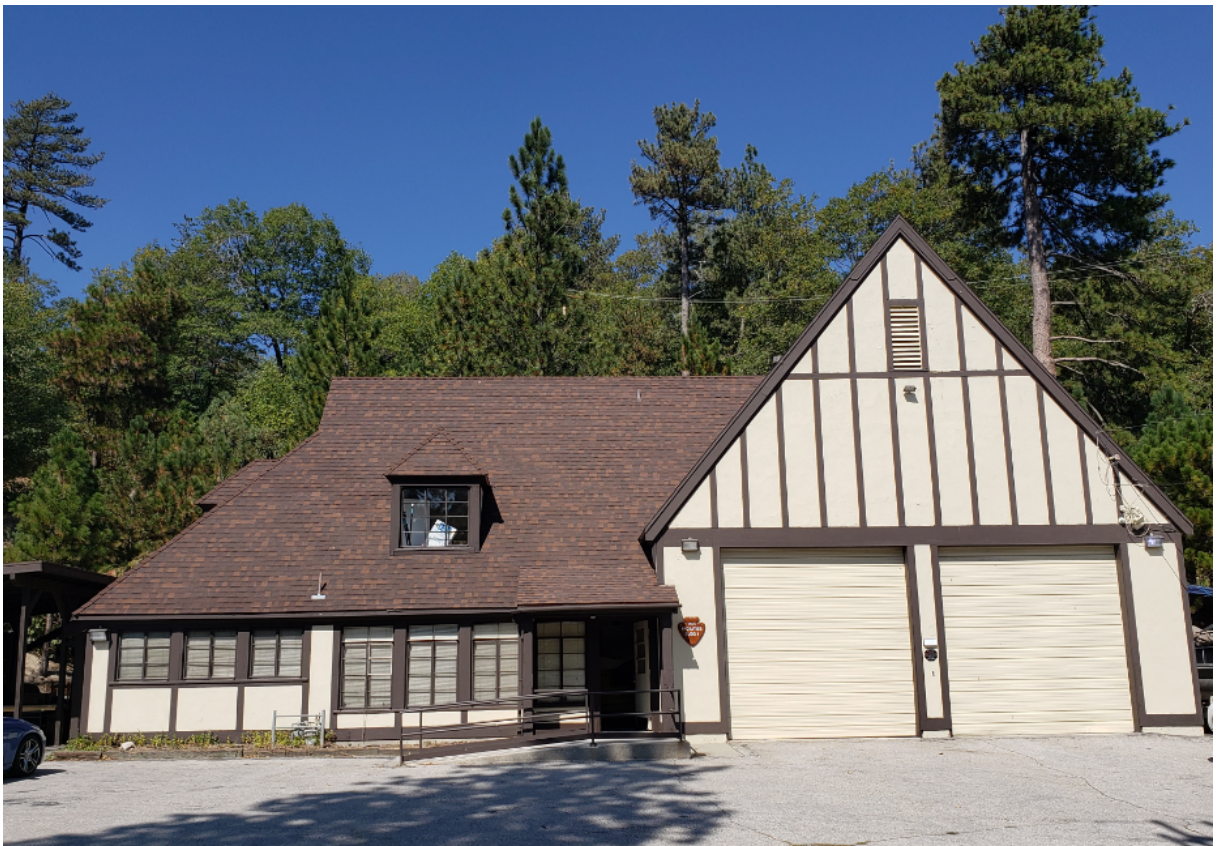
Figure 1.1: Building East (Front) Elevation

- Openings: The east elevation walls are with openings greater than 80% of the length but are not braced with wood structural panel shear walls with aspect ratios of not more than 1.5-to-1 nor are they supported by adjacent construction through positive ties capable of transferring the seismic forces.

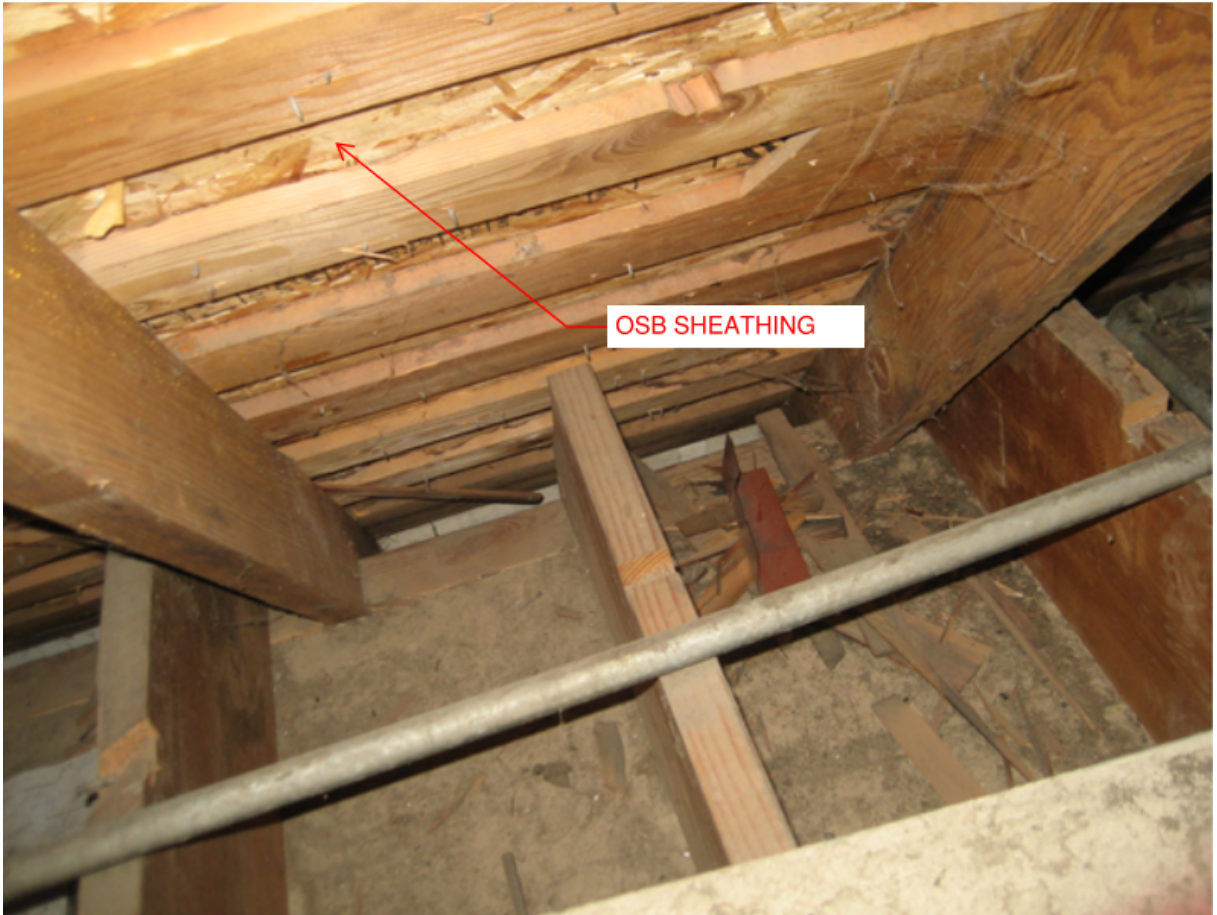
Figure 2.3 As-built Roof Diaphragm Picture

- Load Path: There is no shear blocking between the roof/floor joist to transfer the roof/mezzanine diaphragm loads to the shear walls. The mezzanine diaphragm does not extend to the exterior walls. The discontinuity also creates an incomplete load path.

A Tier 2 analysis cannot justify the existing condition nor waive the requirement of the shear blockings between roof/floor joist to form a complete load path. The item is still considered non-compliant.

- Strengthen the existing shear wall panels by using thicker plywood sheathing and adding nails to reduce the nailing spacing.
- Increase shear wall length by adding infill to some of the window openings.
- Add holdowns at the shear wall boundary elements to increase the overturning capacity.
- Add a moment frame on the inside face of the walls with large openings.
- Add plywood sheathing at mezzanine floor and extend the diaphragm to the walls with shear blocking between the joists to transfer the diaphragm force.

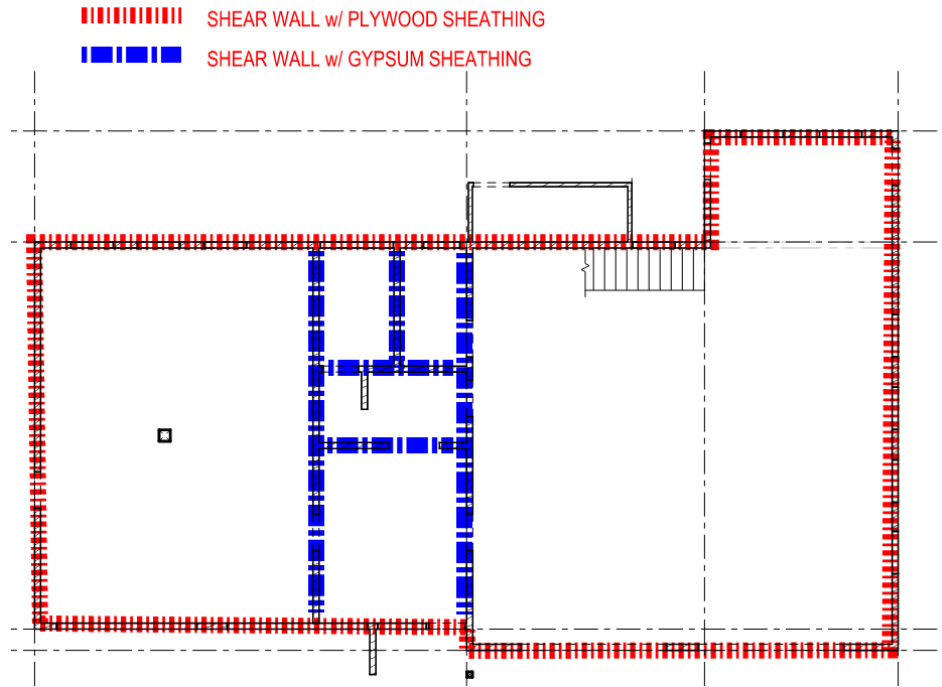
Figure 5.1: Building Shear Wall Layout

There are a number of large window and door openings at the east and west elevations of the building, which leaves very limited length of walls that were considered effective as shear walls. As a result of the openings, the walls have high aspect ratios, which results in high overturning demand. Even though the anchor bolts and holdowns are likely to exist based on the record drawings of Facility 2, the magnitude of the overturning demand exceeds the capacity of holdowns specified in the 1970s. The overturning check is still considered non-compliant.

Tall openings and limited length of shear walls available at the east and west elevations of the building create wall panels with high aspect ratios. In cases where the shear stress is low, the high aspect ratio may be of less concern; however, the shear stress in nearly all shear walls appears to be high. The narrow wood shear walls check is still considered non-compliant.

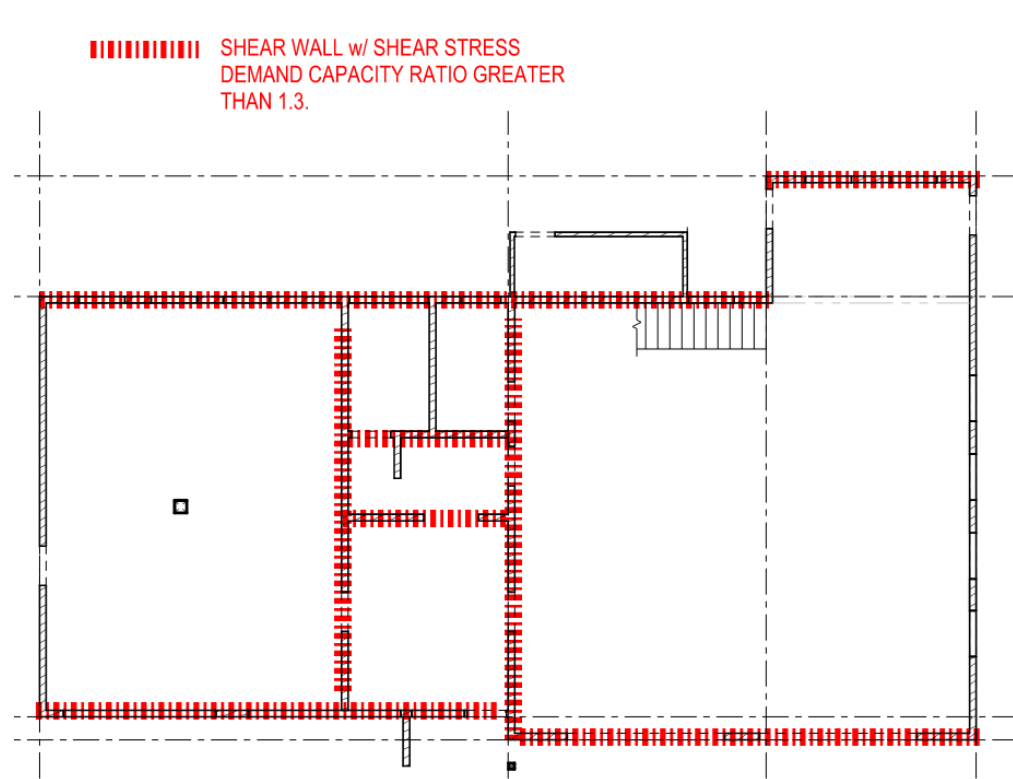
Figure 5.3: Shear Walls with DCR>1.3 Layout

Assumptions were made that all exterior shear walls have plywood sheathing on both sides, and all interior walls have gypsum sheathing. Most of the shear walls in both the building longitudinal and transverse directions, other than the north and south exterior walls, have demand-to-capacity ratios greater than 1.3 in the Tier 2 analysis. The shear wall length may have been reduced due to the addition of the pop-out room at the northwest corner, which shall be considered a negative impact to the structure. The shear stress check is still considered non-compliant. Figure 5.3 shows the non-compliant shear walls with demand capacity ratio greater than 1.3. For the middle shear wall in the east-west direction, another check was made assuming plywood sheathing on both sides. But the demand capacity ratio is still greater than 1.6.
