Subject: 840 Willow Creek Rd, Lake Arrowhead, CA  
Seismic Screening Report  
JLA Job no. 17101-03

Per your request, John Labib + Associates Structural Engineers (JLA) performed a seismic screening of the existing buildings the above noted address. Our services included a site visit performed on May 30<sup>th</sup>, 2017, review of the available record drawings and a general evaluation of the structural systems of the building.

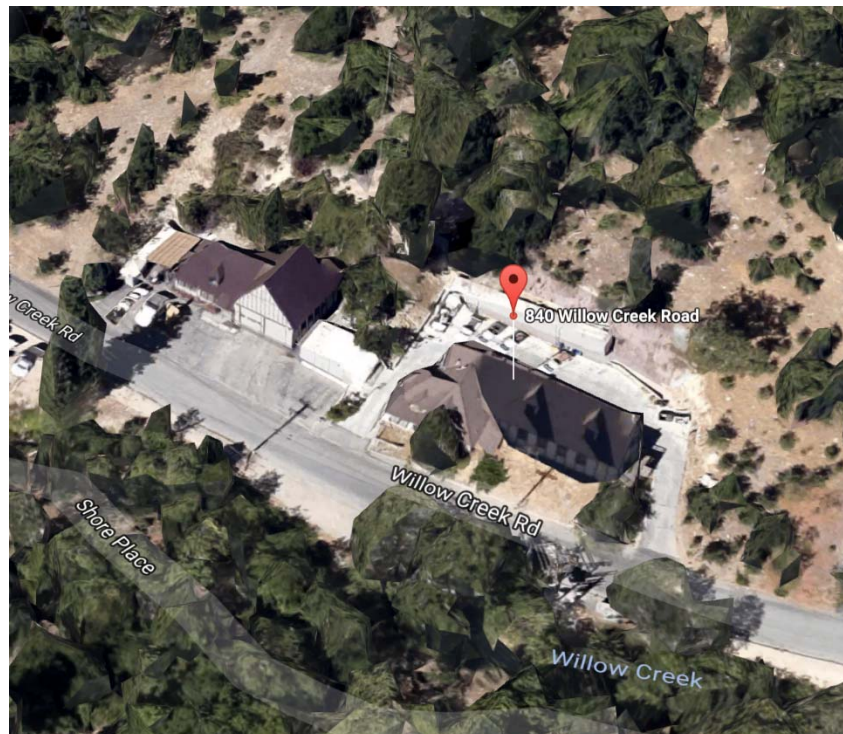
Figure 1: Birds Eye View of Complex

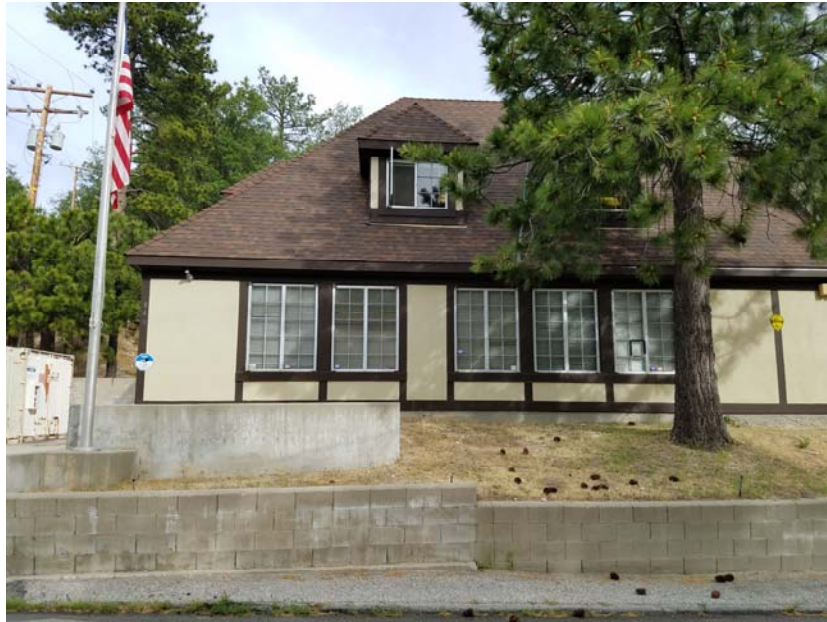
Figure 2: Main Building

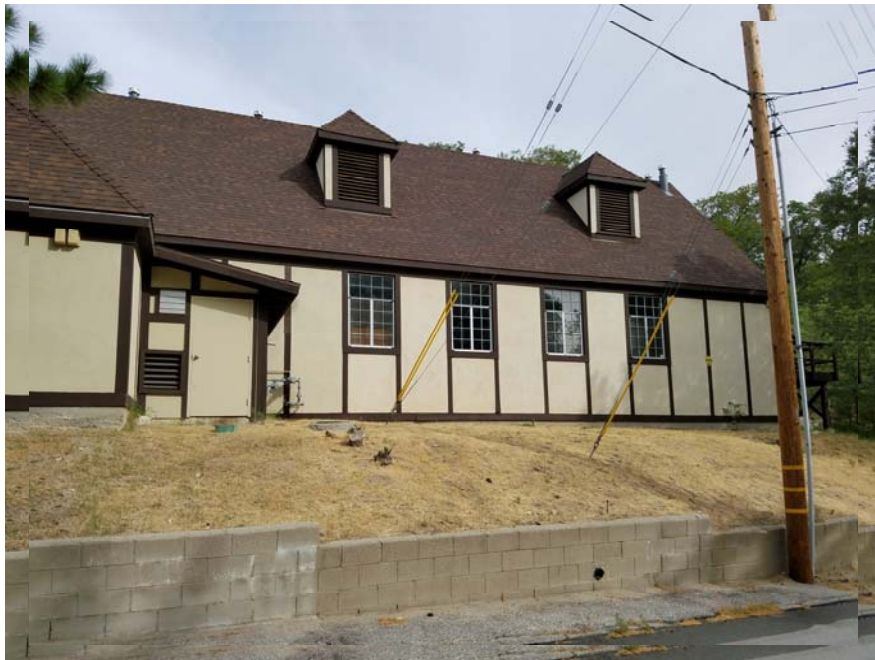
Figure 3: Main Building

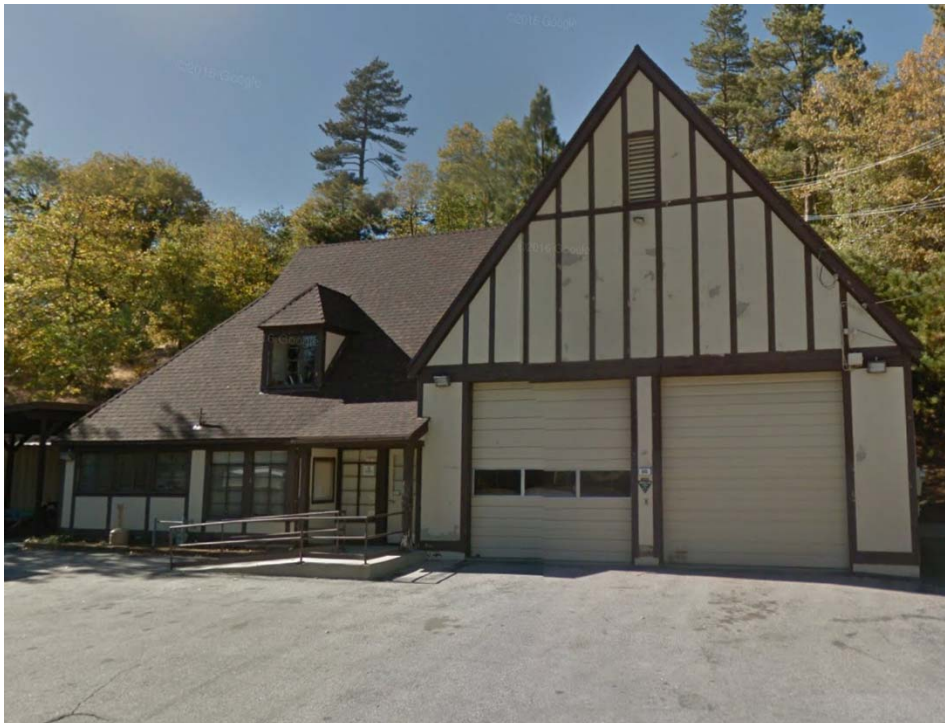
Figure 4: Ancillary Building

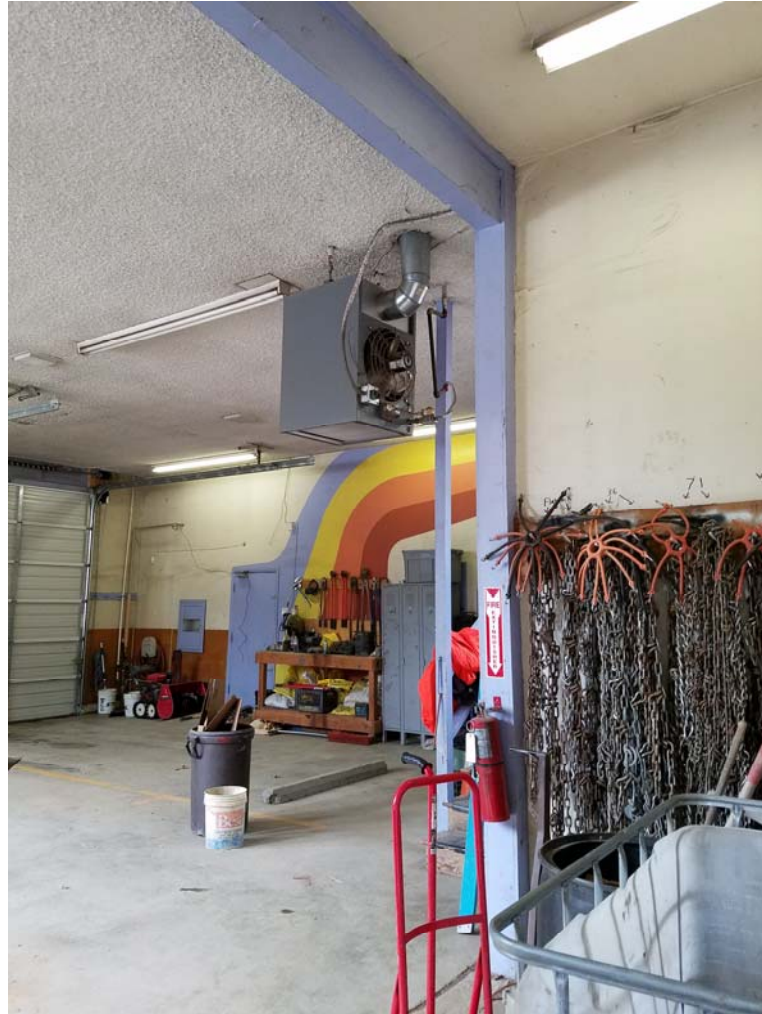
Figure 5: Ancillary Building

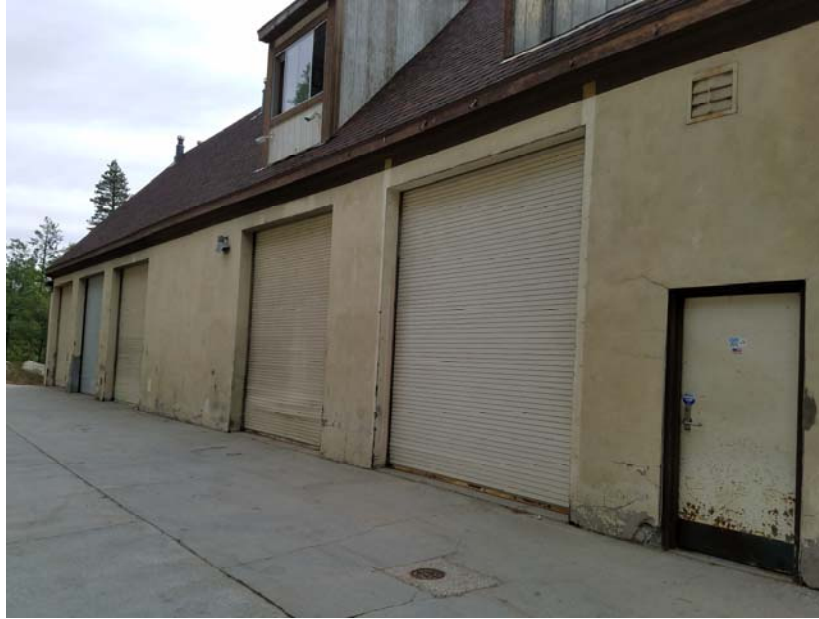
Figure 6: Main Building (Rear)

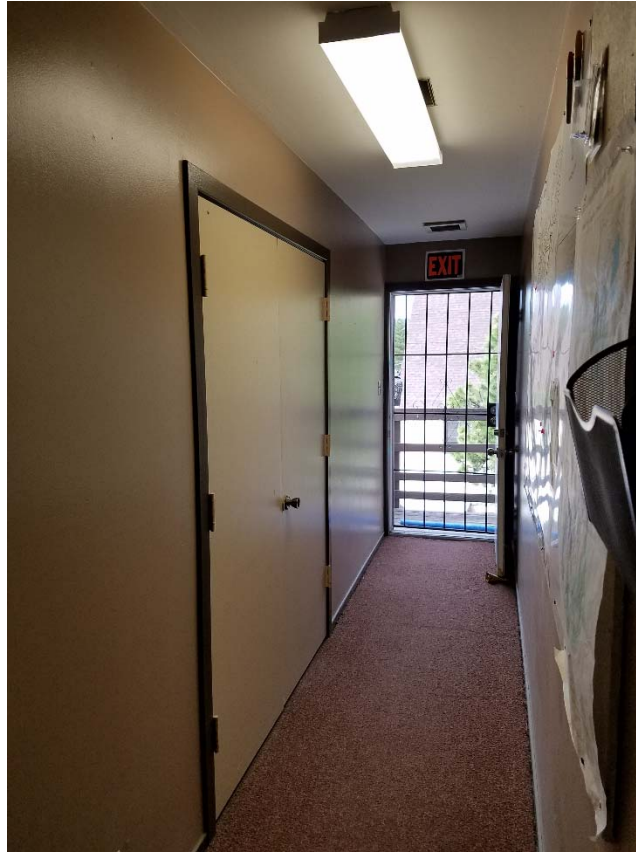
Figure 8: Main Building Corridor
