Seismic Ratings

University of California

Anderson Graduate School of Management
CAANs: 515A, 515B, 515C, 515D, 515E
(Excerpt from 2017 UC Seismic Ratings Document)

June 30, 2017

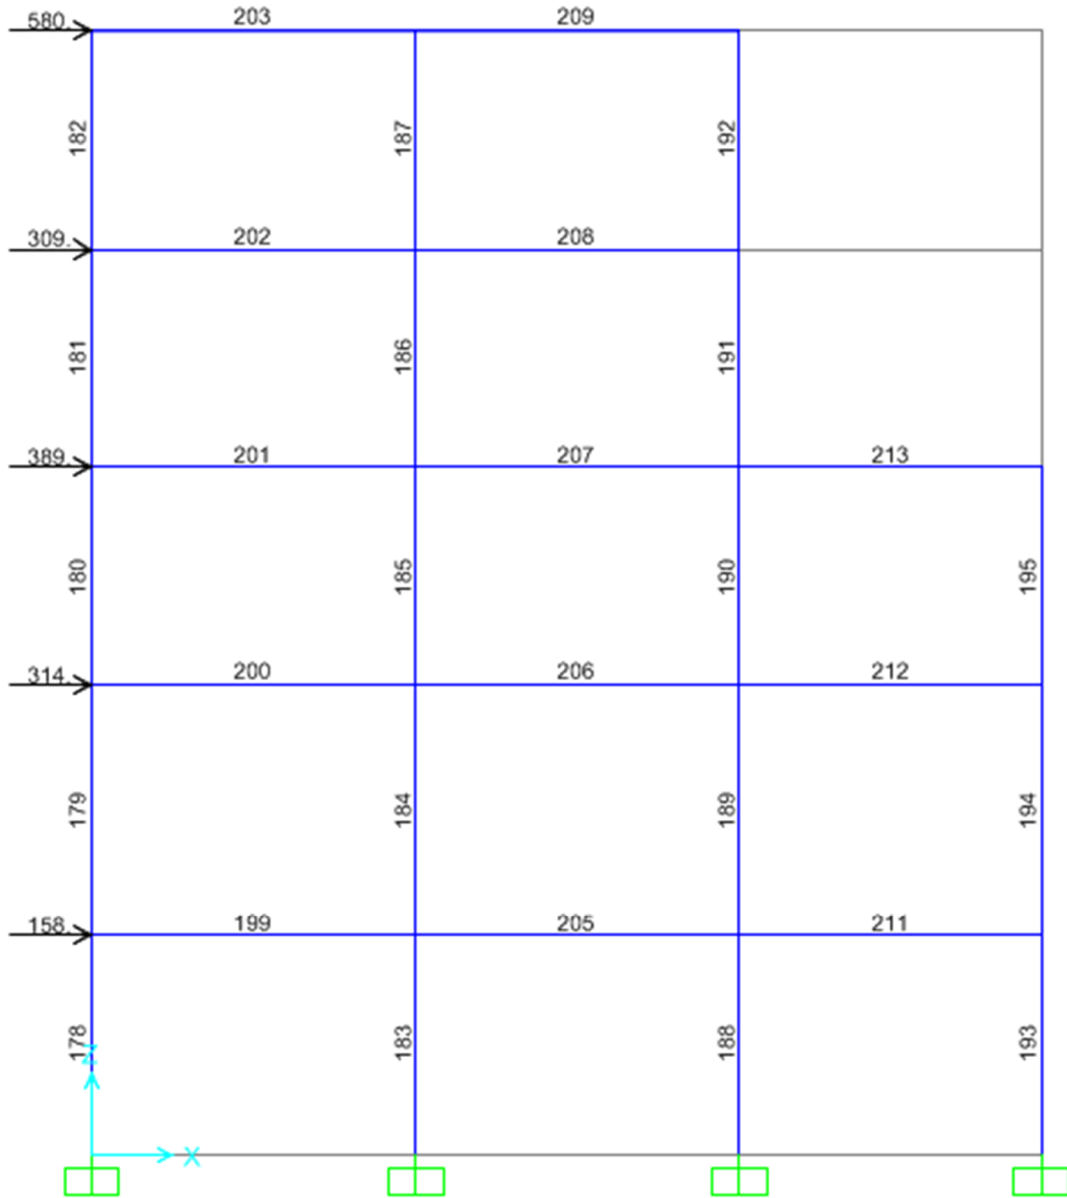
Figure 2 – Gold Hall's Frame #4 – Element numbers and applied seismic forces (kips).

Gold Hall's Frame #4 is presented below showing seismic forces applied and a table with demand/capacity ratios for columns, where a couple of non-compact members are used, with acceptable ratios less than or equal to one. Demands at a BSE-1E level including gravitational loading are compared against the section capacities considering the appropriate m -factor to determine the adequacy of the structure.

Table 1: Gold Hall's Frame #4 columns Demand/Capacity Ratios

Element #	Section Type	Section	D/C
178	I/Wide Flange	W24X229	0.91
179	I/Wide Flange	W24X229	0.63
180	I/Wide Flange	W24X229	0.38
181	I/Wide Flange	W24X146	0.21
182	I/Wide Flange	W24X146	0.13
183	I/Wide Flange	W24X229	0.90
184	I/Wide Flange	W24X229	0.83
185	I/Wide Flange	W24X229	0.57
186	I/Wide Flange	W24X162	0.23
187	I/Wide Flange	W24X162	0.17
188	I/Wide Flange	W24X229	0.91
189	I/Wide Flange	W24X229	0.85
190	I/Wide Flange	W24X229	0.62
191	I/Wide Flange	W24X146	0.25
192	I/Wide Flange	W24X146	0.13
193	Tube	T20X258	0.38
194	Tube	T20X258	0.29
195	Tube	T20X258	0.23

Similarly, moment frame connections are checked with the appropriate *m-factors* to determine their demand/capacity ratios for the different limit states. Results for the connections on the frame presented before are shown next, with acceptable demand/capacity ratios less than or equal to one.

Table 2: Gold Hall's Frame #4 moment resisting connections Demand/Capacity Ratios

Story	Beam	m-factor	D/C
2	W33X152	1.00	0.92
3	W30X124	1.15	1.00
4	W27X114	1.30	0.64
5	W27X114	1.30	0.58
