November 5, 2020

Subject: Parcel 65R Boathouse  
14001 Fiji Way, Marina Del Rey, CA 90292  
Seismic Screening Report  
JLA Job no. 19001-15

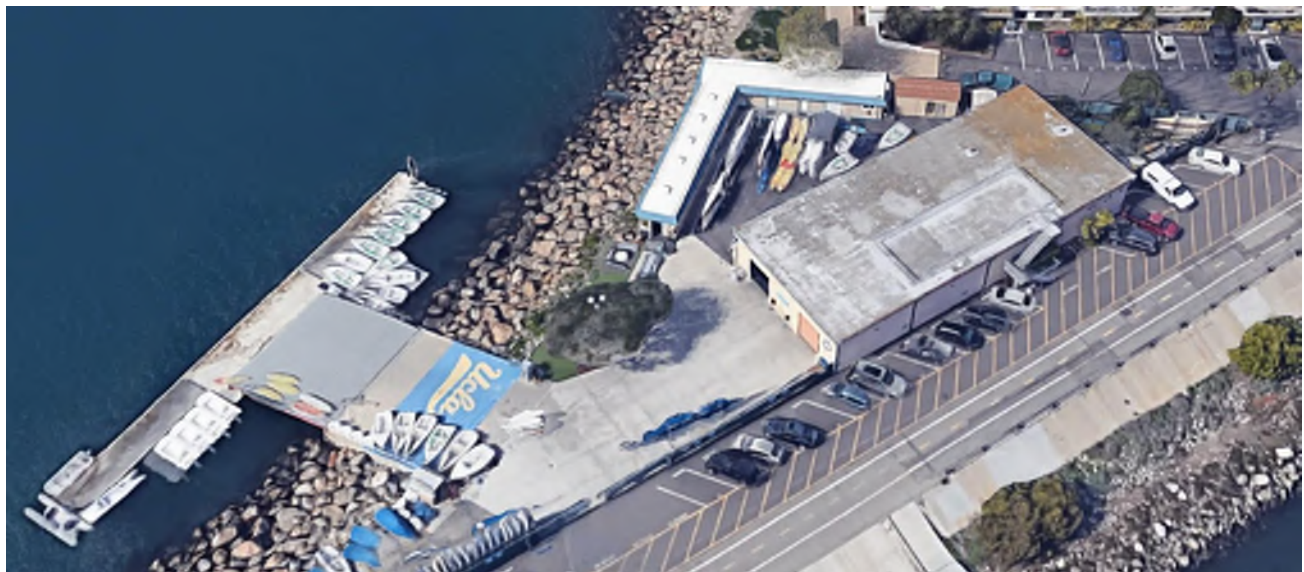
Figure I. View of Overall Subject Existing Building Site
