BUILDING REPORT REQUIREMENTS
ASCE 41-17 TIER 1 SEISMIC EVALUATIONS

- 1) UC Campus: Los Angeles
2) Building Name: Lake Arrowhead Briar Creek
3) Building CAAN ID: 42018
4) Auxiliary Building ID:
5) Date of Evaluation: 6/30/2020
6) Evaluation by: Englekirk, TAS
7) Seismic Performance Rating and Basis of Rating: V, ASCE 41-17 Tier 1

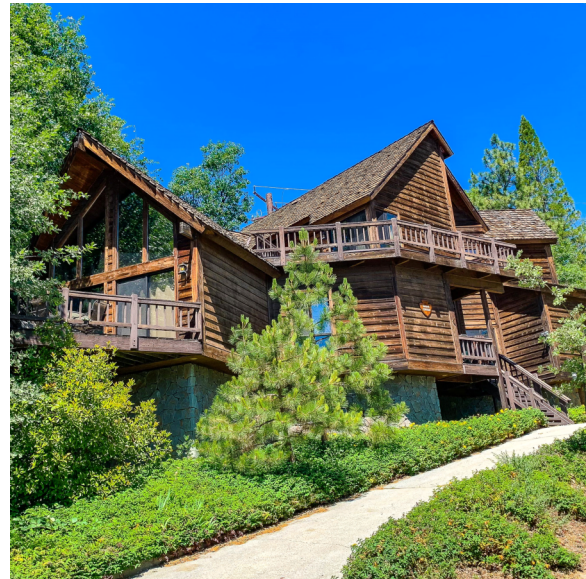
9) Exterior Elevation Photo

Comments: No drawings provided, but most likely pre-1985. Possibly acquired by UCLA from private party. No CGS maps for north shore of Lake Arrowhead. Field visit shows plywood braced crawl space perimeter and structural hardware between framing in crawl space, which suggests an engineering design.. Rating IV assigned but a Tier 2 or 3 recommended to confirm rating.
