September 14, 2017

Subject: 28291 Geneva Lane, Lake Arrowhead, CA  
Seismic Screening Report  
JLA Job no. 17101-06

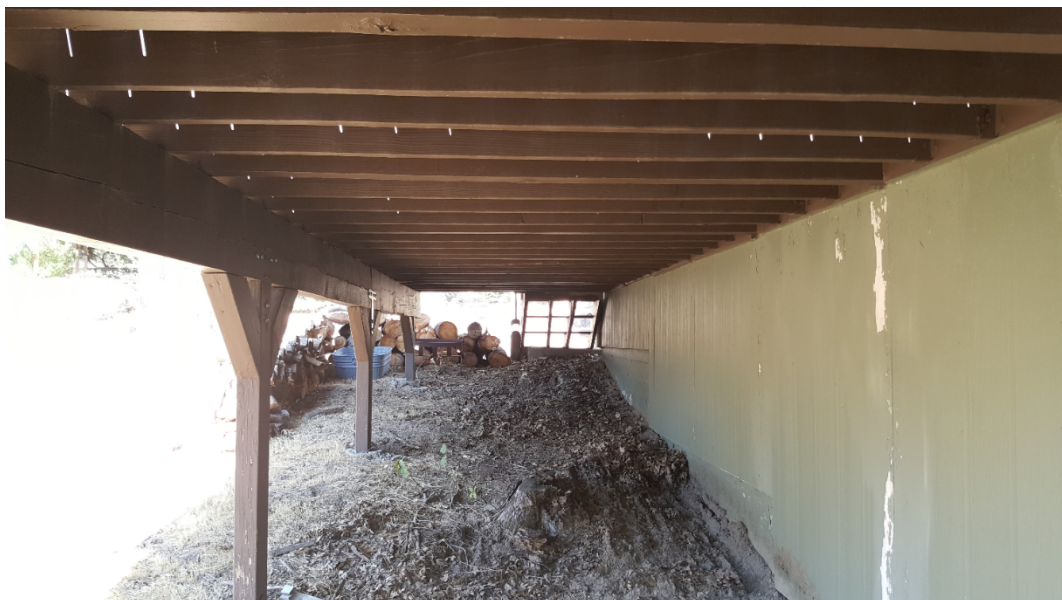
Figure 5: Underside of Rear Balcony / Deck

In general construction of non-structural elements do not pose any risk to safety. Two issues were identified, however, that require attention and repair. Figure 5 shows the underside of the exterior balcony / deck. Note the main girder running at the edge parallel to the length of the deck. This element appears to be twisted and has a horizontal crack running longitudinal to its main axis. This element needs to be replaced (or repaired with strapping). Figure 6 shows a brick chimney. Anchorage of this chimney at the floor and the roof is required to ensure life safety. These could be added and/or the Chimney could be replaced with a conventionally framed chimney.

- Based on our observations and our conceptual evaluation of the lateral-load-resisting system, the lateral system is adequate for the size, configuration, and age of the building. A major seismic disturbance is likely to result in structural and non-structural damage that would represent low life hazards. Improvements to the rear deck and chimney should be pursued to further enhance building performance.

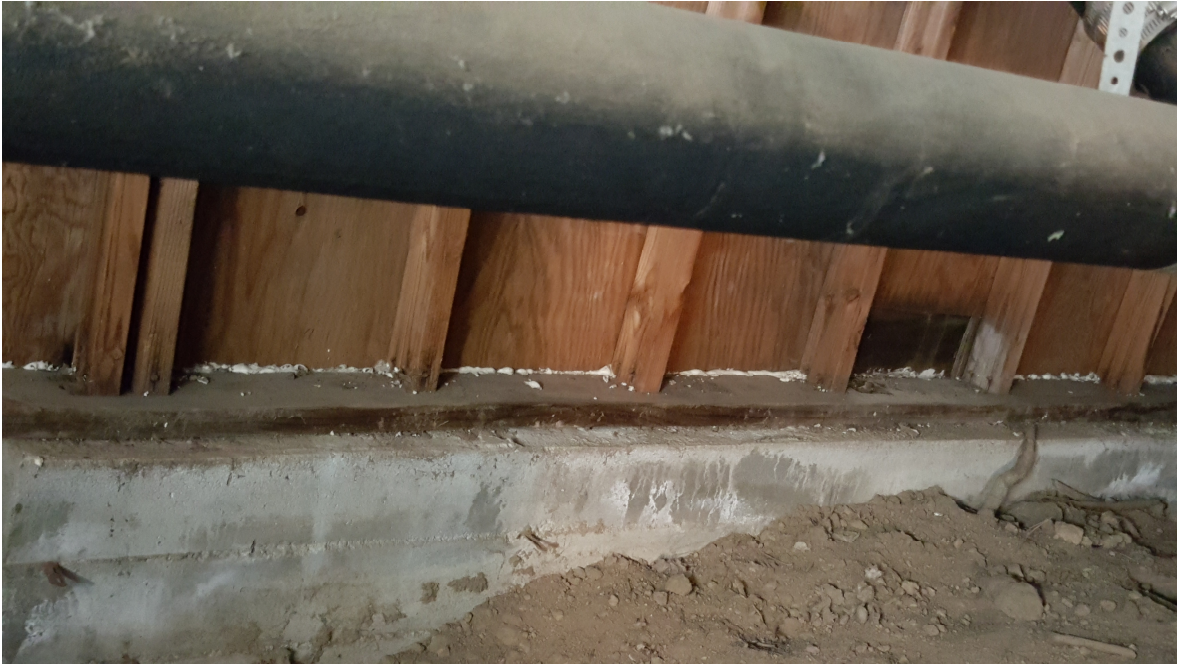
Figure 10: Wall Anchorage

Existing drawings were not made available, however, based on the architecture, vintage, and materials used we expect and can infer from our observations that the lateral system consists of conventional plywood shear walls distributed throughout the building. The wall is anchored to a concrete foundation as observed in the basement. The walls bottom plate is anchored to strip footings using anchors at incremental spacing. The plywood walls extend from the foundation up to tie to the roof. Plywood sheathing transfers floor loads to the shear walls. In general the design and detailing resembles typical timber construction still used today.
