BUILDING REPORT REQUIREMENTS
ASCE 41-17 TIER 1 SEISMIC EVALUATIONS

BUILDING REPORT

- 1) UC Campus: Los Angeles
2) Building Name: Lake Arrowhead Lodge
3) Building CAAN ID: 4201
4) Auxiliary Building ID:
5) Date of Evaluation: 6/30/2020
6) Evaluation by: Englekirk, TAS
7) Seismic Performance Rating and Basis of Rating: V, ASCE 41-17 Tier 1

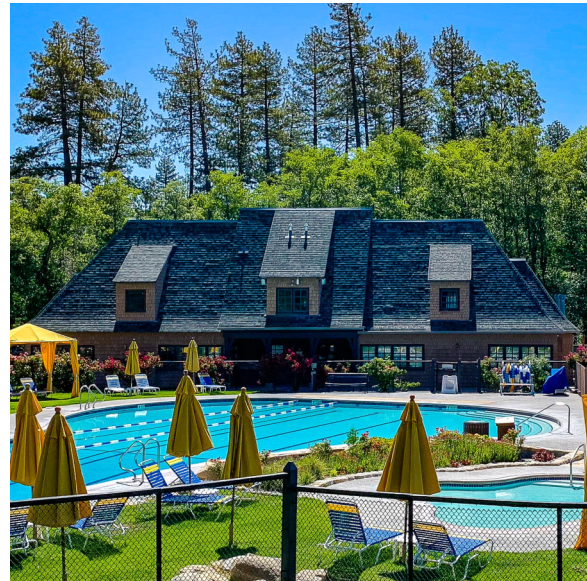
9) Exterior Elevation Photo

Comments: Drawings of original lodge not provided. Extensive two-story addition in 1984. Reference to building code is "California Administrative Code," which would suggest at least 1979 UBC. Extent to which the original structure was replaced or upgraded by the 1984 work cannot be determined without original lodge drawings. No CGS maps for north shore of Lake Arrowhead. Tall CMU chimney tied to roof framing.
