BUILDING REPORT REQUIREMENTS ASCE 41-17 TIER 1 SEISMIC EVALUATIONS

2) Building Name: Lake Arrowhead Lupine

3) Building CAAN ID: 4201Z4) Auxiliary Building ID:

5) Date of Evaluation: 6/30/20206) Evaluation by: Englekirk, TAS

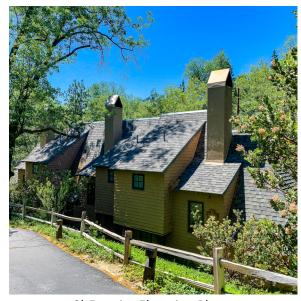
9) Exterior Elevation Photo

Comments: Building code inferred from drawing date (code reference not legible). No CGS maps for north shore of Lake Arrowhead. Except for sloping site which is addressed in the design, building qualifies for presumptive rating of III. Rating lowered one value for deck bracing configuration and lack of chimney detailing to confirm bracing.
