Seismic Ratings

University of California

Brain Mapping Building

(Excerpt from 2017 UC Seismic Ratings Study)

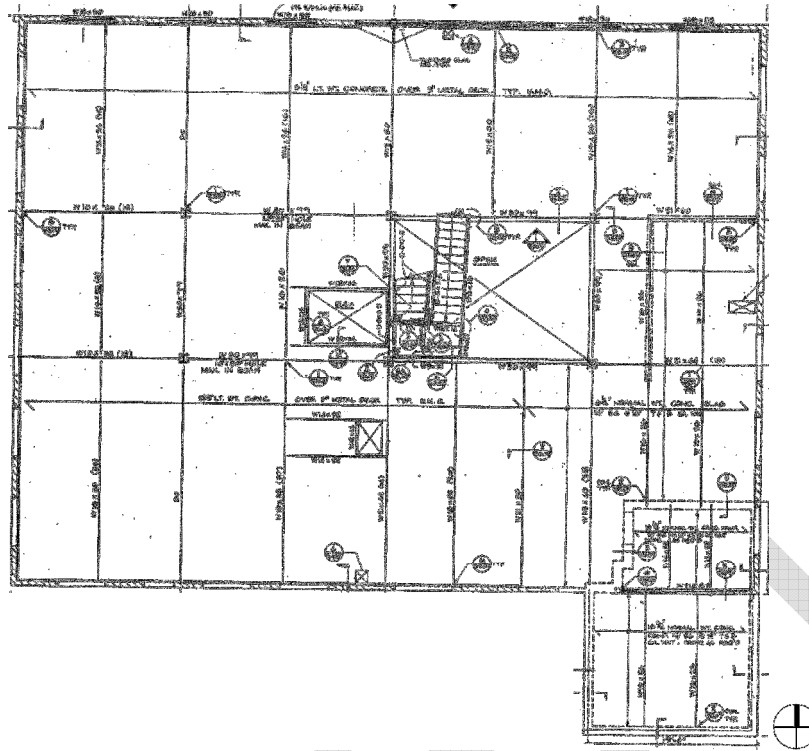
Figure 4.11.2 Typical framing plan

The perimeter walls serve as shear walls. The bottom floor is braced with 7 ½” thick concrete walls with 8” thick solid grouted, reinforced, concrete masonry block walls built on top, starting at Level 2 and terminating at roof parapets. A typical framing plan is shown in Figure 4.13.2.

Per ASCE 41-13, the building is classified as Building Type RM2 and C2 due to different lateral systems up the height of the building.

4.11.2 Seismic Rating: No Tier 1 deficiencies were observed in this building. The building qualifies for a Seismic Rating of III, as defined in Table 1.2.
