SEISMIC EVALUATION  
Of

**UCLA Clark Library Gatehouse**  
University of California  
Los Angeles, CA

**Nabih Youssef & Associates**  
*Structural Engineers*  
550 Hope Street, 17<sup>th</sup> Floor  
Los Angeles, California 90071  
NYA Job # 12101-00  
November 24, 2014

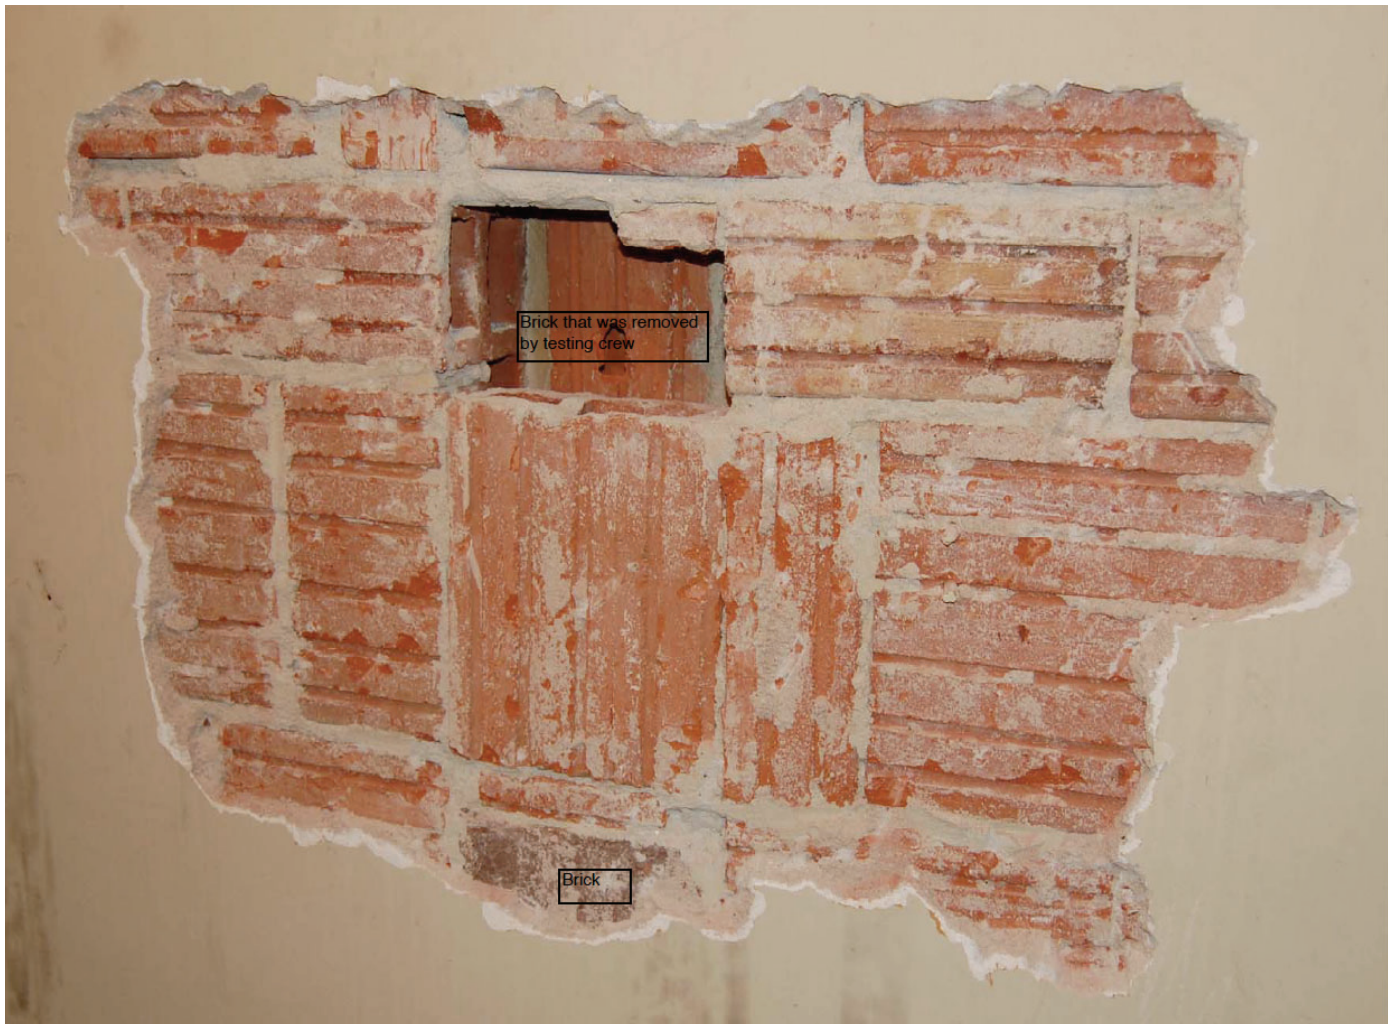
**Test Results:** The interior face of the wall was found to be built with Hollow Clay Tiles (HCT) covered with plaster. In the examined area, the tiles were found to be placed rather randomly with no obvious pattern, such that the cells of the blocks sometimes run horizontally, and some times vertically. Thickness of the interior primarily HCT part/wythes appears to be approximately 8-inches. The blocks are held together with mortared joints.

Besides HCT blocks, it was found that solid bricks were also used to fill in the spaces in the construction of the interior face.

**Figure 2.1 Interior face of the north wall of the single-story wing on the northeast side of the central building. This photo depicts the random arrangement of HCT units and some solid bricks in the test area identified as WC1.3**

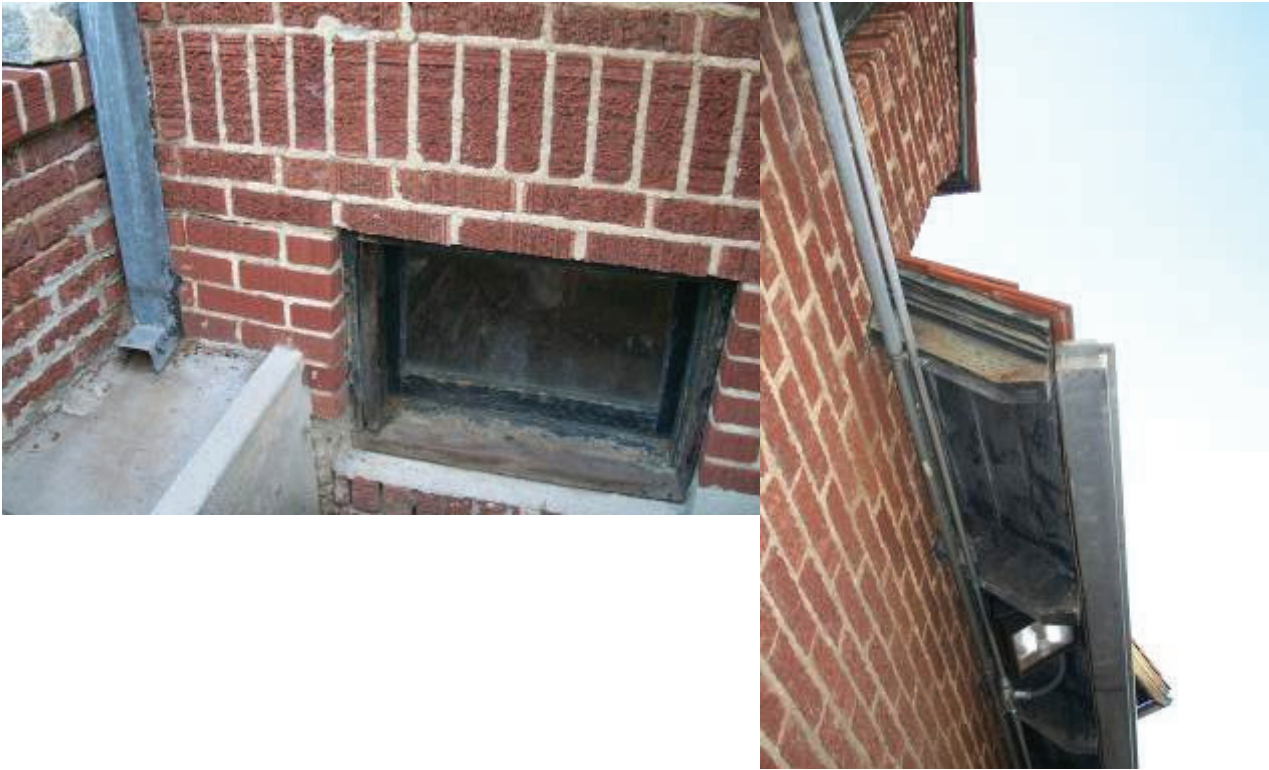
- In general, the building appeared to be in fair condition; there were no signs of significant structural cracking. The quality of construction appears to be good.
- Deterioration of exposed wood was observed at roof rafter tails, and around window frames. See Photo B.1
- Several locations of repointed mortar were visible. See Photo B.2. At some locations the exterior brick mortar was deteriorating. See Photo B.3
- Cracks were visible between the plaster ceiling and the exterior walls. See Photo B.2
- A wall crack at the basement wall was observed. See Photo B.4
- No mechanical connections between the roof framing and the exterior HCT walls were observed. See Photo B.5
- No permanent offset of the building that would indicate structural distress was observed.
- Existing wood walls stop at underside of existing ceiling.

Photo B.1: Exterior Rafter Tail and Window Frame Deterioration

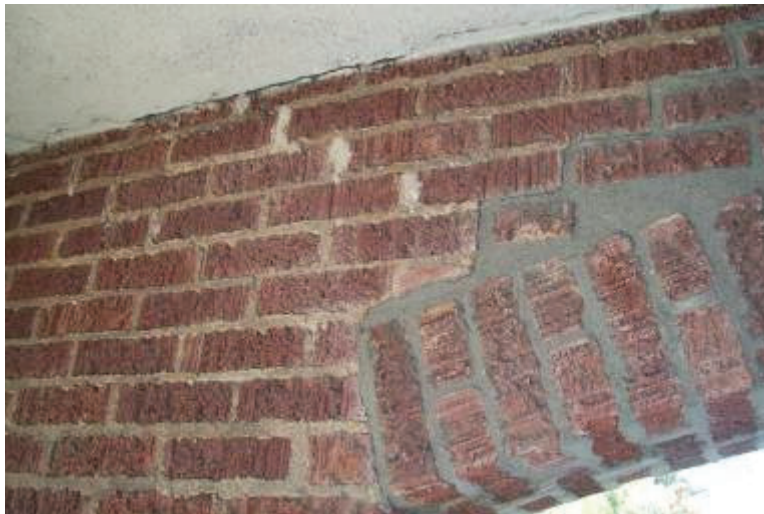
Photo B.2: Repointed Mortar and Plaster Cracks

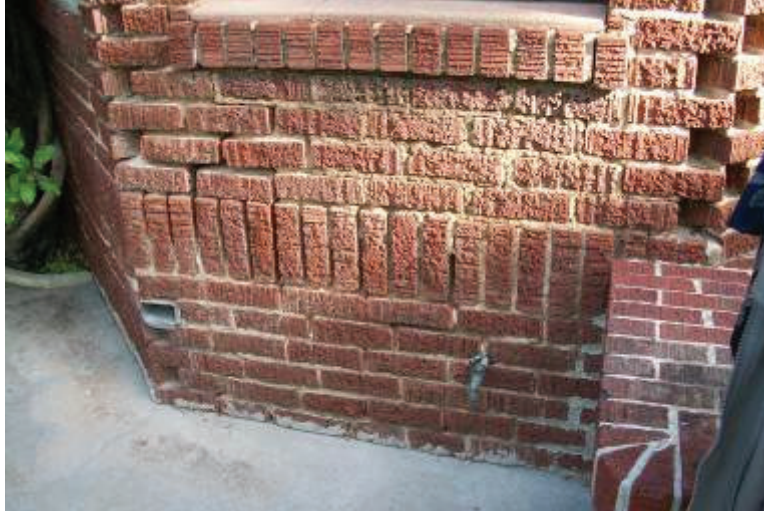
A major cause of damage and injury during earthquakes in buildings is due to exterior falling hazards. The brick façade of this structure is most likely not adequately anchored to the bearing walls and can peel away in a major seismic event.

Photo B.3: Mortar Deterioration at Façade Brick

In order to mitigate the falling hazards deficiencies, the recommended seismic upgrades include providing adequate out-of-plane anchors of the exterior façade brick and the structural walls. This can be achieved by providing brick retrofit anchors from the brick to the structural wall. Repointing of brick mortar at deteriorated locations will also be required.

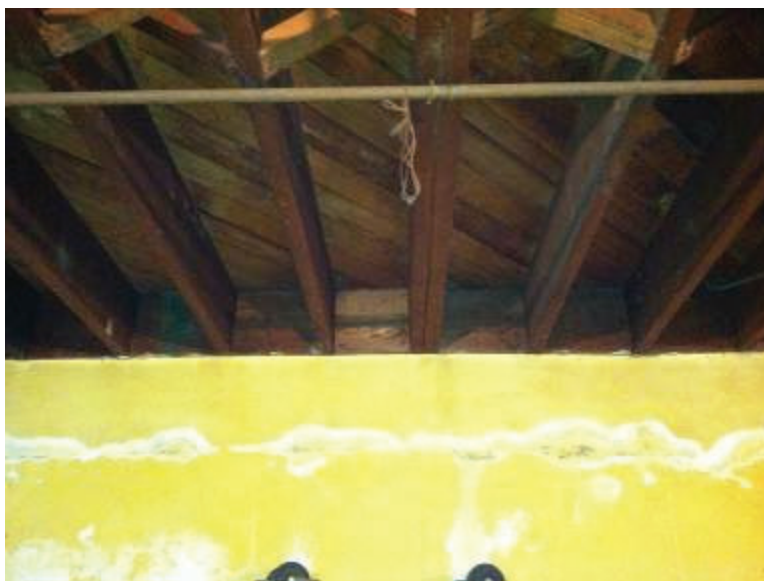
Photo B.4: Basement Wall Crack

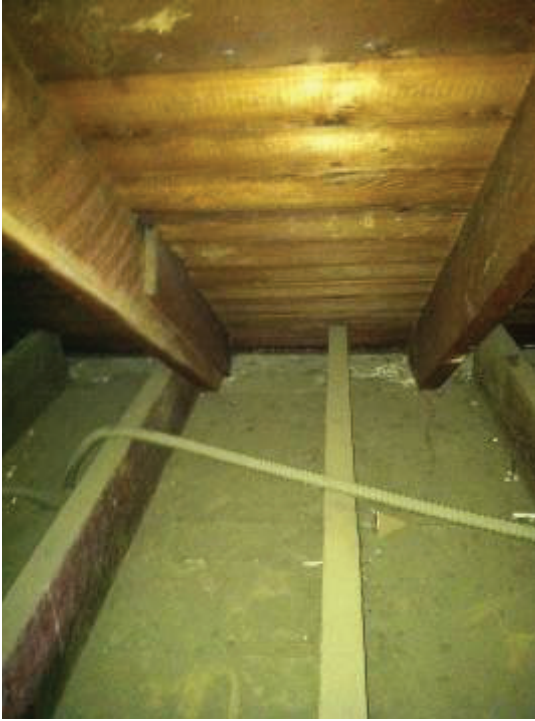
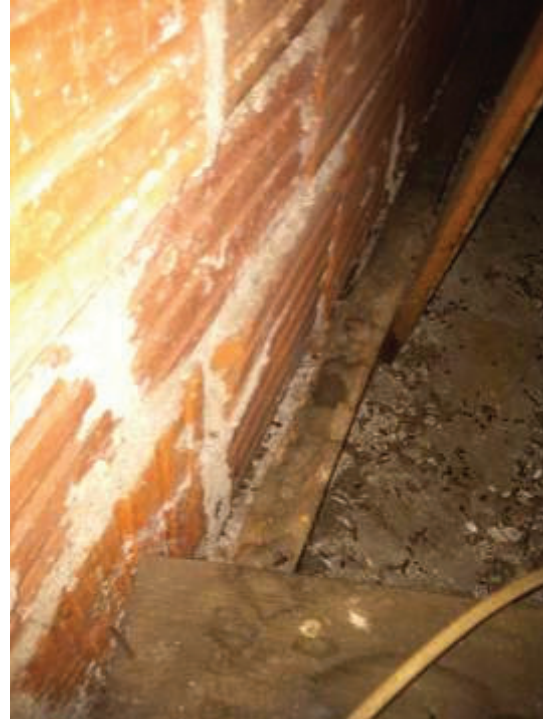
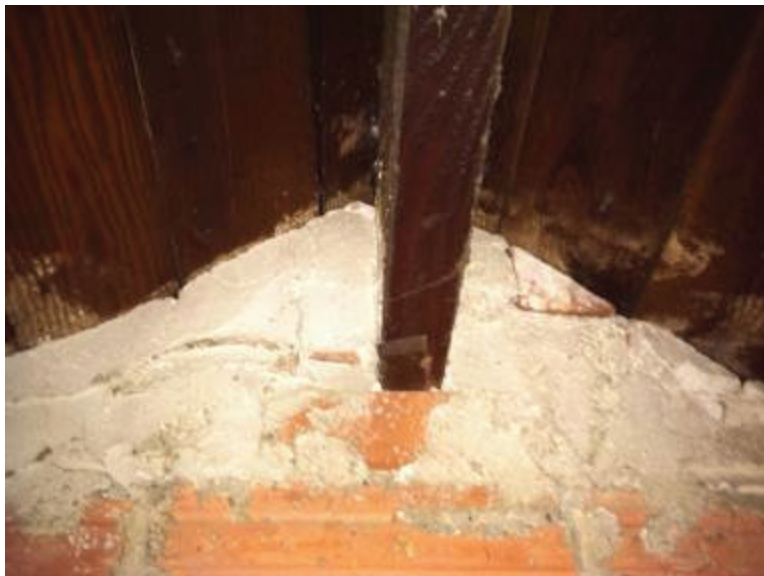
The other major deficiency is the lack of visible connection between the floor and roof diaphragms to the exterior walls. Although the walls are not ductile, they do provide some level of lateral stiffness to the structure. However, without a positive connection between the roof/floors to the walls, in a seismic event, the walls can separate from the floors and roof leading to partial or complete collapse of the building.

Photo B.5: Roof Framing to Exterior HCT Walls

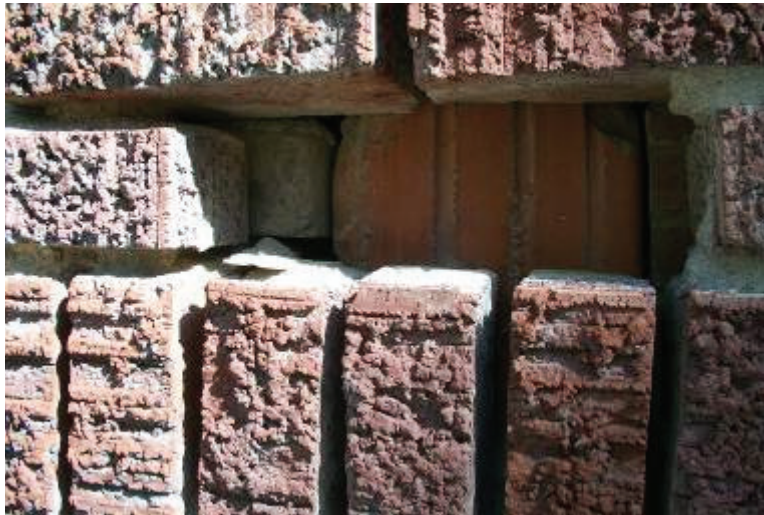
- At one location an exterior face brick was removable. The mortar had been intentionally removed. A loose brick anchor tie was observed behind the brick. See Photo B.6

Photo B.6: Exposed HCT at Exterior

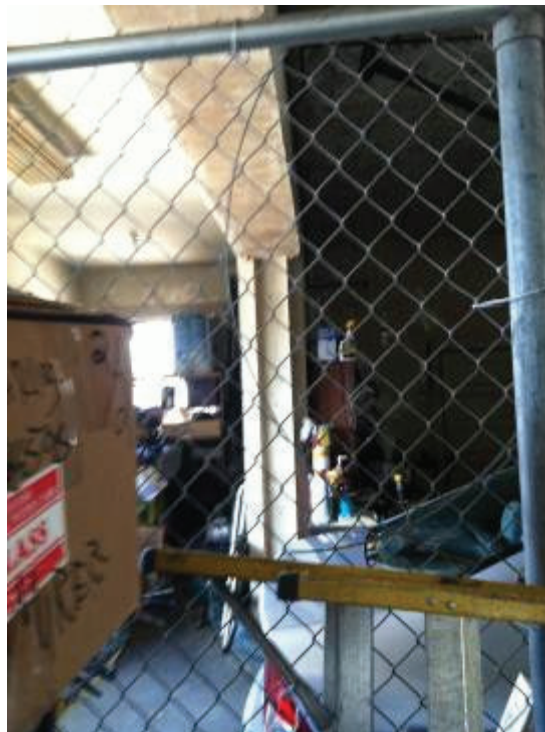
do not continue to the foundation, the supporting beam elements are required to carry the seismic overturning forces of the discontinuous walls. It appears that a steel beam has been added over the large opening on the north side of the structure, but no beams are apparent on the south openings.

Photo B.7: Steel Column and Beam at Opening
