FORM 1
CERTIFICATE OF SEISMIC PERFORMANCE LEVEL

Building Name: [CRA MOD UNIT](#)
Address: [101 De Neve Dr, Los Angeles CA 90024](#)
Site location coordinates: Latitude [34.0732102](#) Longitudinal [-118.4491284](#)

UCLA – CRA MOD UNIT

FEMA 154 Rapid Visual Screening Minimum Building Report Information

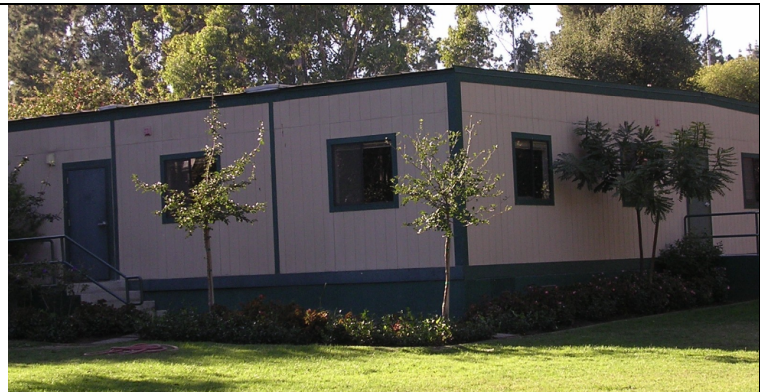
Exterior Elevation

A FEMA 154 Level 2 Rapid Visual Screening was performed in lieu of an ASCE Tier 1 evaluation due to the construction type and lack of as-built documentation. Campus facilities were not able to provide access to view the base of the modular unit so KPFF assumed that dedicated footings and/or anchorage of the base of the modular unit was not provided, which results in a seismic rating of V. This is consistent with other similar buildings observed on campus.

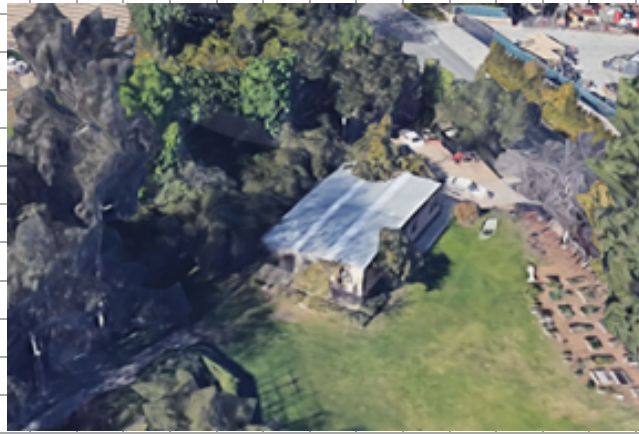
SKETCH

Structure is manufactured housing. Rests on posts that are not laterally braced.
(Assumed since we did not have access to the crawl space underneath the building)
