FORM 1
CERTIFICATE OF SEISMIC PERFORMANCE LEVEL

Building Name: [DWP BLDG 1](#)
Address: [731 Charles E. Young Dr. S, Los Angeles CA 90095](#)
Site location coordinates: Latitude [34.0672582](#) Longitudinal [-118.4461552](#)

UCLA – DWP BLDG 1

FEMA 154 Rapid Visual Screening

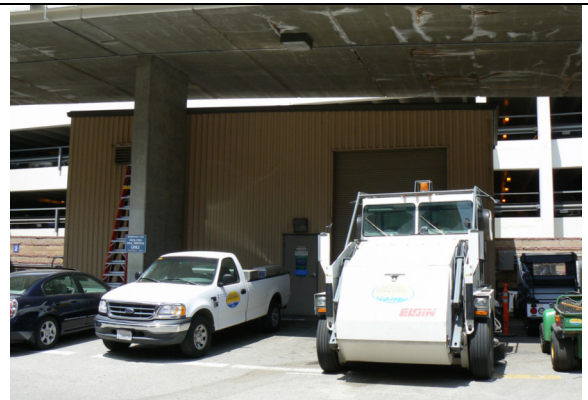
Exterior Elevation

A FEMA 154 Level 2 Rapid Visual Screening was performed in lieu of an ASCE Tier 1 evaluation due to construction type and lack of as-built documentation. The structure is below a bridge that has previously been seismically rated as an IV. Due to the essential equipment within the building, it is given a V rating.

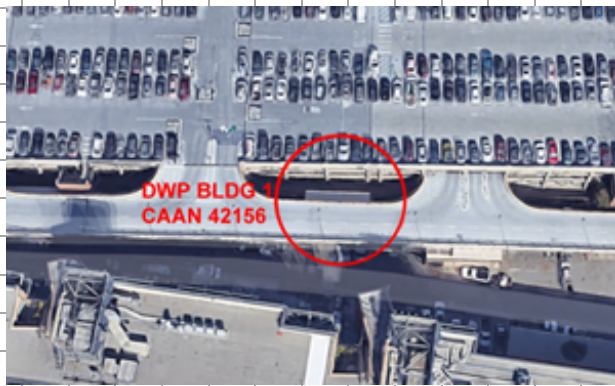
SKETCH

Equipment sits below a bridge previously rated as an IV structure. The building houses essential electrical equipment.
