FORM 1
CERTIFICATE OF SEISMIC PERFORMANCE LEVEL

Building Name: [DWP BLDG 2](#)
Address: [731 Charles E. Young Dr. S, Los Angeles CA 90095](#)
Site location coordinates: Latitude [34.0672582](#) Longitudinal [-118.4461552](#)

UCLA – DWP BLDG 2

FEMA 154 Rapid Visual Screening Minimum Building Report Information

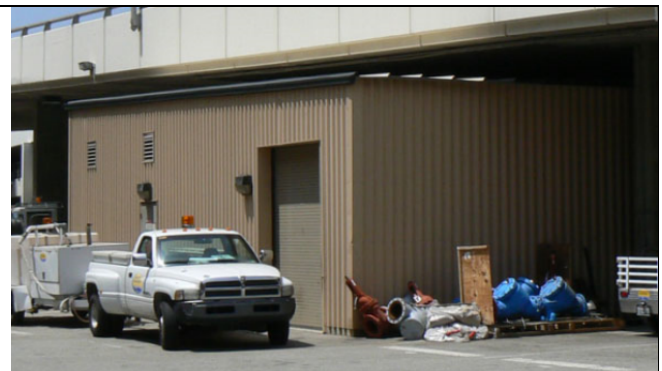
Exterior Elevation

A FEMA 154 Level 2 Rapid Visual Screening was performed in lieu of an ASCE Tier 1 evaluation due to construction type and lack of as-built documentation. The structure is below a bridge that has previously been seismically rated as an IV. Due to the essential equipment within the building, it is given a V rating.
