**FORM 1**  
**CERTIFICATE OF SEISMIC PERFORMANCE LEVEL**

### UCLA – Easton Stadium (Batting Cages)

FEMA 154 Rapid Visual Screening

Building Name: Easton Stadium - Batting Cages

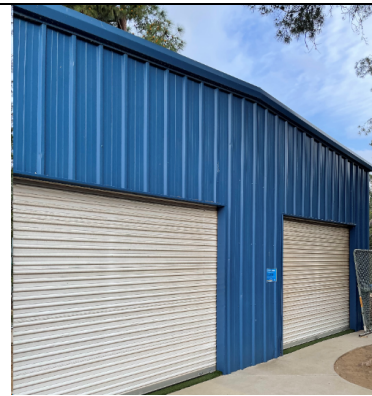
Exterior Elevation

A FEMA 154 Level 2 Rapid Visual Screening was performed in lieu of an ASCE Tier 1 evaluation due to construction type and lack of as-built documentation. Lack of redundancy is the most significant factor in the rating determination.

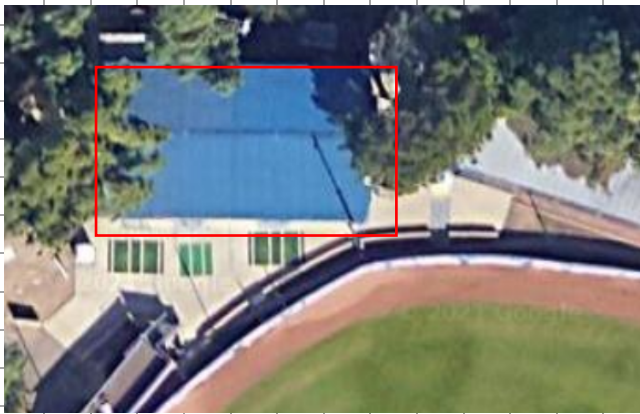
SKETCH

Exterior and interior of the building were inspected. Lateral system consists of large metal stud framing.
