FORM 1
CERTIFICATE OF SEISMIC PERFORMANCE LEVEL

Building Name: [Easton Stadium - Bleacher Concessions](#)
Address: [100 De Neve Dr. Los Angeles, CA 90024](#)
Site location coordinates: Latitude [34.07389225](#) Longitudinal [-118.4424168](#)

UCLA – Easton Stadium (Bleacher Concessions)

FEMA 154 Rapid Visual Screening

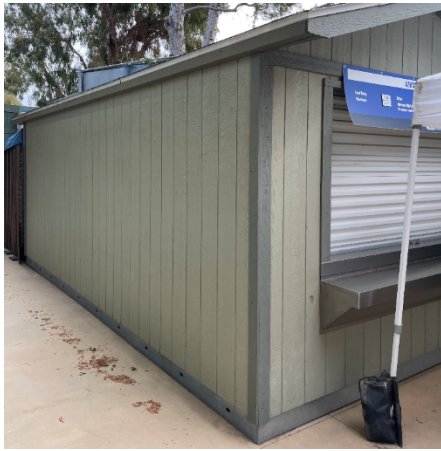
A FEMA 154 Level 2 Rapid Visual Screening was performed in lieu of an ASCE Tier 1 evaluation due to construction type and lack of as-built documentation. Lack of anchorage in the slab below is the most significant deficiency resulting in the assigned rating.

COMMENTS:
Exterior of unit was inspected. Unit does not appear to be anchored to the slab below.
