**FORM 1**  
**CERTIFICATE OF SEISMIC PERFORMANCE LEVEL**

### UCLA – Easton Stadium (Bleacher Storage)

**FEMA 154 Rapid Visual Screening**

Building Name: **Easton Stadium - Bleacher Storage**

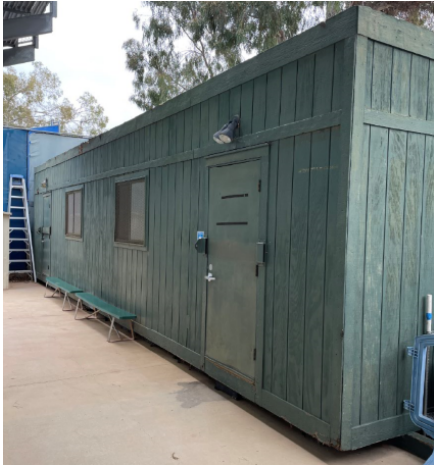
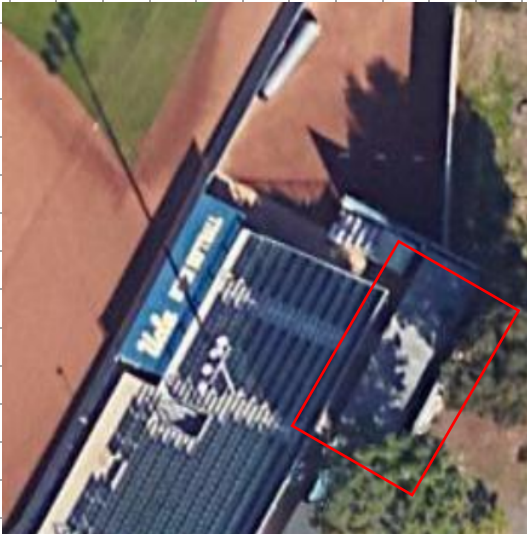
COMMENTS:  
Observed exterior of modular unit. Unit is not anchored to the slab below and rests on top of wood members.  
 Additional sketches or comments on separate page
