FORM 1
CERTIFICATE OF SEISMIC PERFORMANCE LEVEL

Building Name: [Easton Stadium - Outfield Storage](#)
Address: [100 De Neve Dr. Los Angeles, CA 90024](#)
Site location coordinates: Latitude [34.07389225](#) Longitudinal [-118.4424168](#)

UCLA – Easton Stadium (Outfield Storage)

FEMA 154 Rapid Visual Screening

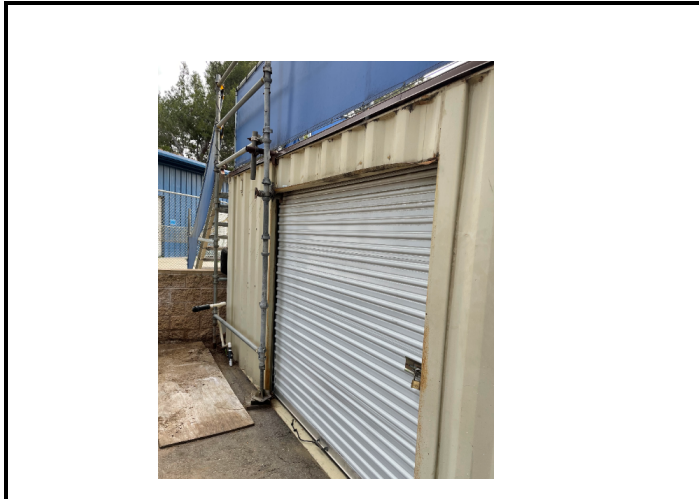
A FEMA 154 Level 2 Rapid Visual Screening was performed in lieu of an ASCE Tier 1 evaluation due to construction type and lack of as-built documentation. Lack of anchorage in the slab below is the most significant deficiency resulting in the assigned rating.

COMMENTS:
Both the exterior and the interior of the modular unit was inspected. The unit is not anchored to slab below.
