BUILDING REPORT REQUIREMENTS
ASCE 41-17 TIER 1 SEISMIC EVALUATIONS

Faculty Levering (CAAN 4297)

Seismic Evaluation

September 24, 2021

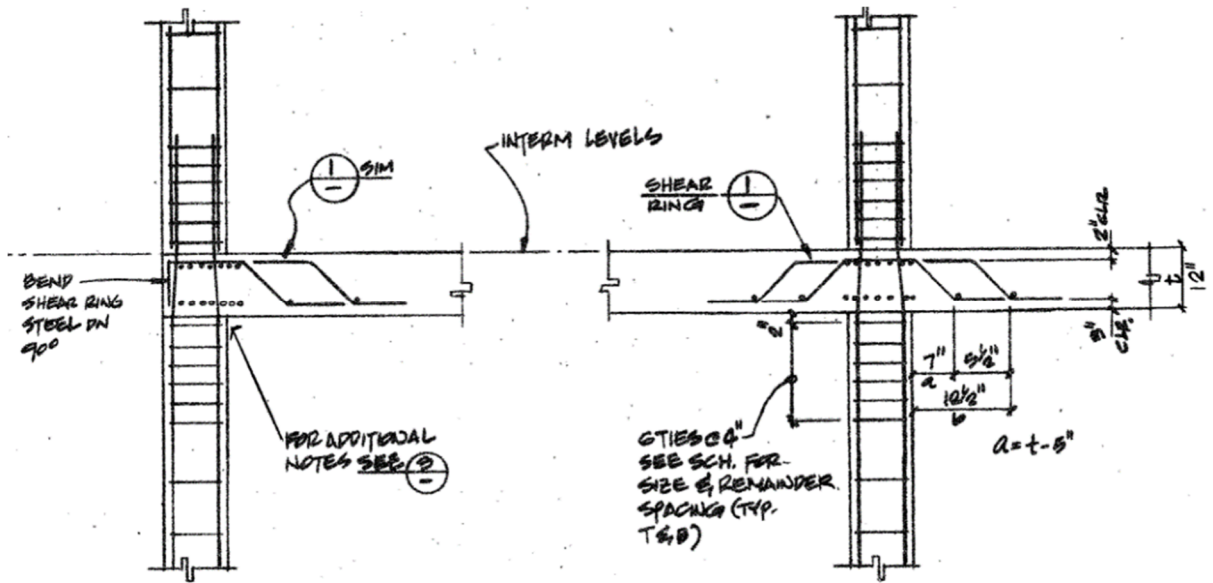
Figure 2.4: Typical Concrete Column Details

- **Non-Compliant Items for Collapse Prevention Structural Checklist for Building Types C2 and C2a:**
 - SHEAR STRESS CHECK: The Quick Check procedure indicates that the shear stress of the concrete shear walls is greater than $2\sqrt{f_c}$.
 - DEFLECTION COMPATIBILITY: A significant percentage of the columns have large tie spacing, e.g., 12" on center. The shear capacities may be insufficient to develop the flexural strength of the columns.
 - FLAT SLAB: The record structural drawings are incomplete, and the typical slab detail sheet is missing. It is unknown if the slabs have continuous bottom steel through the column joints.

Concrete columns were modeled in the 3D linear model with full fixity at both ends. The shear and moment demands of the columns were obtained from the linear dynamic analysis. Shear capacities were calculated and compared against the demand. PMM interaction checks were conducted using SpColumn software to verify the moment demands against the capacities. The results show the demand-capacity ratios of both shear and flexural are less than 1.0. Hence the checklist item is considered compliant based on the Tier 2 results.

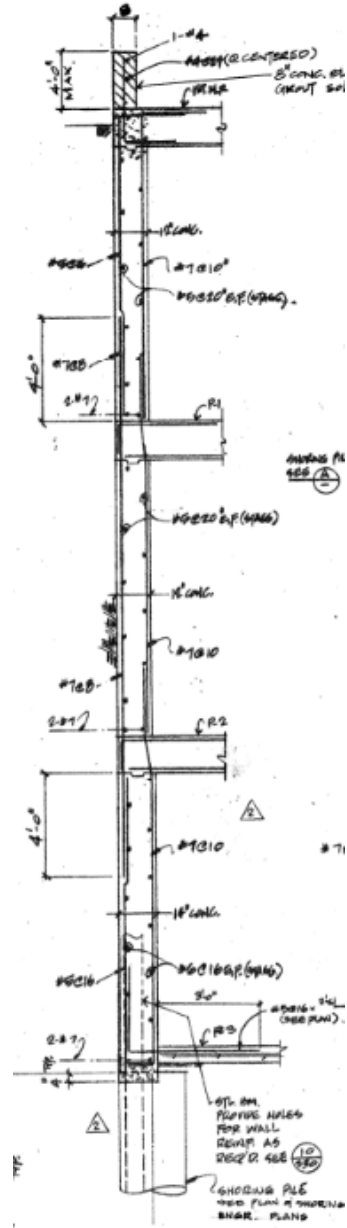
Figure 2.5: Typical Perimeter Concrete Wall Section

For the concrete structure, the lateral system consists of reinforced concrete shear walls along the perimeter over approximately full length. The diaphragm consists of flat concrete two-way slabs at all floors. Figure 2.5 shows a section at the west concrete wall.

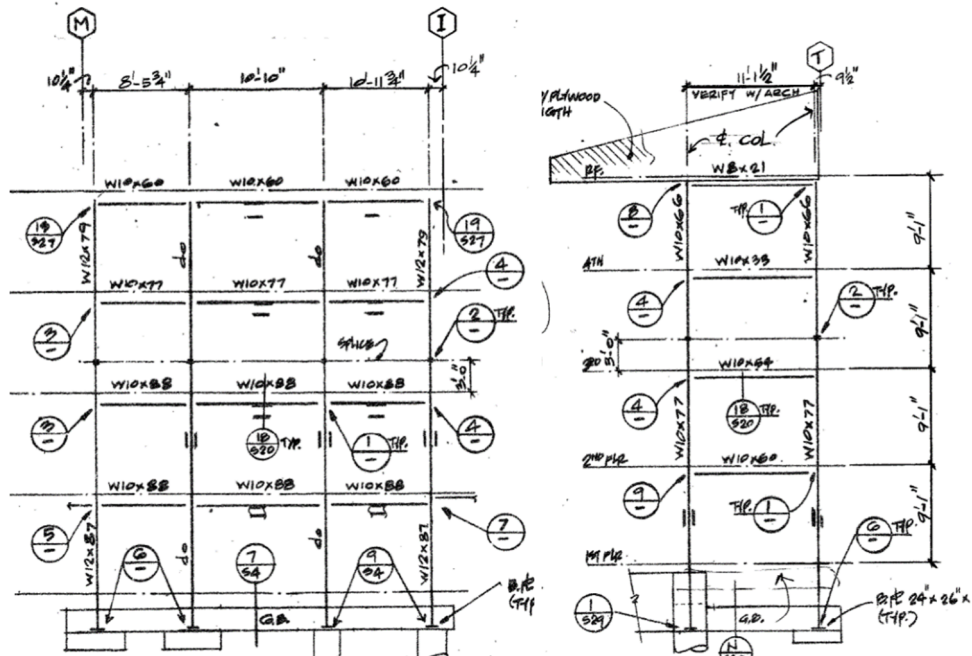
Figure 2.6: Steel Moment Frame Elevations

- **Non-Compliant Items for Collapse Prevention Structural Checklist for Building Types S1 and S1a:**
 - **PANEL ZONE:** The panel zones don't have the shear capacity to resist the shear demand required to develop 0.8 times the sum of the flexural strengths of the girders framing in at the face of the column.

A linear static analysis was conducted to evaluate the steel moment frames. The demands on the panel zones were calculated based on the tributary seismic and gravity loads applied on the moment frames. The capacities were calculated as deformation-controlled action. The demand-capacity ratios of the panel zone are all less than 1.0. This checklist item is considered compliant.

Add doubler plates at steel moment frame panel zones.
