**FORM 1**  
**CERTIFICATE OF SEISMIC PERFORMANCE LEVEL**

Building Name: Fernald CTR – CLSRM 1  
Address: 320 CHARLES E. YOUNG DRIVE, NORTH  
Site location coordinates: Latitude 34.07636829 Longitudinal -118.44363768

### Fernald CTR Classroom 1

**ASCE 41-17 Tier 1 Seismic Evaluation  
Minimum Building Report Information**

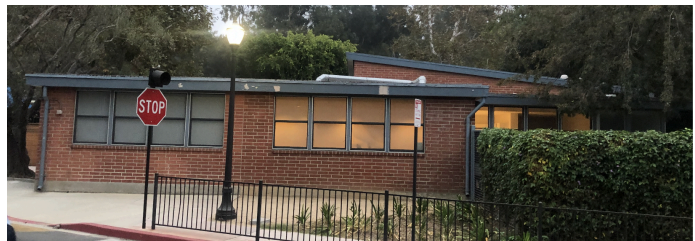
Exterior Elevation

There is differing stiffness on the north elevation, where most of the elevation consists of mullions, as opposed to the south elevation, where brick wall exists along most of elevation. The lack of wall on the north elevation may lead to local overstressing of the drag elements and mullions along the north exterior wall. However, since the seismic demand on the existing lateral system is found to be low, any increased local demands will be absorbed by the shear wall's residual capacity.
