FORM 1
CERTIFICATE OF SEISMIC PERFORMANCE LEVEL

Fernald CTR Classroom 2

ASCE 41-17 Tier 1 Seismic Evaluation
Minimum Building Report Information

Building Name: Fernald CTR Classroom 2

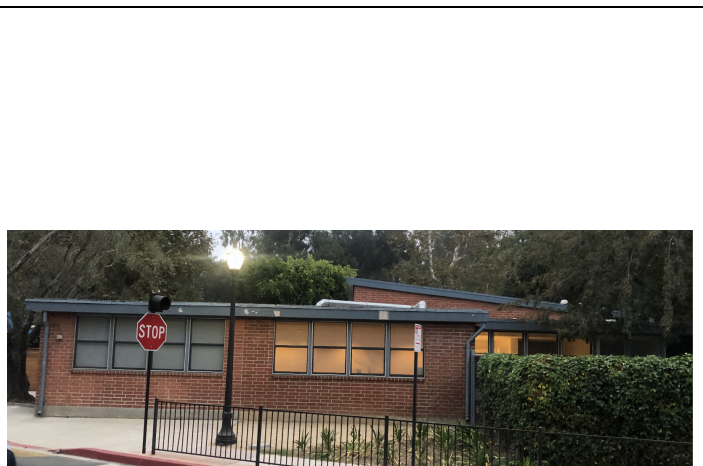
Exterior Elevation

There is differing stiffness on the north elevation, where most of the elevation consists of mullions, as opposed to the south elevation, where brick wall exists along most of elevation. The lack of wall on the north elevation may lead to local overstressing of the drag elements and mullions along the north exterior wall. However, since the seismic demand on the existing lateral system is found to be low, any increased local demands will be absorbed by the shear wall's residual capacity.
