FORM 1
CERTIFICATE OF SEISMIC PERFORMANCE LEVEL

Fernald CTR Classroom 3

**ASCE 41-17 Tier 1 Seismic Evaluation
Minimum Building Report Information**

Building Name: **Fernald CTR Classroom 3**

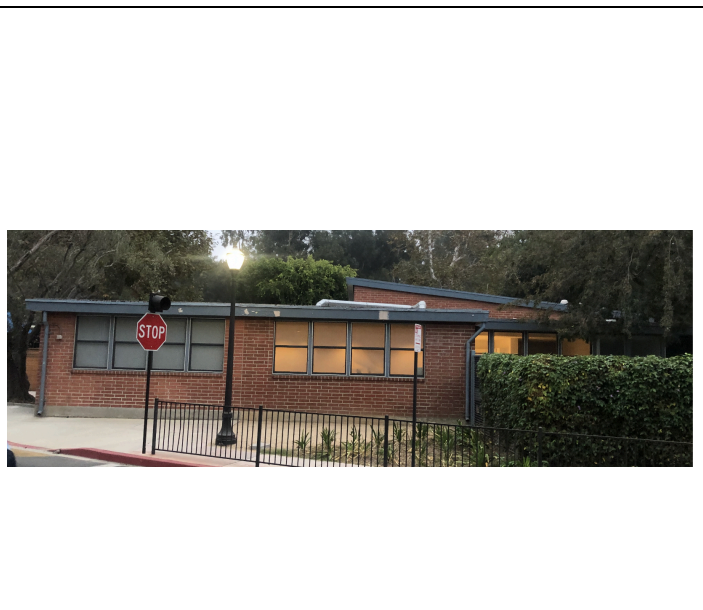
Exterior Elevation

There is differing stiffness on the north elevation, where most of the elevation consists of mullions, as opposed to the south elevation, where brick wall exists along most of elevation. The lack of wall on the north elevation may lead to local overstressing of the drag elements and mullions along the north exterior wall. However, since the seismic demand on the existing lateral system is found to be low, any increased local demands will be absorbed by the shear wall's residual capacity.
