FORM 1
CERTIFICATE OF SEISMIC PERFORMANCE LEVEL

Fernald CTR Classroom 4

ASCE 41-17 Tier 1 Seismic Evaluation
Minimum Building Report Information

Building Name: Fernald CTR Classroom 4

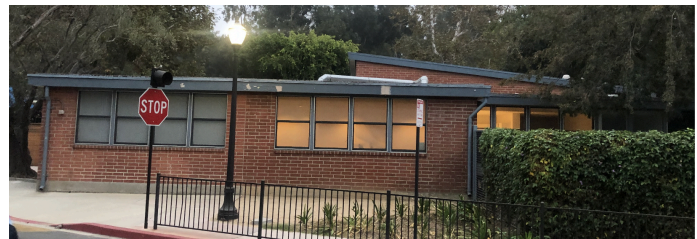
Exterior Elevation

There is differing stiffness on the north elevation, where most of the elevation consists of mullions, as opposed to the south elevation, where brick wall exists along most of elevation. The lack of wall on the north elevation may lead to local overstressing of the drag elements and mullions along the north exterior wall. However, since the seismic demand on the existing lateral system is found to be low, any increased local demands will be absorbed by the shear wall's residual capacity.
