FORM 1
CERTIFICATE OF SEISMIC PERFORMANCE LEVEL

Fernald CTR

ASCE 41-17 Tier 1 Seismic Evaluation
Minimum Building Report Information

Building Name: Fernald CTR

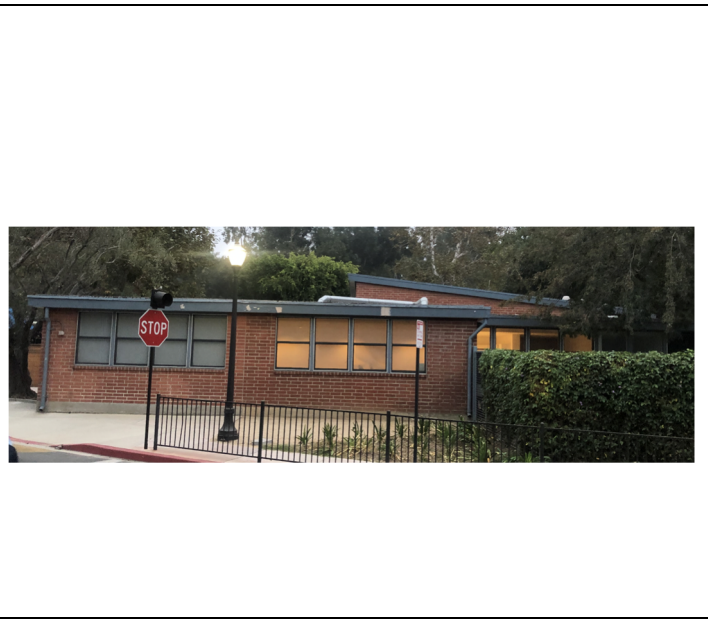
Exterior Elevation

There are two exterior walls that consist of several openings in lieu of brick masonry walls. Where these exterior walls occur, localized stress in the mullions could occur. However, since the seismic demand on the existing lateral system is found to be low, any increased local demands will be absorbed by the shear wall's residual capacity. In addition, the localized stress may result in potential cracking and deformation around window and door openings in the reinforced masonry walls.

Classrooms 1, 2 and 3 are connected to Classroom 5 via an arcade canopy without a seismic joint. Because the diaphragm of the canopy is flexible, it should allow for movement between the buildings. Potential damage during a seismic event may occur due to the simultaneous movement of each classroom building, causing canopy framing damage and/or connection failure.
