Psychology Building – Franz Hall

DATE: 10/30/2020

**ASCE 41-17 Tier 1 Seismic Evaluation
Minimum Building Report Information**

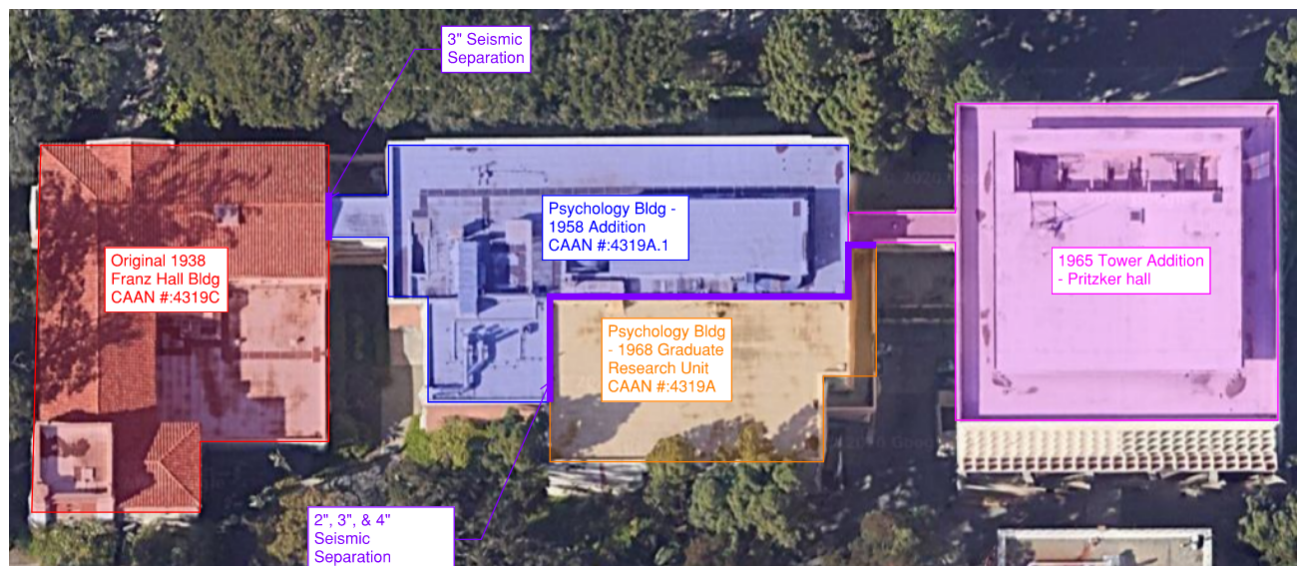
Figure 1 Key Plan of the Psychology Department Complex

The Psychology Department complex is composed of multiple buildings. Each building is separated by several seismic separations allowing the different segments of the complex to act independently of one another. Shown below is a key plan of the complex along with the distribution of CAAN #'s at the complex and the various seismic separations.
