**FORM 1**  
**CERTIFICATE OF SEISMIC PERFORMANCE LEVEL**

Building Name: [NC Elec Dist](#)  
Address: [290 Royce Dr. Los Angeles, CA 90095](#)  
Site location coordinates: Latitude [34.0734907](#) Longitudinal [-118.4425835](#)

### UCLA – NC Elec Dist

FEMA 154 Rapid Visual Screening

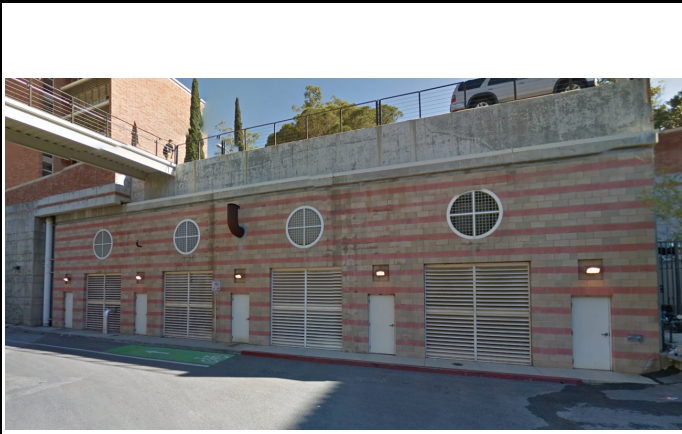
**COMMENTS:**  
 The bridge pictured in the elevation was not included in our screening of this building.
