## UCLA PARKING STRUCTURE PS18 SEISMIC PERFORMANCE REVIEW

714 Tiverton Drive  
Los Angeles CA 90095  
Location: 34.064, -118.443

<b>Building ID</b>	
<b>Date</b>	June 4, 2020
<b>Project #</b>	19x044
<b>UC Rating</b>	VI

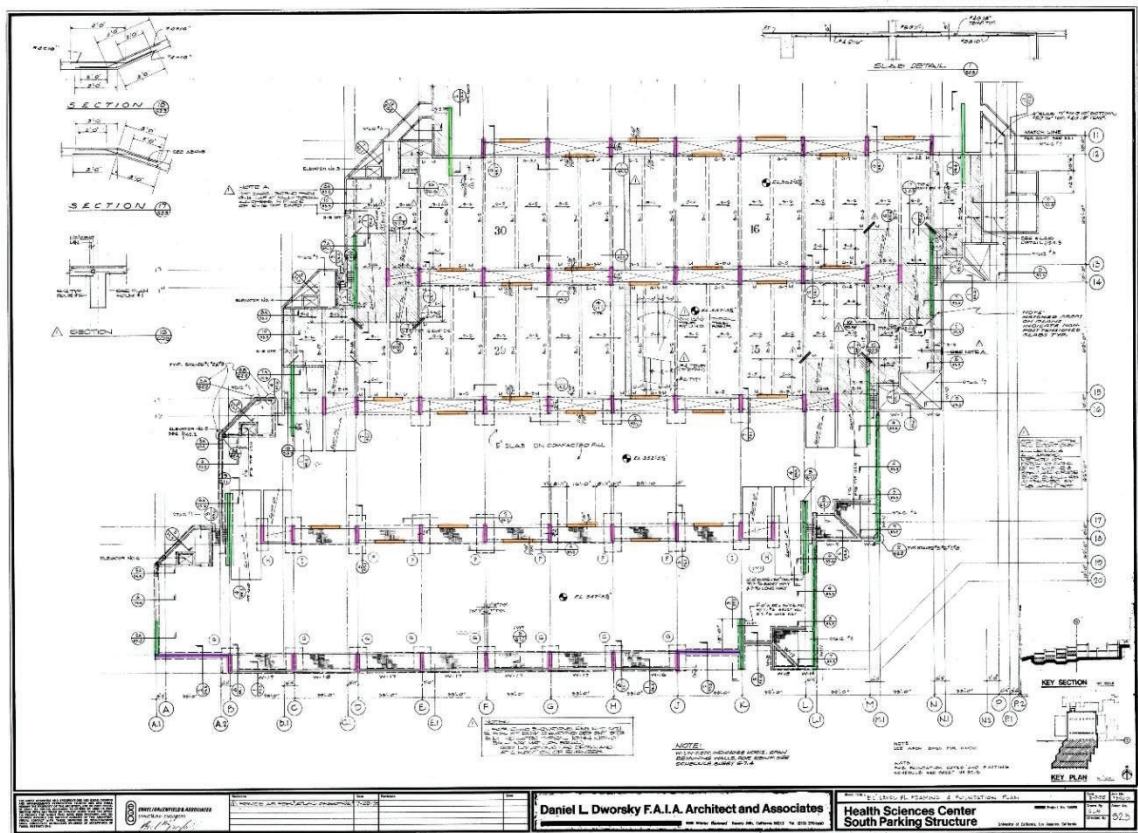
Figure 3 Ground Floor Plan Showing Concrete Shear Walls

The structural system of the building consists of post-tensioned one-way suspended slab supported on post-tensioned concrete beams. The lateral load resisting system of the structure consists of reinforced concrete shear walls. Layout of reinforced concrete shear walls is shown on as-built structural sheets S-2.5 (Figure 3).

***All of the shear walls in the existing light wells do not pass this criterion.***

Based on the analysis conducted, the UCLA parking structure PS18 failed the performance criterion and could collapse during a major seismic event. Most of the issues noted were limited to the existing reinforced concrete shear walls in the existing light wells that were found to be highly overstressed in both flexure and shear.

Based on the analysis performed, it is our opinion that the UCLA parking structure PS18 P is in the expected seismic performance category VI based on the seismic policy adopted by the University of California. This would indicate that the building could sustain substantial structural damage, can experience partial collapse, and can cause substantial risk to life. Further evaluation/retrofit is recommended. Further detailed analysis and retrofit would be required per the UC policy.

Because of the localized nature of the issue at the light well walls and easy accessibility of structural elements, the expected retrofit costs for the parking structure are anticipated to be in the low range of less than \$50 per sq. ft.
