**BUILDING REPORT REQUIREMENTS  
ASCE 41-17 TIER 1 SEISMIC EVALUATIONS**

**BUILDING REPORT**

| 2) Building Name: <a href="#">Park Wilshire Condominiums</a> | 6) Evaluation by: <a href="#">Englekirk, TAS</a> |

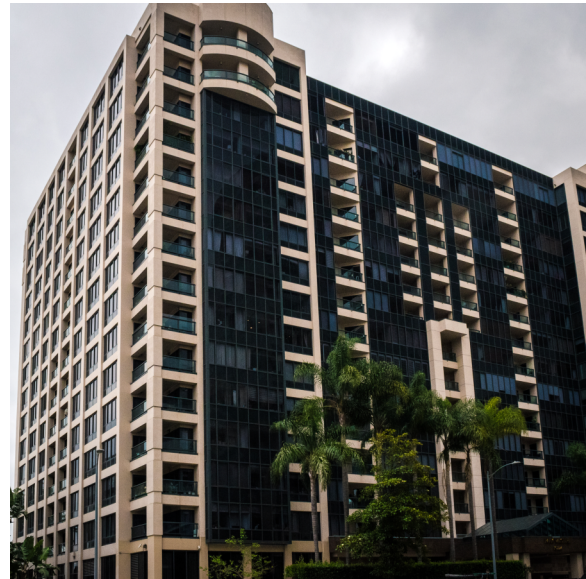
9) Exterior Elevation Photo

Given the age of the structure, it is assumed that column joint shear and column confinement details will not be adequate. Tall first story (with a mezzanine) leads to concerns regarding a weak and/or soft story.

This is assumed to be a concrete moment frame building. Adding shear walls or adding damping is likely to be more effective than trying to strengthen and stiffen the frame.
