## Psychology Building – Graduate Research Unit

**ASCE 41-17 Tier 1 Seismic Evaluation**

**Minimum Building Report Information**

Building Name: [Psych Bldg. – Grad Rsrch](#)

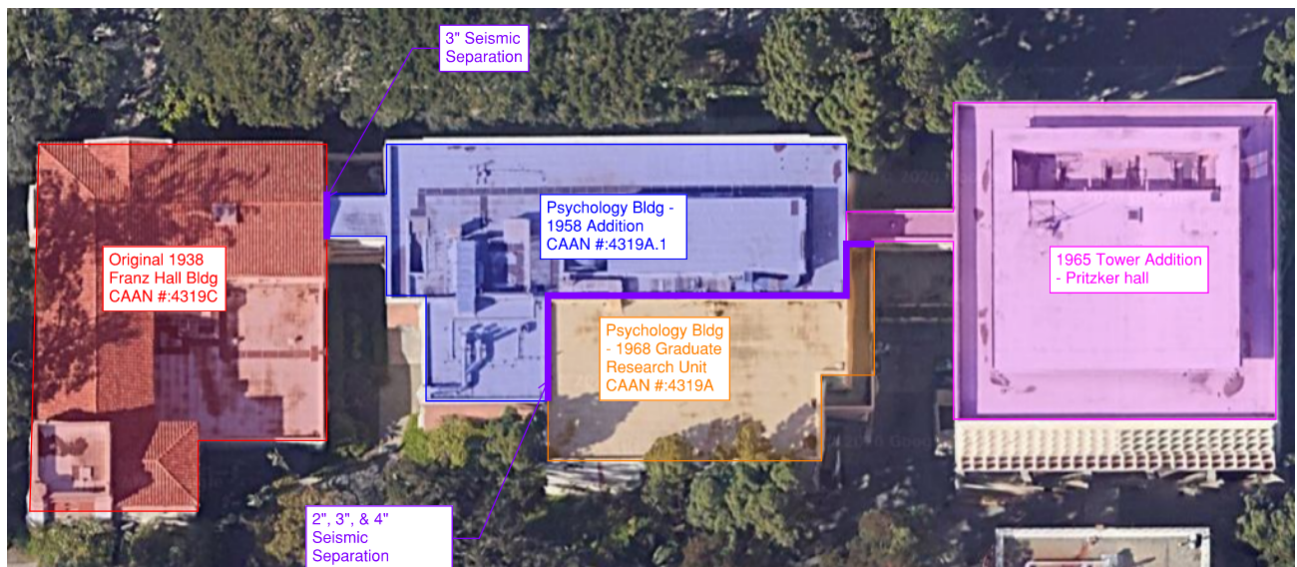
Figure 1 Key Plan of the Psychology Department Complex

The Psychology Department complex is composed of multiple buildings. Each building is separated by several seismic separations allowing the different segments of the complex to act independently of one another. Shown below is a key plan of the complex along with the distribution of CAAN #'s at the complex and the various seismic separations.

Lastly it was found that the seismic separation between the Graduate Research Unit Building and the 1958 Franz Hall Expansion is less than the allowed limit per the Tier 1 evaluation. This could lead to the two buildings colliding in a seismic event providing unanticipated forces and damage to the lateral system.
