ASCE 41-17 Tier 1 Seismic Evaluation

DATE: 5/18/2021
UC Campus: UCLA
Building Name: 6 Schoenberg – Herb Alpert Building
CAAN ID: 4335.2
Auxiliary Building ID: 4335, 4335.1, 4335.3

SUMMARY OF INFORMATION PROVIDED BY EVALUATOR: **THORNTON TOMASETTI**

UCOP SEISMIC PERFORMANCE LEVEL (OR “RATING”) BASED ON TIER 1 EVALUATION FINDINGS: **V**

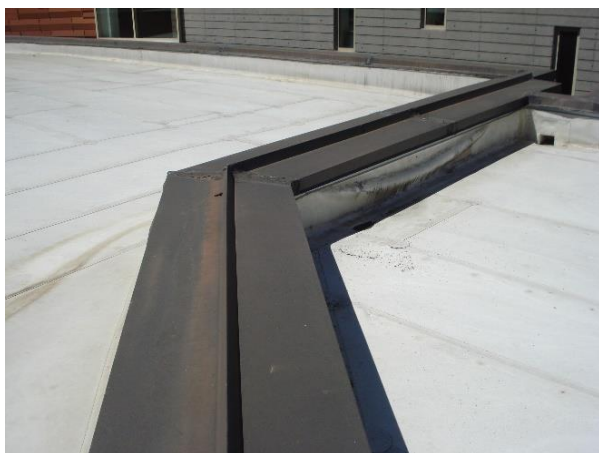
6.1. Seismic Separation between Buildings: During intense ground shaking by a seismic event the adjacent structures (Organ Room, Schoenberg Hall) could collide causing localized damage. The damage would likely be limited to the cracking of wall mortar joints and seismic joint cover flashings over the top of the parapet walls. Possible damage on the roof where two water lines and a conduit pass over a seismic joint as they appear to lack flex connections to allow for movement. There is also a pedestrian bridge over to the Evelyn & Mo Ostin Music Center building on the west side of the building that has a seismic joint as well at the 3rd floor. The size of the seismic joint is not known at this time.

Seismic joint / flashing at Organ Chamber Building With Herb Albert Building

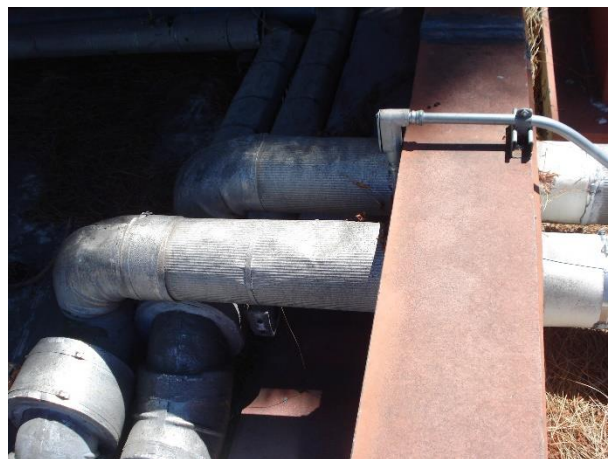
Plumbing lines and conduit crossing over seismic joint at northeast corner of building with Schoenberg Hall

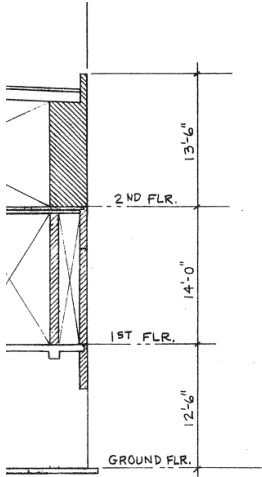
6.4. Perimeter Masonry Wall stacking is discontinuous: Ideally, the masonry walls at each floor level would stack directly on top of each other. At the perimeter of the building, the shear walls on the east, south and west sides have discontinuous features. Shown below are examples of discontinuous south walls.

2nd floor wall straddles two wall

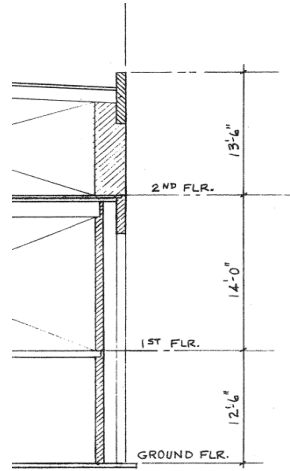
2nd floor wall straddles wall and beam

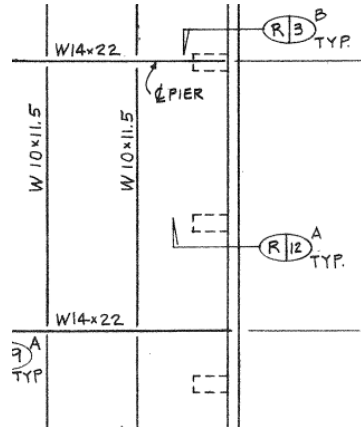
Roof Plan – some piers braced by beams

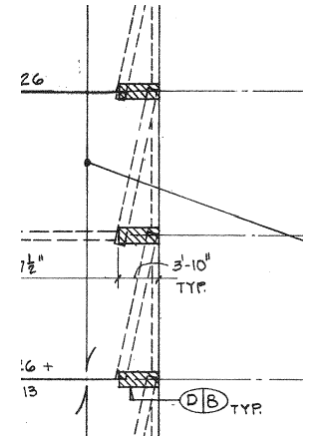
2nd floor plan – pier straddles two walls below

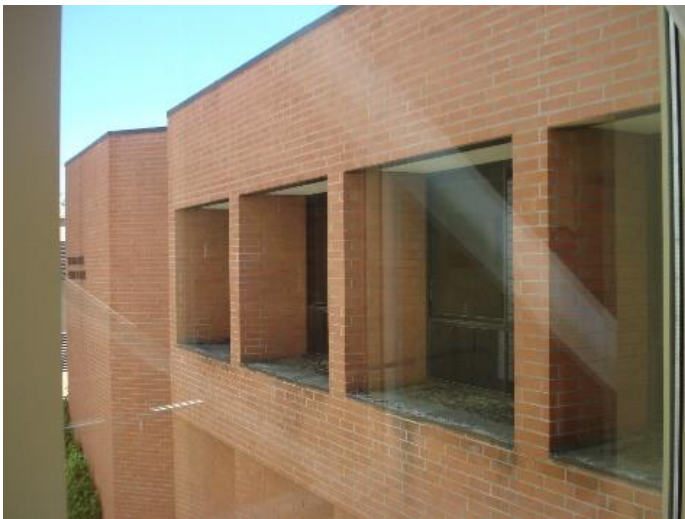
West side of building - Brick piers at 2nd floor

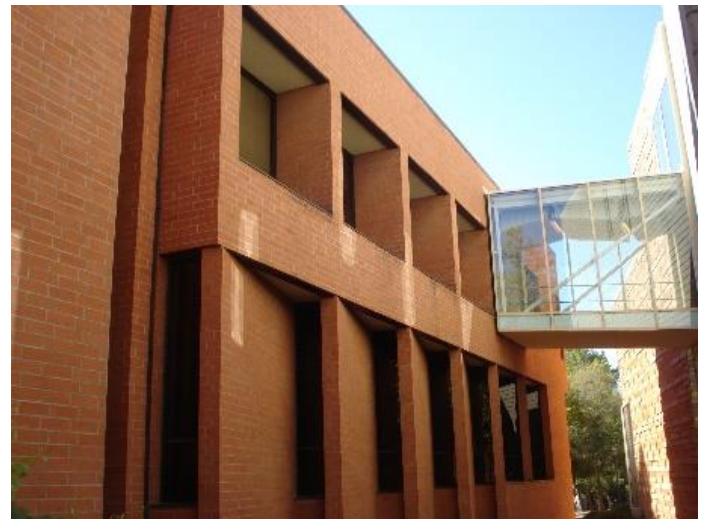
West side of building: Brick piers at 2nd floor, skewed walls at first floor

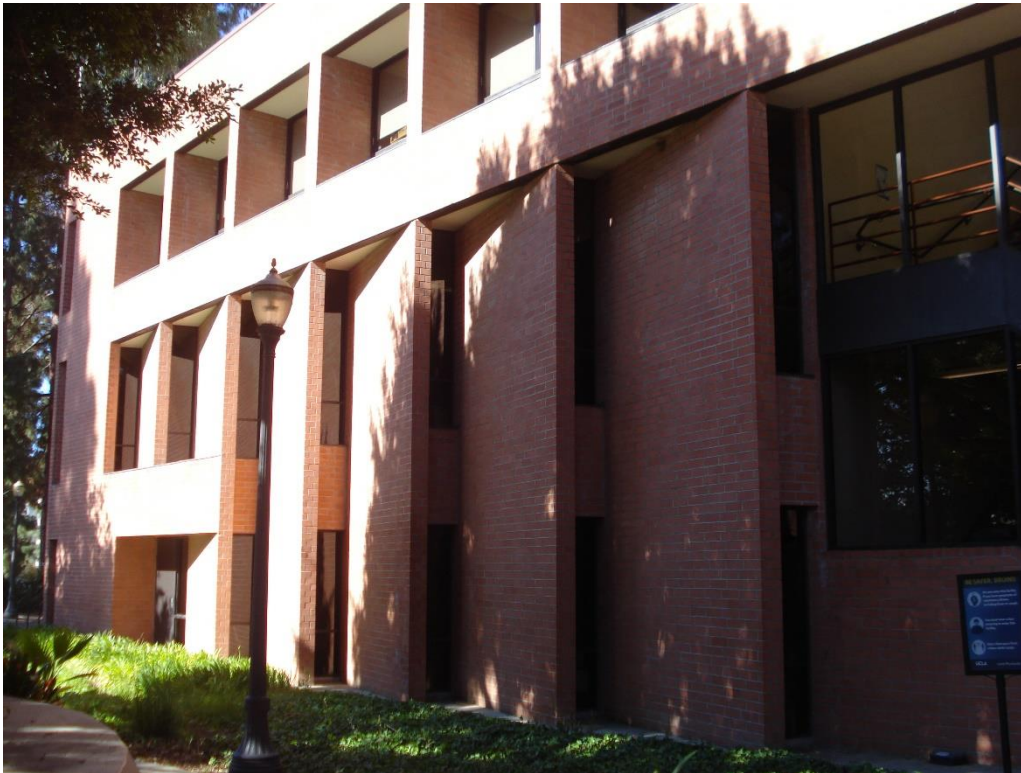
East side of building – Discontinuous piers, skewed walls and skewed wall sits on lintel.

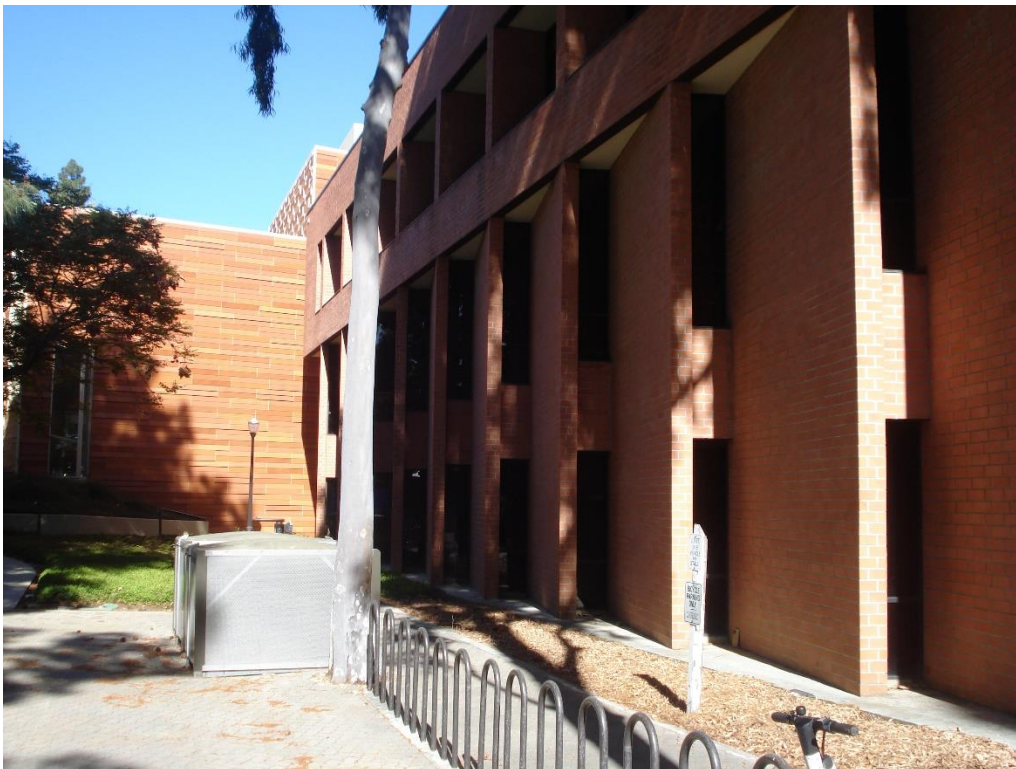
South side of Building – Discontinuous 2nd floor pier straddling skewed walls from ground to 2nd floor.

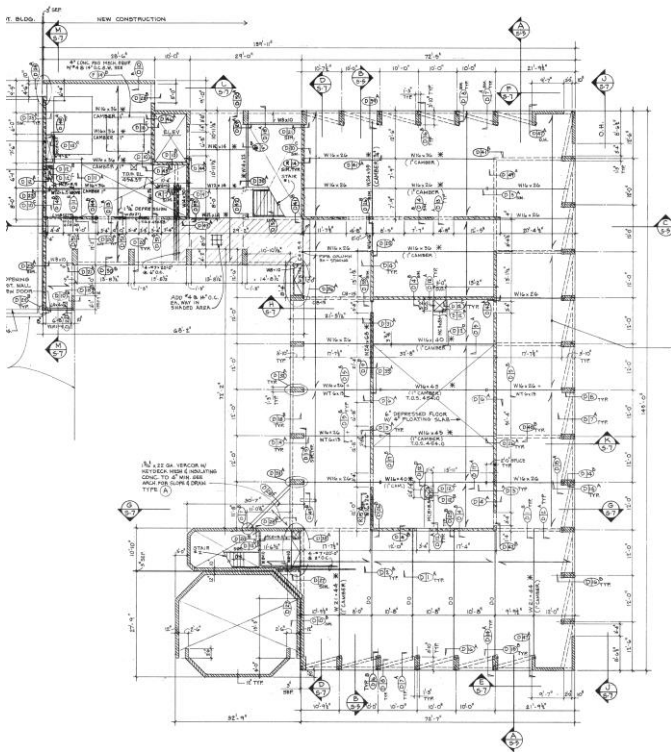
Floor Structural Framing Plan – 2nd Floor

Herb Albert 2nd floor plan showing extent of discontinuous piers above and skewed walls below along east, south and west faces of the building. With these discontinuities in the wall framing, further analysis is needed beyond a Tier 1 evaluation. At the first floor courtyard, the building perimeter appears to be two story masonry frames. As reinforcing details are not available, it's unclear how this frame will perform as lintels are offset to the edge of the columns/piers.

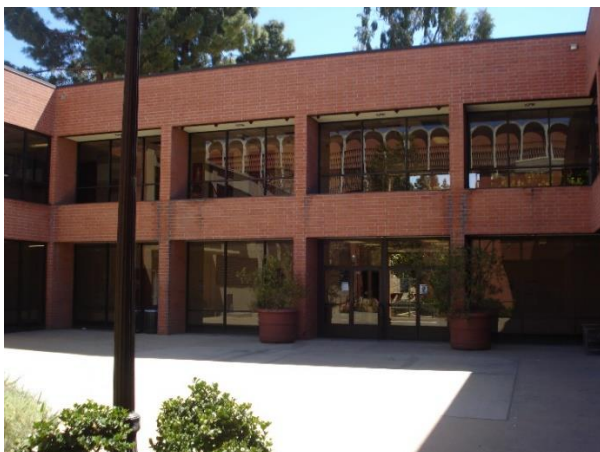
Westside of Building - Courtyard Elevation at first floor

At the ground floor there appear to be sufficient shear walls. At the first floor, the number of shear walls decreases compared to the ground floor, and decreases further at the second floor. Additional analysis is required to understand the load path of how seismic forces are distributed between shear walls above and below the floor diaphragms.

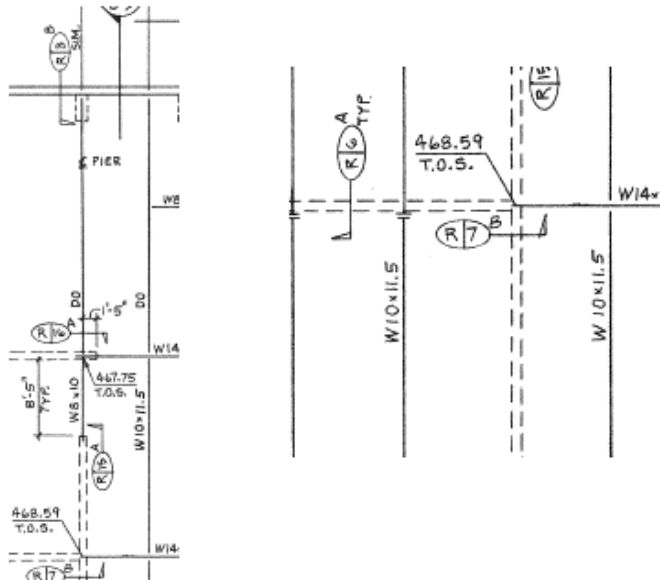
6.5. Drag Lines and Collectors w/ Flexible Diaphragm: Beam collector connections to ends of shear walls should be reviewed to determine if they have sufficient capacity to not pull away from the shear walls and piers. Connection details are not available to review.

Partial Roof Framing Plans – collector steel beams to brick masonry walls
