**ASCE 41-17 Tier 1 Seismic Evaluation**

**DATE:** 5/18/2021  
**UC Campus:** UCLA  
**Building Name:** 6 Schoenberg – Herb Alpert Teaching/Organ Studio Building  
**CAAN ID:** 4335.3  
**Auxiliary Building ID:** 4335, 4335.1, 4335.2

**SUMMARY OF INFORMATION PROVIDED BY EVALUATOR:** **THORNTON TOMASETTI**

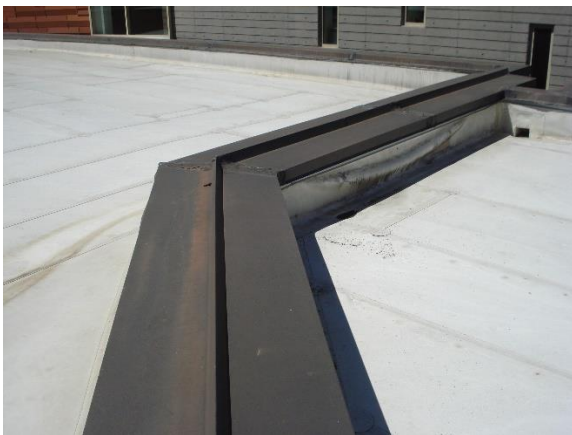
**6.1. Seismic Separation between Buildings:** During intense ground shaking by a seismic event the adjacent structures could collide causing localized damage. The damage would likely be limited to the cracking of mortar joints and joint separations, as well as tearing of the seismic joint cover over the top of the parapet walls. The vertical seismic joint cover on the west side of the building is starting to deteriorate and likely needs to be replaced to help prevent future rain water intrusion.

Seismic joint cover / flashing at roof south edge

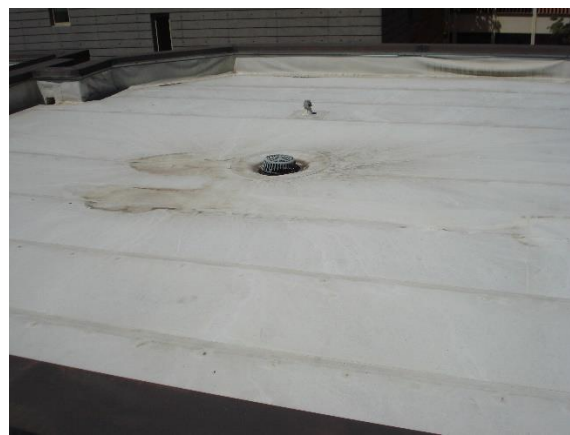
Seismic joint cover and top of wall flashing

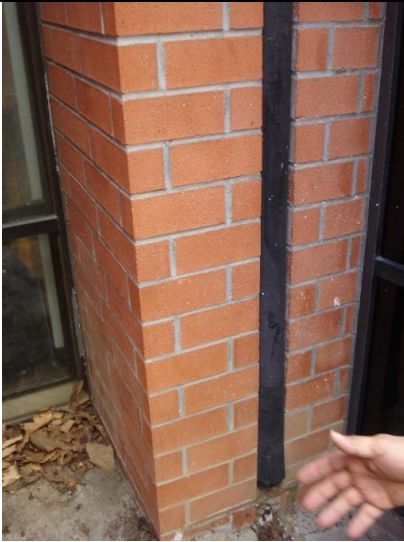
Seismic joint in wall at ground floor level (West side of building) in need of review and/or replacement cover.

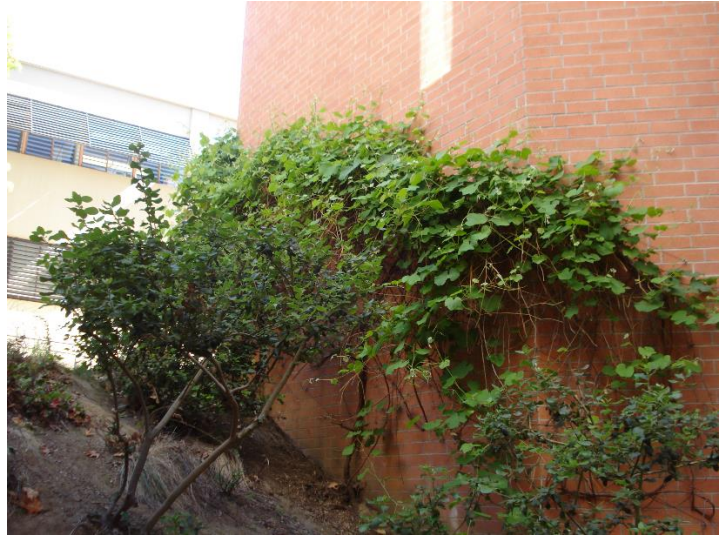
Exposed west wall (ground floor to first floor) showing brick veneer over concrete wall.

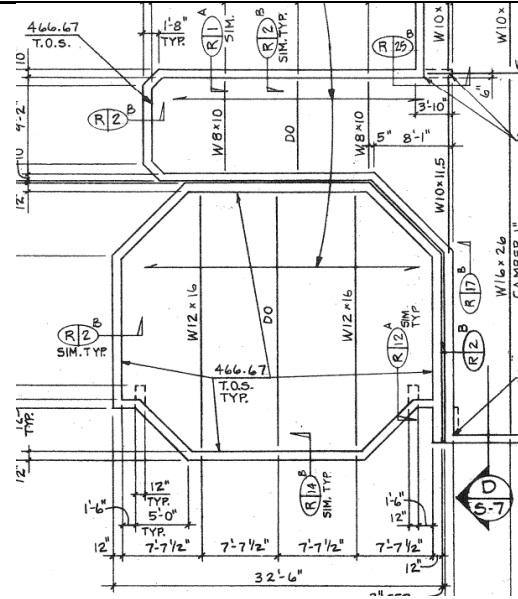
Roof Framing Plan

**6.2. Roof Flexible Diaphragm:** The roof 1 5/16 inch, 22 gauge, metal deck diaphragm is considered flexible as it has an insulating concrete topping and not a lightweight or normal weight concrete topping. The “Project Detail Book” is not available to review how the roof metal deck is anchored to the brick wall. The attachment is assumed a steel ledger angle and the anchor bolts spaced uniformly along the length of the masonry lintel.

Seismic Concern: During an earthquake, there is a concern that the roof diaphragm can detach from the wall and lead to damage of the roof structure.

Utilization of the existing lateral system is not a concern, however, a lack of information for the connections of the roof diaphragm to the masonry walls and the connection of the masonry walls to their foundations supports a SPL V rating. A more detailed analysis of the wall connections at the roof diaphragm and foundation could make this building a good candidate to have a SPL IV or better. However, if a more detailed analysis shows the roof connections to be inadequate a retrofit may require adding steel, welding and post-installed anchorage to provide more positive connections between elements.

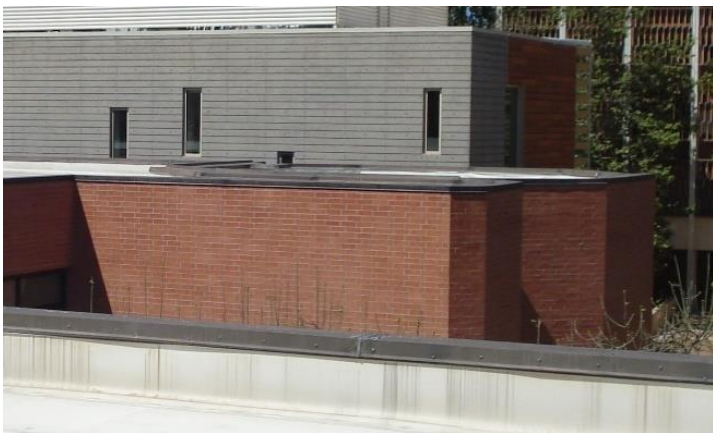
**6.3. Silo Wall Structure:** The organ chamber resembles a silo with some tall vertical slots in it for windows. The first floor-to-roof is a two-story tall high volume space.

Organ Chamber & Stairwell – looking west

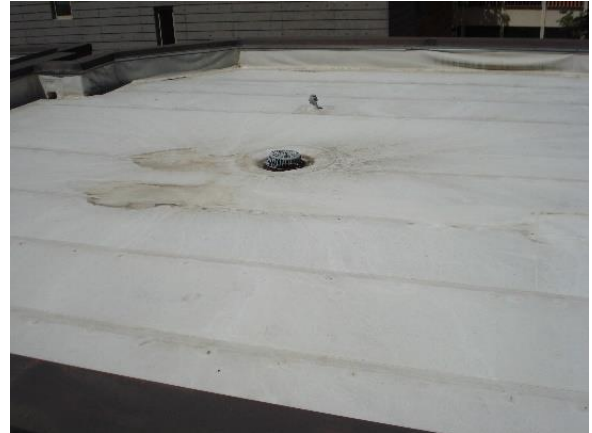
**DEFECTS AND DETERIORATION:** No structural defects or deterioration was noted while performing visual observations except at the roof where some roofing was falling away from the parapet walls.

Organ Chamber Roof - some loose roofing at parapet

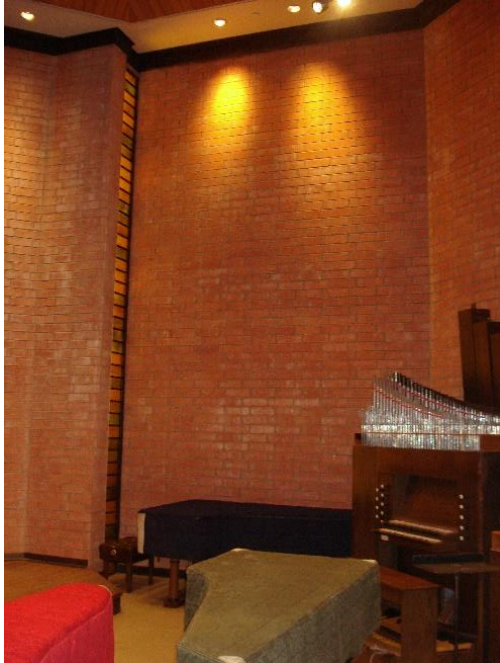
**Seismic Concern:** The brick wall reinforcing is #4 at 20" O.C. in each direction and the sum of the ratio of rebar in the vertical and horizontal planes is at least 0.002. The concern is the long vertical length of the windows in the organ room and possible breakage of the glass due to wall movement during an earthquake.

Organ Chamber – 2-story wall

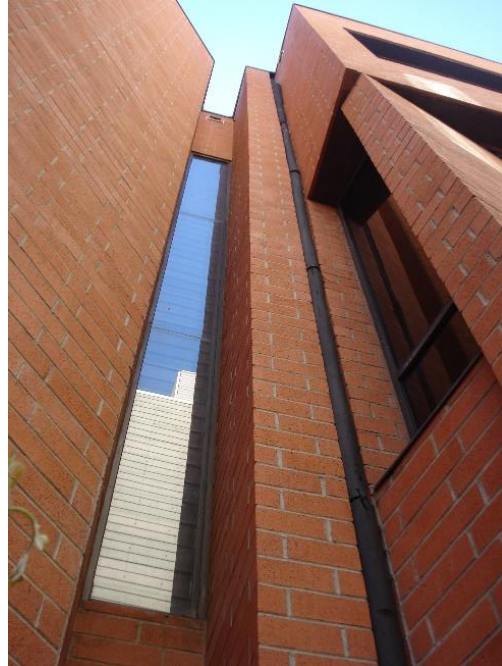
Seismic Joint – West Side of Building with Window Slot

Tier 1 Quick Checks show that the two existing 3 inch seismic separations between the Teaching/Organ Studio and Herb Alpert buildings is not adequate, but a more detailed analysis could rule out this potential deficiency.

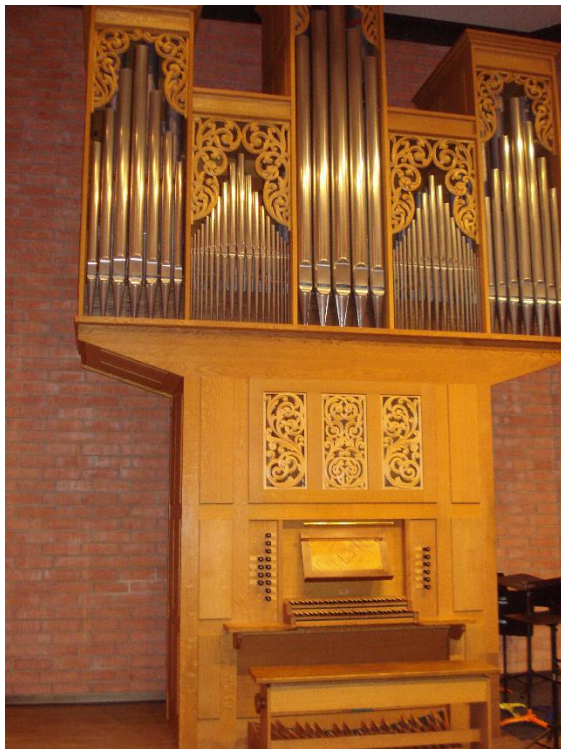
**NON-STRUCTURAL FALLING HAZARD NOTES:** The organ studio houses a large organ with many component parts. The attachment of these organ components to their respective parts and to the building structure is unknown and could pose a falling hazard risk to room occupants, but the occupant load is low. The large organ bracing to the wall and floor needs to be reviewed to determine its adequacy to keep the organ secured in position during the earthquake. The masonry wall design should be reviewed for the imposed out-of-plane load of the organ's weight during an earthquake on the two story tall wall.

Picture of organ

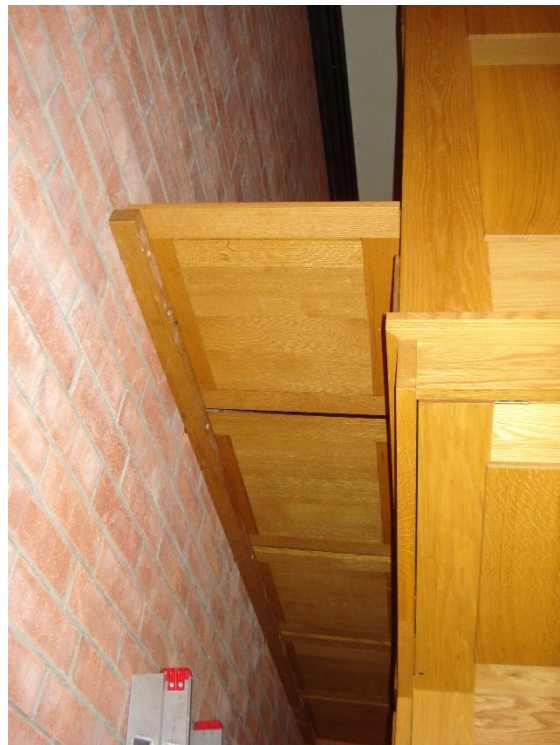
Existing organ wall bracing
