ASCE 41-17 Tier 1 Seismic Evaluation

DATE: 5/18/2021
UC Campus: UCLA
Building Name: Schoenberg – Scene Shop Building
CAAN ID: 4335.1
Auxiliary Building ID: 4335, 4335.2, 4335.3

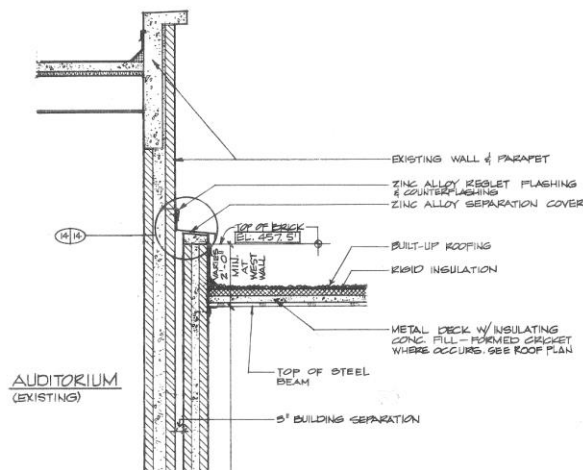
6.1. Seismic Separation between Buildings: During intense ground shaking by a seismic event the two structures could collide causing localized damage due to the limited seismic joint widths of 2 and 3 inches. The damage would likely be limited to the cracking of the plaster finish of reinforced masonry walls or possibly damage to the walkway canopy on the west side of the building.

North Wall Separation Joint

Tier 1 Quick Checks show that the existing 2 and 3 inch seismic separations are not adequate, but a more detailed analysis could rule out this potential deficiency. Additionally, the utilization of the existing lateral system is not a concern but the lack of detail information for connections of the roof diaphragm to masonry walls and connections of masonry walls to the foundation warrant an SPL V rating. A more detailed analysis of these connections could make this building a good candidate to have a SPL IV or better. However, if a more detailed analysis shows the connections to be inadequate a retrofit may require adding post-installed anchorage to provide more positive connections between elements. At the roof diaphragm additional framing members may be required to provide a sub-diaphragm connection between the existing metal deck and masonry walls.

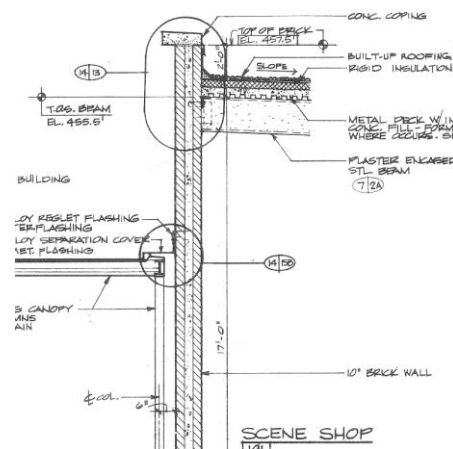
West Wall Separation Joint

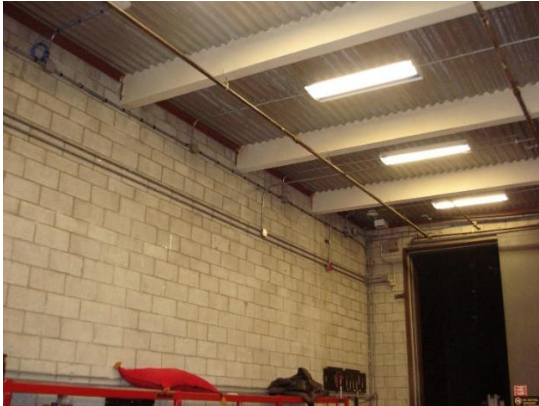
6.3. Out-of-Plane Wall Anchors: The anchorage of the north and south walls of the Scene Shop building to the roof metal deck appears to be deficient due to lack of sub-diaphragm struts and possibly insufficient welds of metal deck to ledger angle and insufficient ledger anchorages to the wall. Further analysis beyond Tier 1 is required.

North wall opening to Schoenberg Auditorium

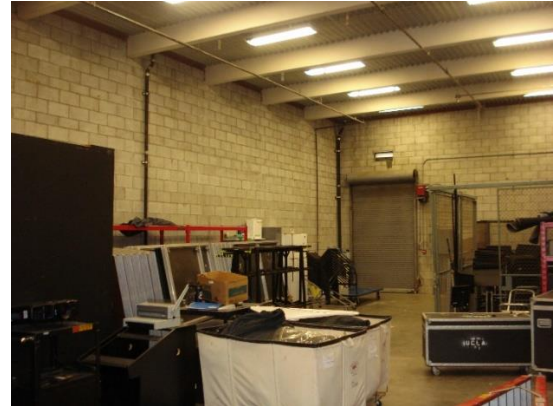
South wall opening to exterior
