ASCE 41-17 Tier 1 Seismic Evaluation

DATE: 5/18/2021
UC Campus: UCLA
Building Name: Schoenberg Building
CAAN ID: 4335
Auxiliary Building ID: 4335.1, 4335.2, 4335.3

SUMMARY OF INFORMATION PROVIDED BY EVALUATOR: THORNTON TOMASETTI

UCOP SEISMIC PERFORMANCE LEVEL (OR "RATING") BASED ON TIER 1 EVALUATION FINDINGS: VI

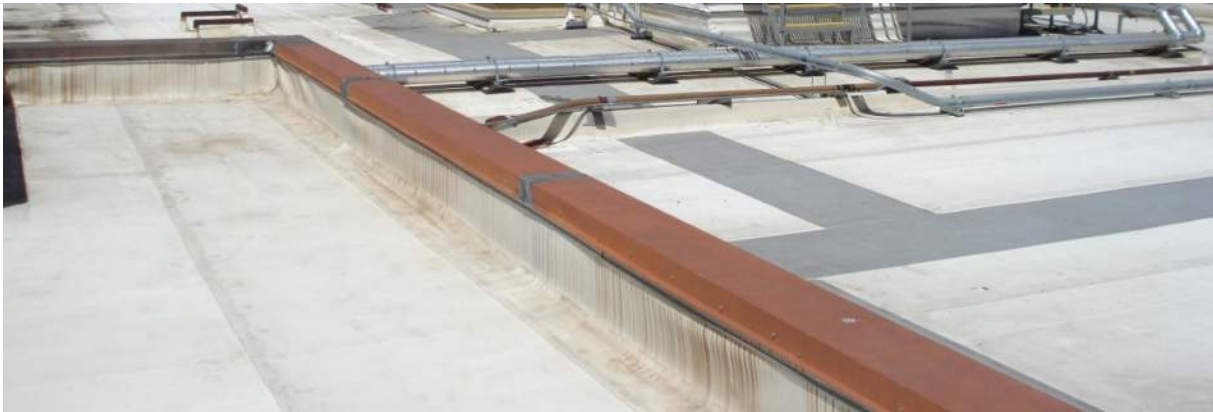
6.1. Possible inadequate joint separation between buildings: The two structures could collide causing localized damage at the existing seismic joint at the Herb Albert Building. The seismic gap between the buildings is three inches. The damage would likely be limited to brick damage along the seismic joint and buckling of wall flashing/joint cover at the top of the adjacent parapets that serves as the roof seismic joint cover. There is also a pair of water lines and a conduit that cross the seismic joint that have no flex connections, which could lead to pipe and conduit failure when the buildings move during an earthquake.

Parapet wall flashing cover that serves as seismic joint cover where two adjacent buildings occur

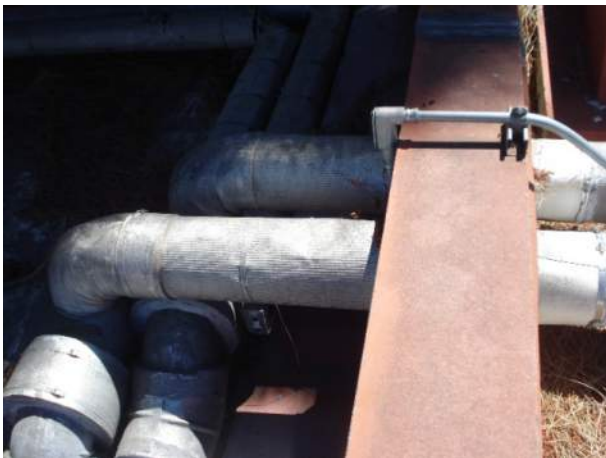
Water pipes and conduit crossing seismic joint with no visible flexible connections provided.

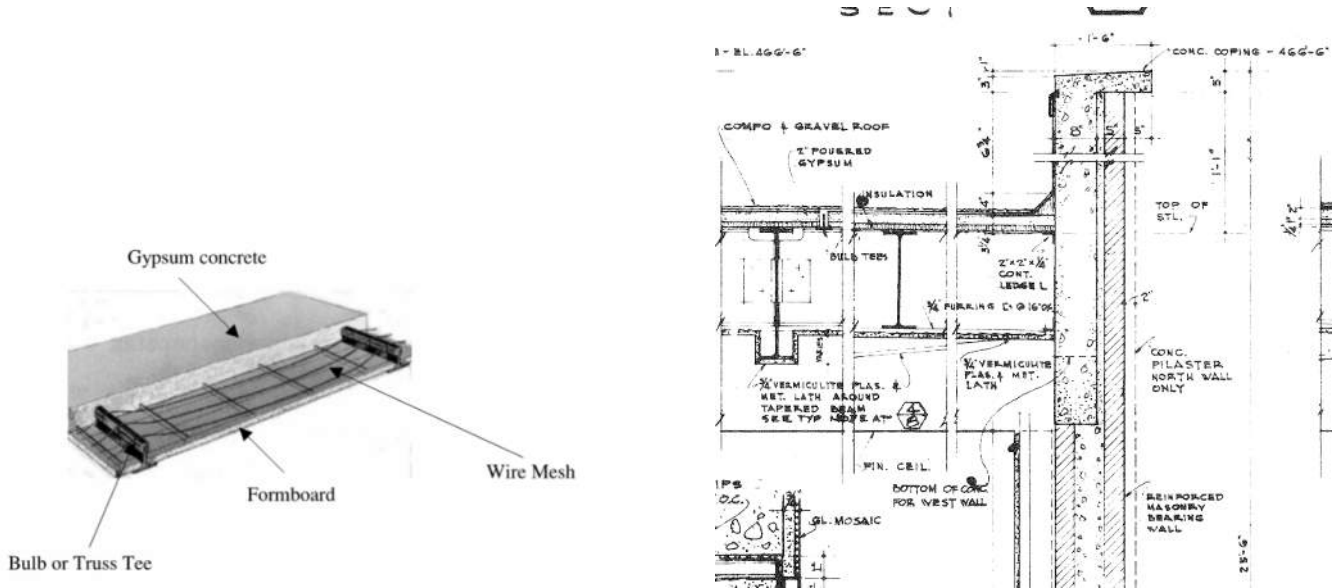
6.2. Roof Diaphragm of weak strength: The majority of the roof diaphragm consists of two-inch thick gypsum concrete, reinforced with 4"-8"/12-18 welded wire mesh placed over a one inch thick insulation board that spans between steel rails (Bulb-Tees) located at 2'-8 5/8" on center that are supported by steel beams and steel angle wall ledgers. As building codes have evolved over the years, and the seismic design forces have increased as well, there is the concern the existing gypsum roof diaphragm may be inadequate to resist current building code seismic design forces and remain connected to the wall. Similar roof systems today now utilizes a continuous metal deck for diaphragm strength in lieu of the gypsum concrete over form board.

Component Illustration of Gypsum Concrete Roof System Building Section from Architectural Drawings

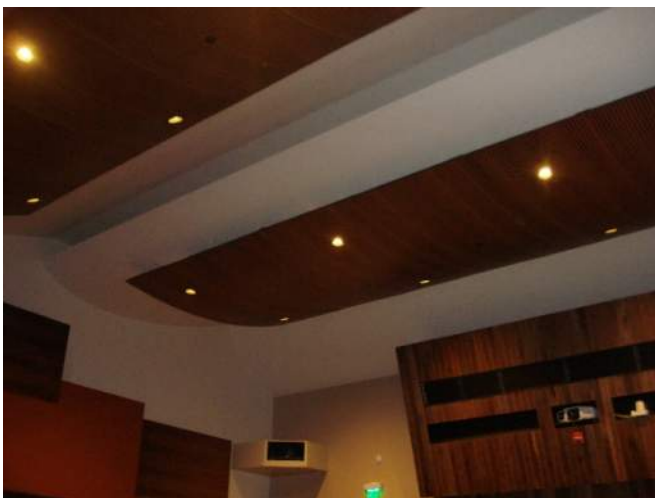
Small auditorium - ceiling remodel recently

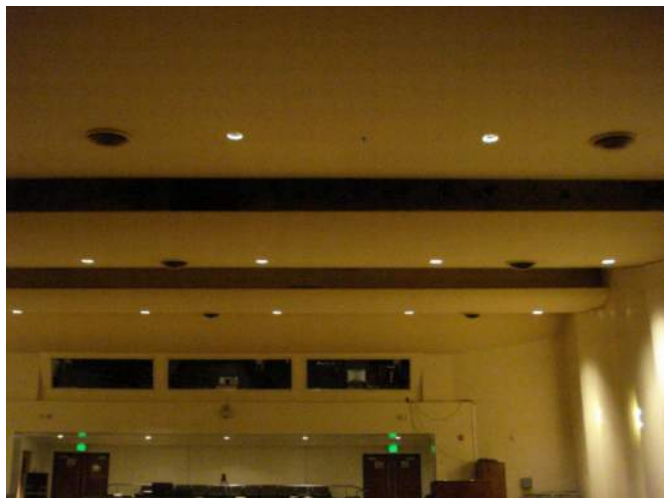
6.3. Bracing of Existing Heavy Ceilings (acoustical attachments): The existing auditorium ceilings that have not been redone in the last 15 years or so should be reviewed for bracing relative to current building code requirements. Additional ceiling bracing wires and closer spaced compression posts may be required. For the more recent ceiling remodels within the building, it is assumed they comply with the more modern codes.

Main auditorium ceiling – three ceiling sections

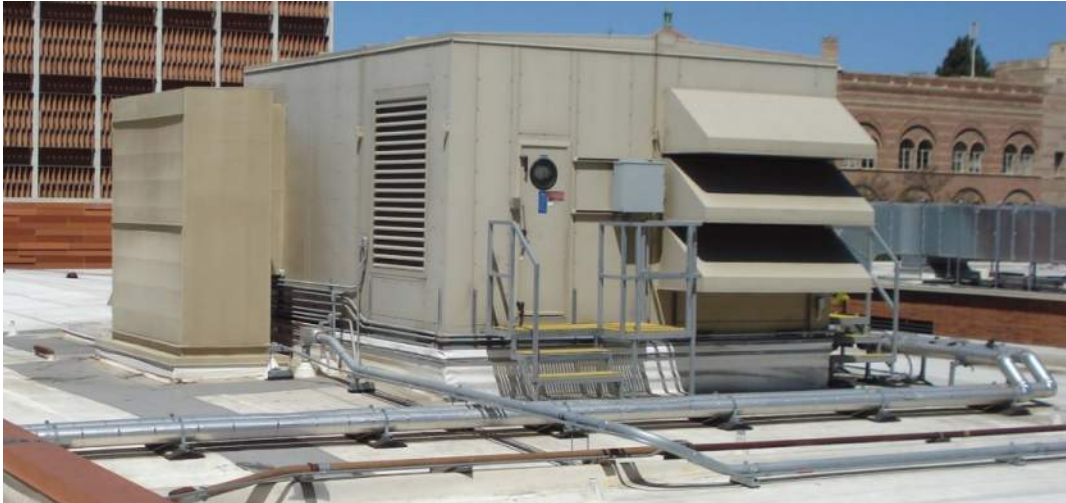
Mechanical Unit #1 (south end of building)

6.4. Roof MEP Anchorage: The large mechanical unit on the roof may require additional seismic bracing than is currently provided. The concern is the unit could pull free during a significant earthquake as it sits on four cantilever posts.

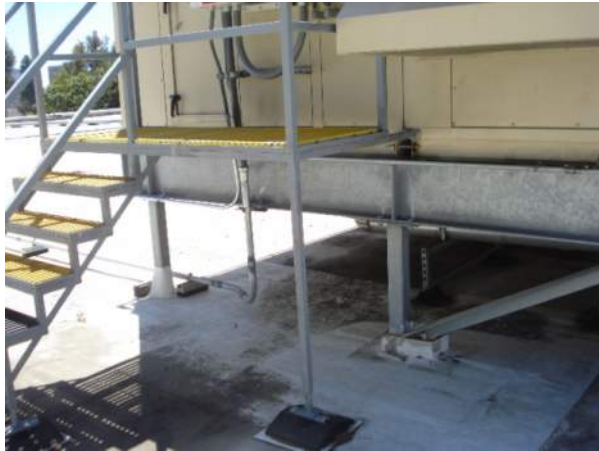
Mechanical Unit #2 supports

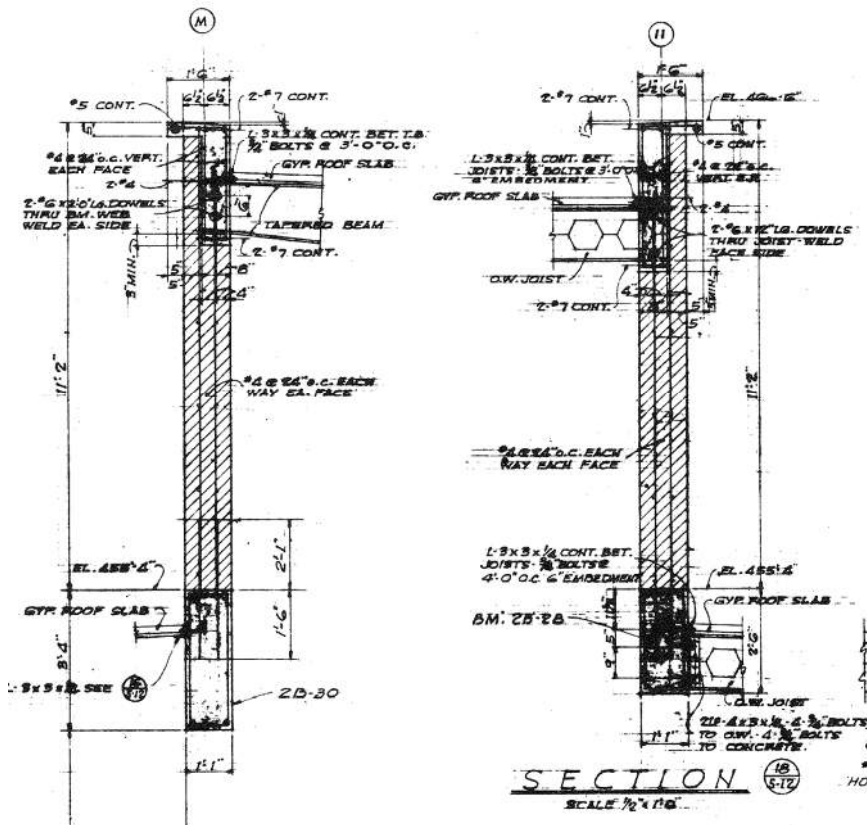
6.5. Wall out-of-plane anchorages at the gypsum roof: There has been a significant increase in seismic design forces for masonry and concrete wall anchorages to roofs since the gypsum concrete roof framing system wall attachments were designed for this building. The adequacy of the existing wall anchor system to the gypsum roof diaphragms should be verified.

Beam to wall connections with welded rebar dowels

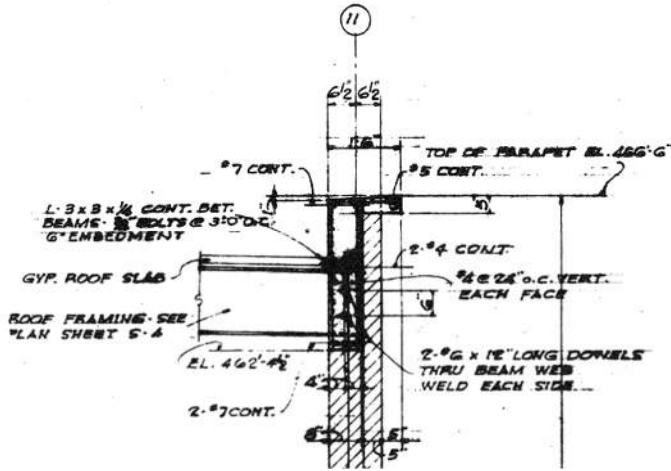
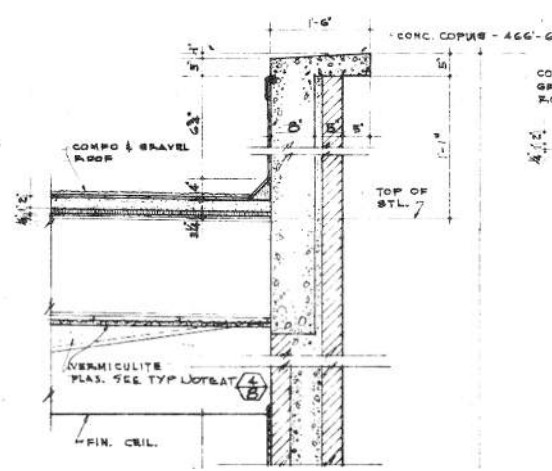
6.6. Brick Veneers: The perimeter walls of the building are a combination of reinforced concrete and reinforced brick masonry. Typically, along the roof level, there is a single wythe brick veneer in front of a concrete beam. There appears to be no positive anchorage between this brick veneer and the concrete beam surface shown on the original construction drawings, as would be required by the current building code.

Steel beam connection at concrete beam with brick veneer

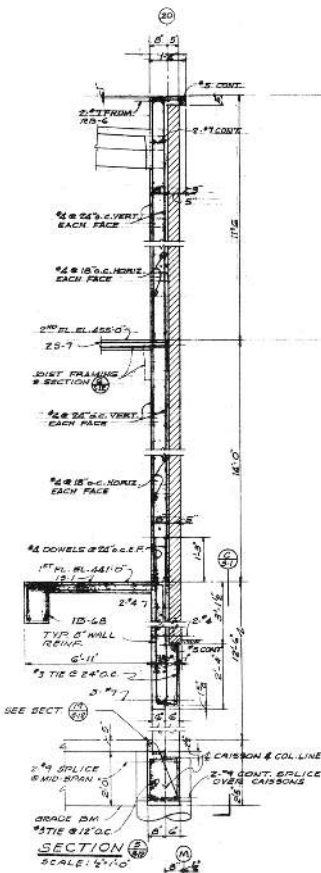
Two story concrete wall section with masonry brick veneer (south side of building)

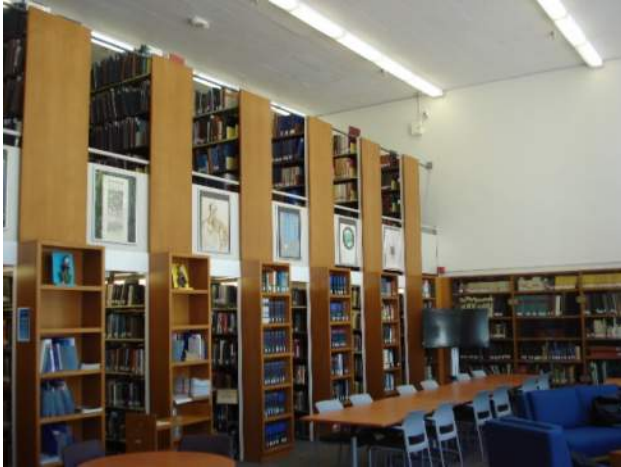
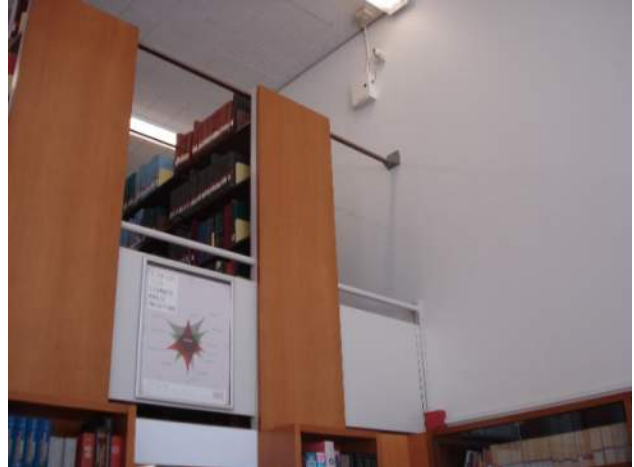
6.7. Library book storage racks – lateral system: The library stacks in the music library is a two-story manufactured light gauge metal framing system. Given the age of this framing system it should be reviewed and evaluated based on current building code seismic design requirements to verify the adequacy of the existing system. This would include anchorages to the building walls and floor.

2-story, pre-manufactured book stacks in Music Library Continuous book case strut to wall at 2nd floor level.

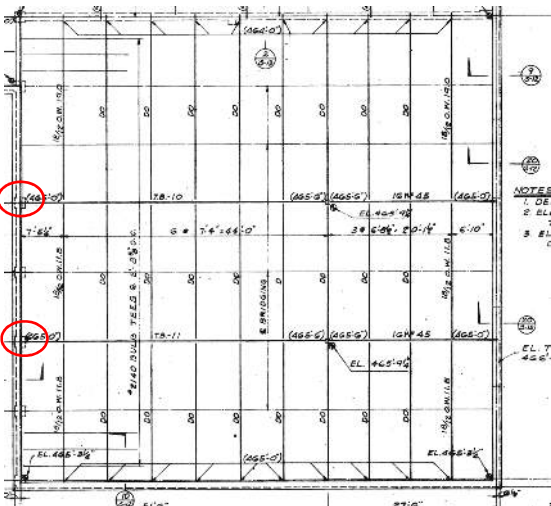
Partial Roof Plan at Music Library

At the north side of the music library, the tapered steel beams frame to the concrete columns as shown below:

The concern is that there should be a more adequate connection between the column and the beam, particularly given the weak capacity of the existing roof diaphragm. Section 11/S12 and the column cross section, shown below, shows how little anchorage there is between the beam and column and how lightly reinforced the column is. There is likely little column rebar at the roof level above the bottom of the steel beam along the sides of the steel beam. There is a similar condition

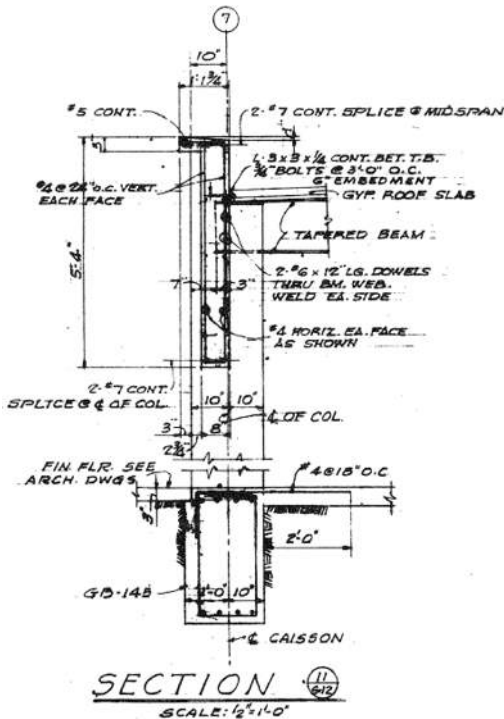
Column Location: C-7, E-7
 Column size: 20"x 20"
 Column Reinforcing: 4-#7, #3 ties at 14" o.c.

Steel beam with minimal anchorage to the concrete beam, rebar dowels are at face of concrete beam

Columns with minimal confinement ties

at the main auditorium (shown below), the small auditorium, as well as the three teaching auditoriums. They all have similar girder spans. In some seismic retrofits, a new secondary column is placed under the beam, in front of the wall, to support the beam should the beam pull away from the existing wall anchorage.

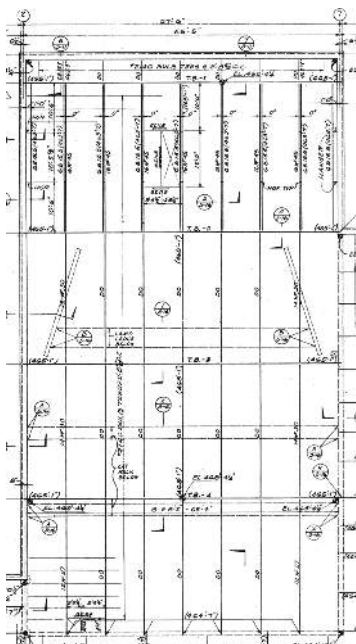
Partial Roof framing Plan

Main Auditorium Wall Connection: Beam span = 67'-6"

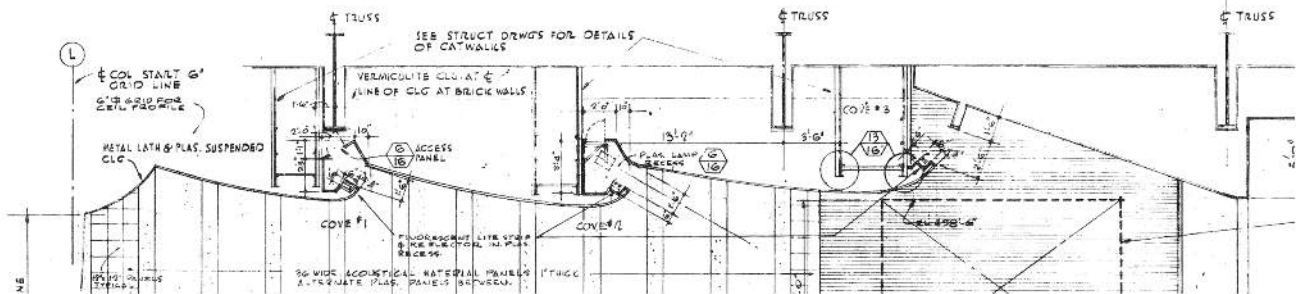
Architectural section through main auditorium showing ceiling and catwalk profile.

It is unclear as to the anchorage of the existing ceiling to the steel beam member above. Given the age of the building, it is highly likely additional bracing supports are required for the ceiling (compression posts and diagonal splay wires). The structure of the lighting supports off of the catwalks was not reviewed. We were not able to view this area, so additional investigation is required.

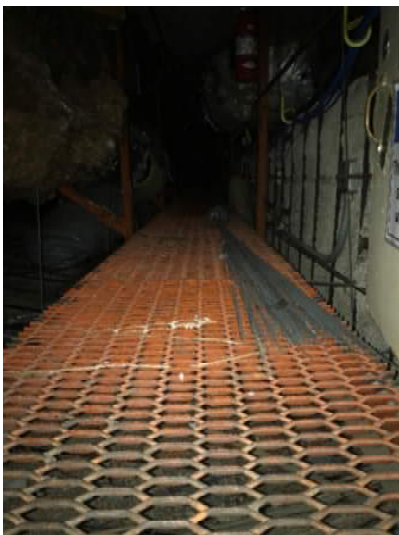
The lighting support framing suspended from the roof over the stage in the main auditorium area should be reviewed for adequate seismic bracing. We understand that new stage lighting was provided in the last several years, so the current support framing bracing may be adequate.

Catwalk framing above main auditorium (catwalk shown in ceiling section above)

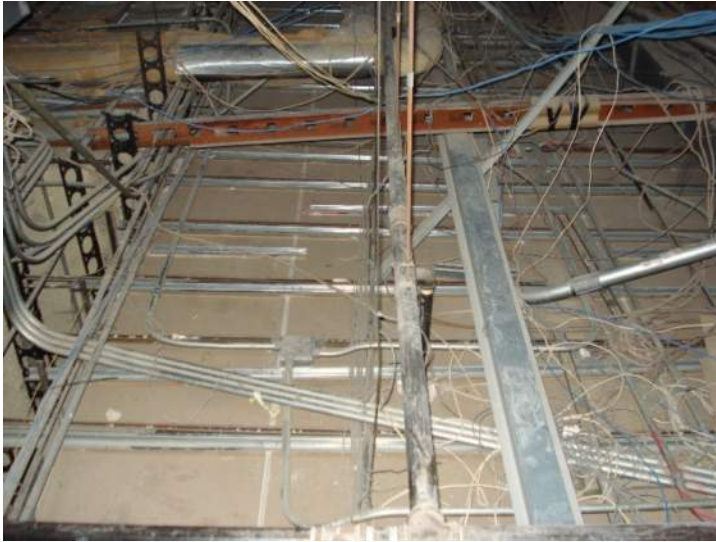
7.2. Ceiling framing: Partition Stud walls only braced by ceiling as can be seen on the left side in the photograph below. The ceiling visible in the picture is a hard-lid gypsum board ceiling. The studs extending above the ceiling should have bracing extending up to the roof framing.
