**UC Seismic Evaluation**

**Date:** 06/11/2021  
**UC Campus:** UCLA – on campus  
**Building Name:** Park Pool Locker Room (pool equipment)  
**Building Address:** 111 Easton Drive, Los Angeles, CA 90024  
**CAAN ID:** 4205H.1  
**Auxiliary Building ID<sup>1</sup>:** N/A

**UCOP Seismic Performance Level<sup>2</sup> (or “Rating”) based on ASCE 41-17 Tier 1/Tier 2 evaluation findings: V**

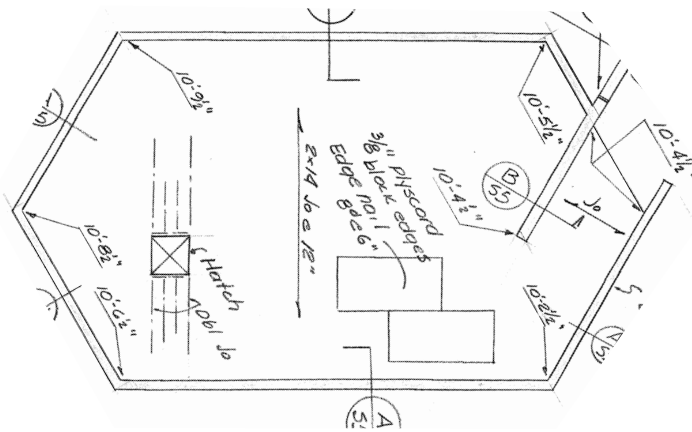
*Roof Framing Plan*

Note: Positive connection (out-of-plane wall anchors) between the concrete walls and wood framed roof is required.

Connection between the wood roof and concrete walls due to out-of-plane loading.

Provide out-of-plane anchors between the concrete walls and wood roof.

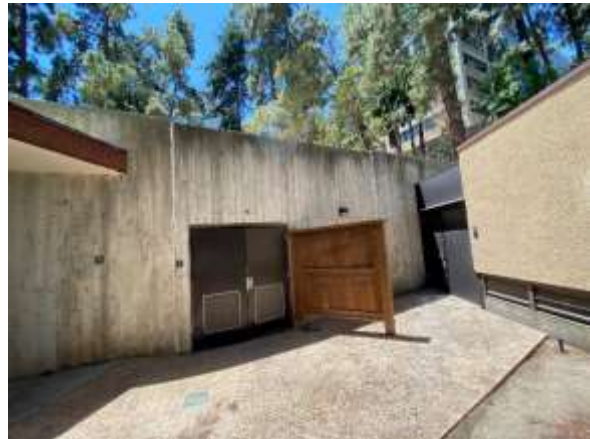
*Exterior Elevation Photo*

The 1-story building includes a 1000 sf pool equipment room. The building is hexagonal in plan. The back side of the building retains about 9'-0" of soil against the hillside.
