FORM 1
CERTIFICATE OF SEISMIC PERFORMANCE LEVEL

Building Name: [Sunset Canyon Recreation Center – Main Office & Conference Center](#)
Address: [111 Easton Drive](#)
Site location coordinates: Latitude [34.075283](#) Longitudinal [-118.451105](#)

UCOP SEISMIC PERFORMANCE LEVEL (OR “RATING”): IV

Original Structural Drawings:
Seismic Evaluation: [Structural Evaluation of UCLA Sunset Canyon Recreation Center, Nabih Youssef Associates, June 27, 2014, ASCE 31/Tier 1](#)
Retrofit Structural Drawings:

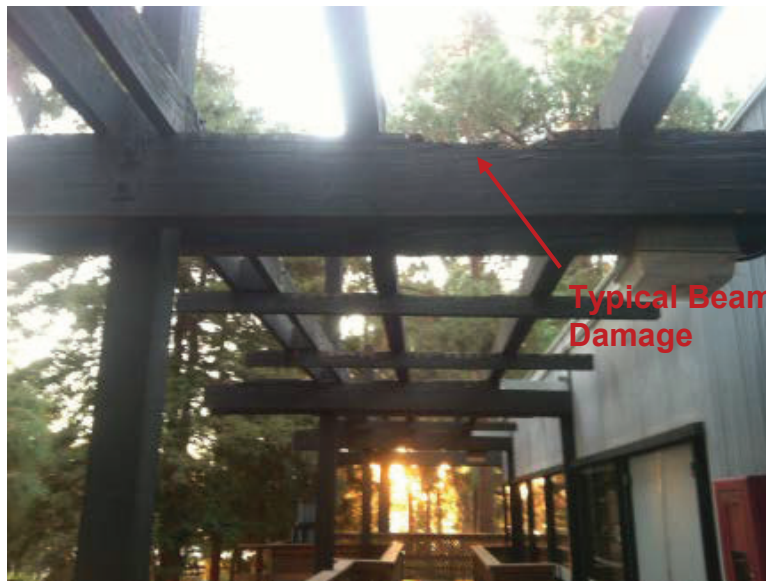
- Building A: No visible damage observed.
- Building B: Dry rot of wood framing above exterior walkway. Intermediate trellis framing had been removed due to substantial damage prior to our visit.

Photo 3.1: Exterior Walkway at Building B – Beam Damage

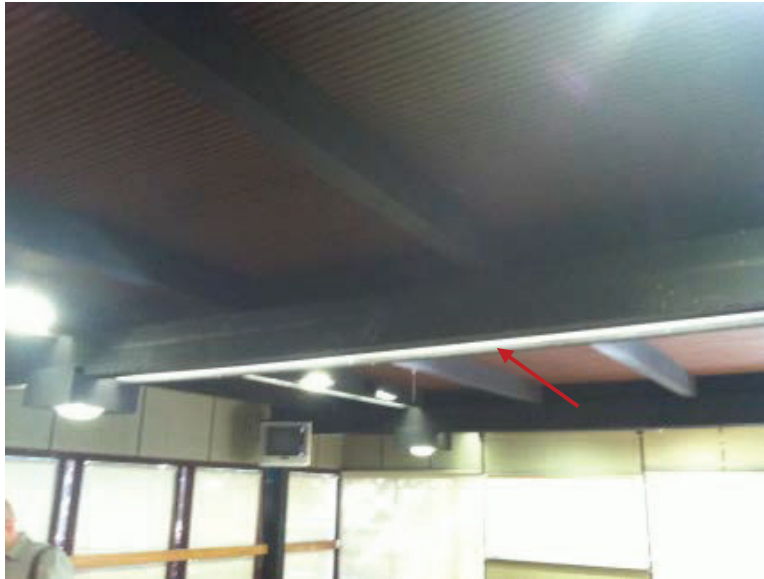
- Building C: Dry rot damage similar to Building A. An interior roof beam appears to have excessive deflection relative to the adjacent beams. See Photo 3.2. Below the floor level the exposed Floor Girder to Post connections appear to have extensive deterioration at 2 post locations. The base of the wood post to foundation has extensive wood deterioration.

Photo 3.2 : Interior Building C - Deflected Roof Beam

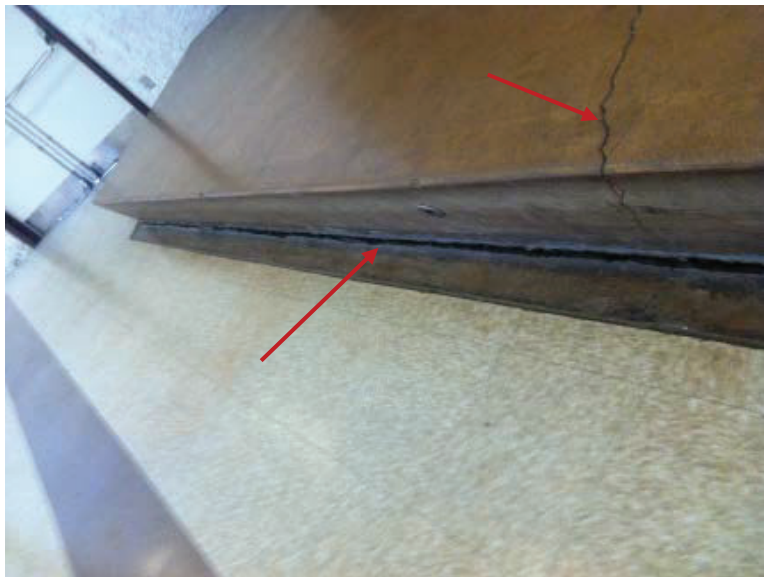
- Building D: Floor cracks adjacent to the fireplace on the north side of the structure. Concrete slab cracks at the connection between the stair (Building E) and the floor.

Photo 3.3: Interior Building D - Concrete Cracks at Stage

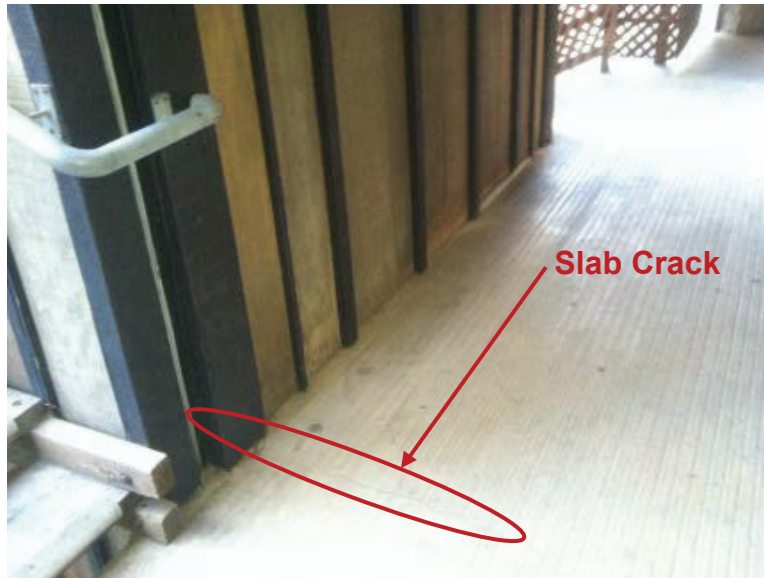
- Building E: Concrete slab cracks at the connection between the stair and Building D.

Photo 3.4: Building D/F: Concrete Slab Cracks at Connection

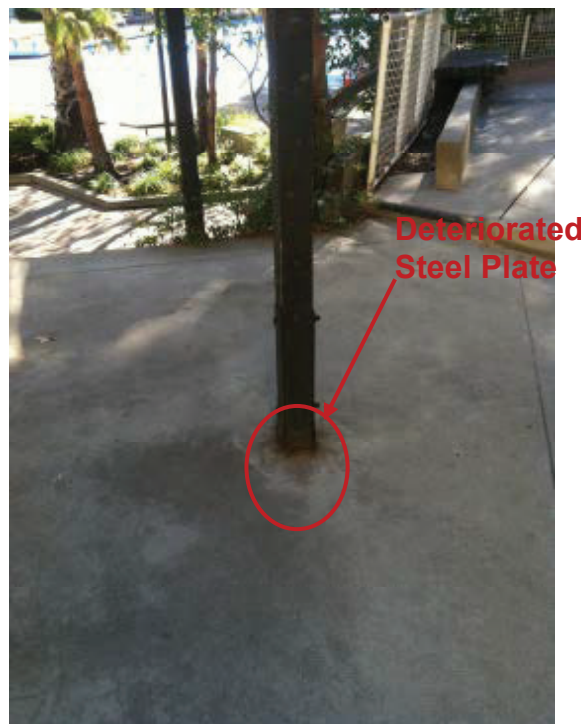
- Building F: No visible damage observed.
- Building G: No visible damage observed on the building. The walkway cover between Building G and Building C had dry rot damage of the wood beams and deterioration of the steel anchor plates at the posts. Intermediate trellis framing had been removed due to substantial damage prior to our visit.

Photo 3.5: Trellis Post to Slab Connection

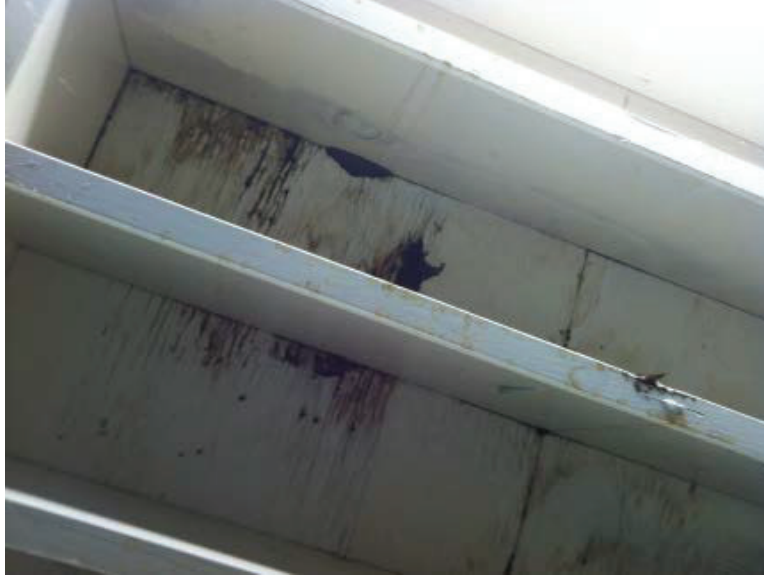
- Building H: No visible damage observed on the building.
- Building P: Water damage and/or dry rot of the wood sheathing on the north side of the structure.

Photo 3.6: Building P: Roof Sheathing Damage

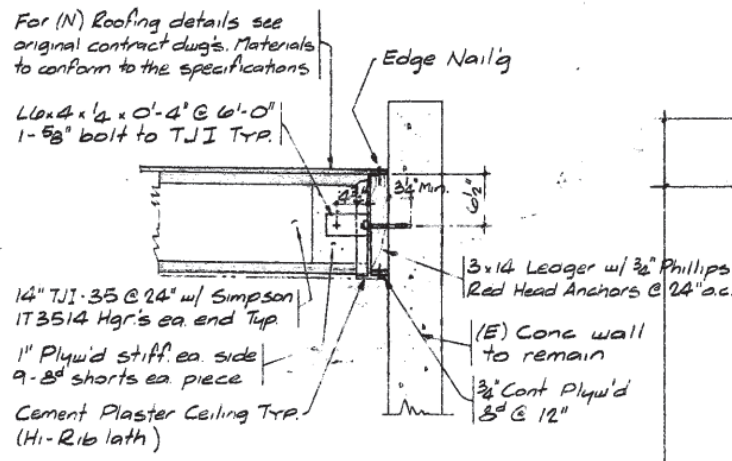
Figure 4.1: Out-of-plane Wall Anchor

Exterior concrete walls that are dependent on wood diaphragms for lateral support require anchorage for out of plane forces at each diaphragm level. The structural repair drawings, prepared in 1981, for the rehab of the pool equipment room (Building P) indicate the addition of horizontal wall anchors at the top of the concrete wall to the wood roof framing. See Figure 4.1. A similar repair detail to Building B is required.

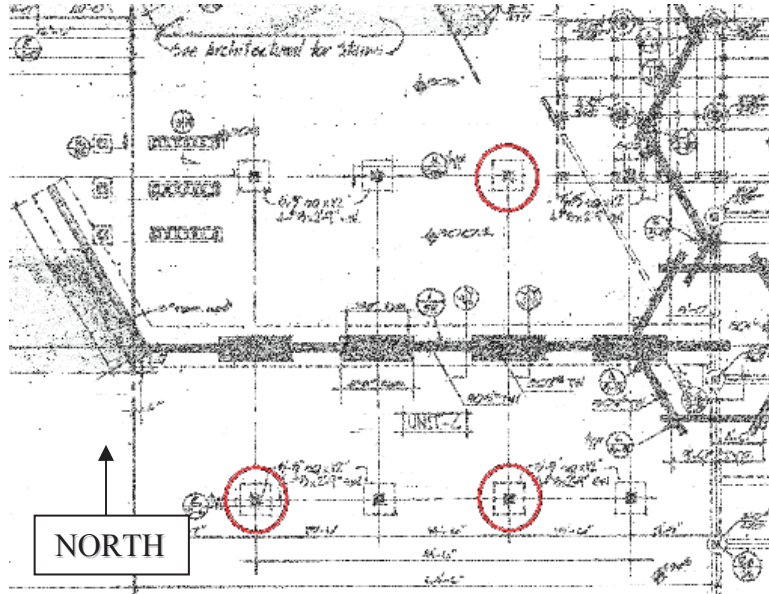
Figure 5.1: Building C Plan: Posts Requiring Immediate Repair

In addition, two gravity supporting posts on the north and south side were observed to have substantial deterioration at the Beam/Post connection which should be mitigated.

We recommend that the 3 support connections identified in Figure 5.1 should be repaired as depicted in Figure 5.2.
