Campus: [UCLA](#)
Building Name: [Transit Operations Center](#)
CAAN ID: [4522](#)
Auxiliary Building ID:

FORM 1
CERTIFICATE OF SEISMIC PERFORMANCE LEVEL

ASCE 41-17 Tier 1 Seismic Evaluation
Minimum Building Report Information

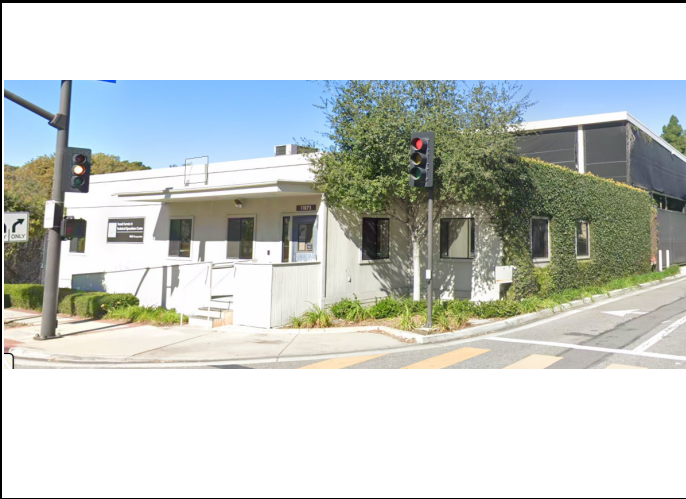
Lack of anchorage which means that the building can potentially slide off of the foundation.

COMMENTS:
 Observed inside and outside of structural. No anchorage to supporting curb at base rails of modular trailers observed in field investigation

Add anchorage to prevent building from sliding off foundation.
