FORM 1
CERTIFICATE OF SEISMIC PERFORMANCE LEVEL

Building Name: Lab School 1: Cluster Building
Address: 330 CHARLES E. YOUNG DRIVE, NORTH
Site location coordinates: Latitude 34.07538043 Longitudinal -118.4441833

UCLA Lab School 1 – Cluster Building

ASCE 41-17 Tier 1 Seismic Evaluation
Minimum Building Report Information

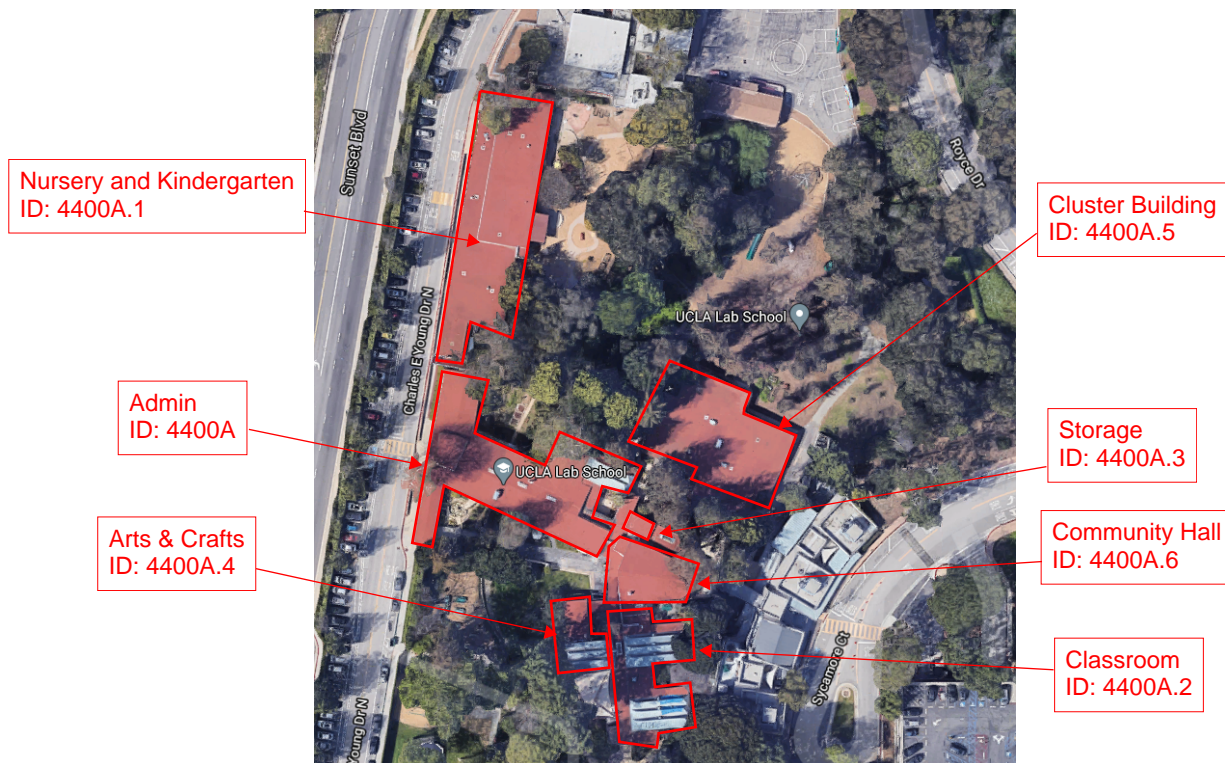
Figure 1 Key Plan of the Lab School 1 complex

The Lab School 1 complex is composed of multiple buildings. Each building is separated by several seismic separations allowing the different segments of the complex to act independently of one another. Shown below is a key plan of the complex along with the distribution of Building ID's at the complex.
