FORM 1
CERTIFICATE OF SEISMIC PERFORMANCE LEVEL

UCLA Lab School 1 – Nursery and Kindergarten Building

ASCE 41-17 Tier 1 Seismic Evaluation
Minimum Building Report Information

Building Name: Lab School 1 - Nursery and Kindergarten Building

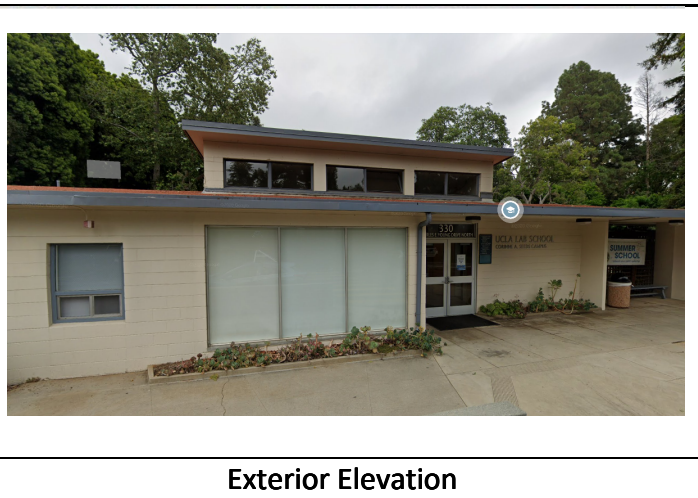
Exterior Elevation

All of the exterior walls consist of concrete masonry block where potential cracking and deformation may occur around window and door openings in the reinforced masonry walls.

Wood ledgers do not occur at typical wall panel to diaphragm connections. However, the atypical locations where they do exist within the building and along the canopy supports may be subject to connection damage due to cross-grain bending or tension in the wood ledgers. Also, cross-ties are not shown throughout the building, but blocking and bridging are present and will aid with the direct shear transfer.
