**FORM 1**  
**CERTIFICATE OF SEISMIC PERFORMANCE LEVEL**

Building Name: Lab School 1: Arts and Crafts  
Address: 330 CHARLES E. YOUNG DRIVE, NORTH  
Site location coordinates: Latitude 34.07538043 Longitudinal -118.4441833

### UCLA Lab School 1 – Arts and Crafts

ASCE 41-17 Tier 1 Seismic Evaluation  
Minimum Building Report Information

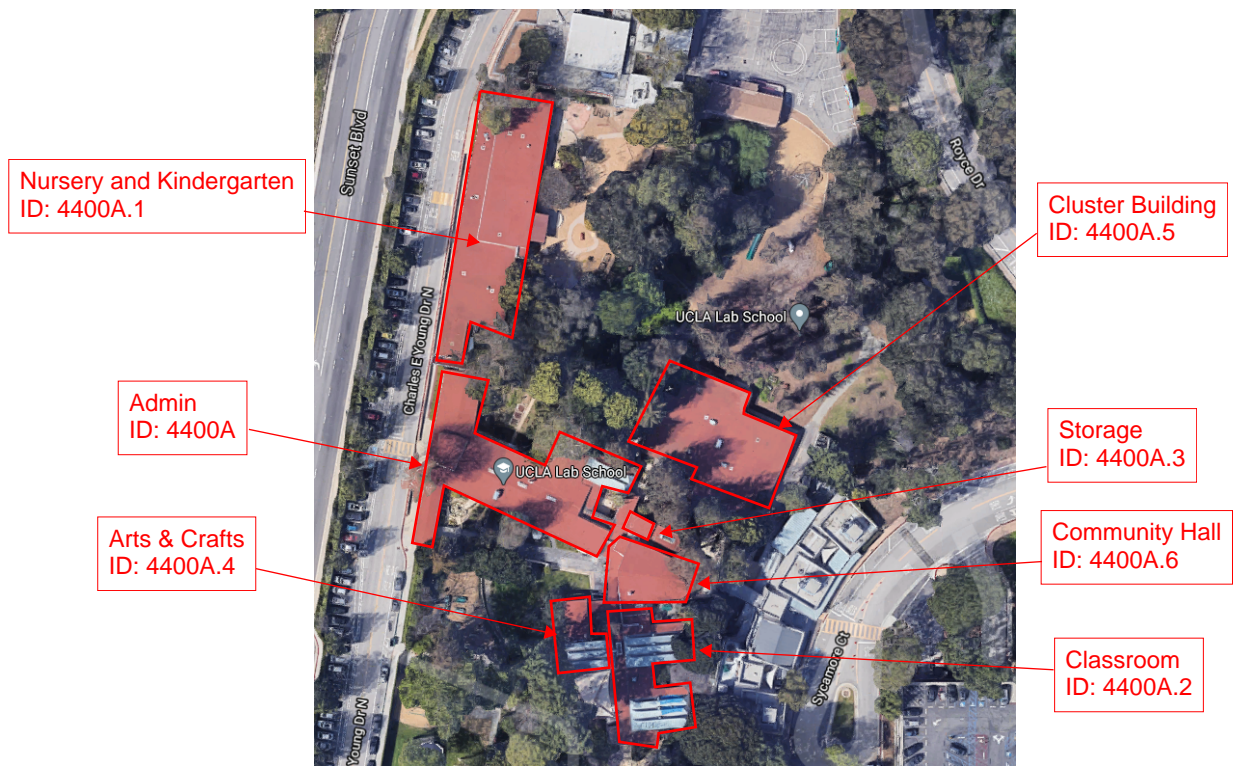
*Figure 1 Key Plan of the Lab School 1 complex*

The Lab School 1 complex is composed of multiple buildings. Each building is separated by several seismic separations allowing the different segments of the complex to act independently of one another. Shown below is a key plan of the complex along with the distribution of Building ID's at the complex.
