FORM 1
CERTIFICATE OF SEISMIC PERFORMANCE LEVEL

UCLA Lab School 1 – Classroom

ASCE 41-17 Tier 1 Seismic Evaluation
Minimum Building Report Information

Building Name: [Lab School 1 - Classroom](#)

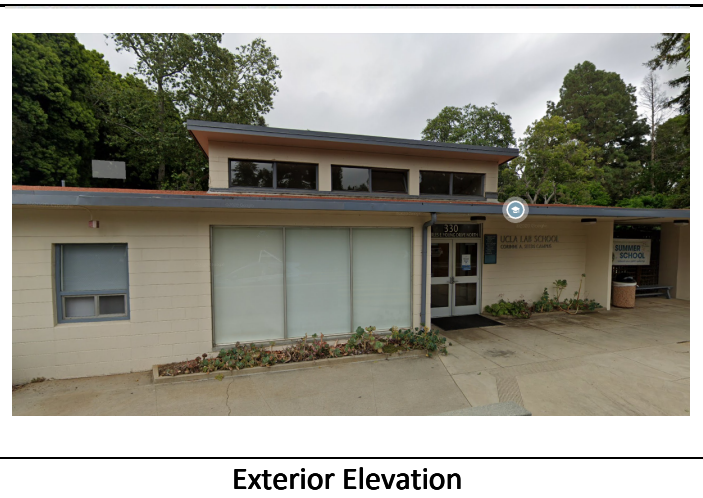
Exterior Elevation

All of the exterior walls consist of concrete masonry block where potential cracking and deformation may occur around window and door openings in the reinforced masonry walls.
