Campus: [UCLA](#)  
Building Name: [LAB 1 Comm Hall](#)  
CAAN ID: [4400A](#)  
Auxiliary Building ID: [4400A.6](#)

**FORM 1**  
**CERTIFICATE OF SEISMIC PERFORMANCE LEVEL**

### UCLA Lab School 1 – Community Hall

ASCE 41-17 Tier 1 Seismic Evaluation  
Minimum Building Report Information

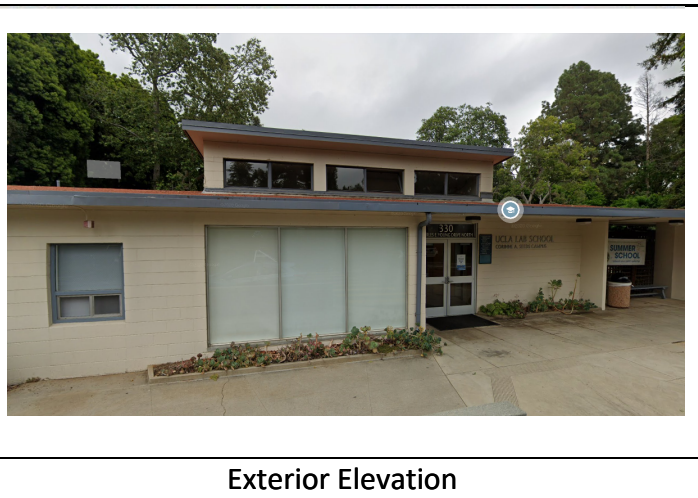
Exterior Elevation

The Community Hall building’s reinforcement ratio did not meet the minimum requirement for a reinforced masonry building, and must be considered an unreinforced masonry building according

to ASCE 41-17. Also, the height-to thickness of the masonry walls does not meet the minimum requirements. Potential damage could be caused by out-of-plane forces that may result in falling hazards and potential collapse of the structure in addition to potential cracking and deformation that may occur around openings in the masonry walls.

The roof is supported by trusses with rafters spanning between the trusses. The diaphragm exceeds the maximum span requirements and the roof rafters do not have bridging or blocking between the members which may result in joist rolling. Also, the trusses are supported by the masonry walls and do not have independent secondary columns for the support of vertical loads. The loss of masonry capacity caused by seismic demands may cause potential failure of the gravity system.

Wood ledgers do not occur at typical wall panel to diaphragm connections. However, the atypical locations where they do exist within the building and along the canopy supports may be subject to connection damage due to cross-grain bending or tension in the wood ledgers.

Based on the deficiencies identified in the Tier 1 evaluation, a rating of SPL V has been assigned. A Tier 2 evaluation is recommended to confirm whether the Tier 1 deficiencies require mitigation.
