FORM 1
CERTIFICATE OF SEISMIC PERFORMANCE LEVEL

Building Name: Lab School 1: Storage
Address: 330 CHARLES E. YOUNG DRIVE, NORTH
Site location coordinates: Latitude 34.07538043 Longitudinal -118.4441833

UCLA Lab School 1 – Storage

**ASCE 41-17 Tier 1 Seismic Evaluation
Minimum Building Report Information**

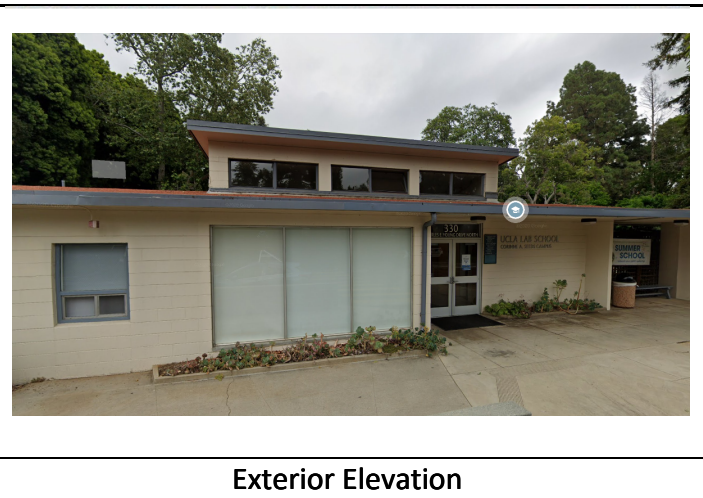
Exterior Elevation

Potential cracking and deformation may occur around openings in the reinforced masonry walls. Wood ledgers do not occur at typical wall panel to diaphragm connections. However, the atypical

locations where they do exist along the exterior canopy supports may be subject to connection damage due to cross-grain bending or tension in the wood ledgers.
