UCLA Lab School 2 CAAN: 4400B (Excerpt from 2017 UC Seismic Studies Report)

June 30, 2017 Job No. 15-G103A

Seismic Ratings

University of California

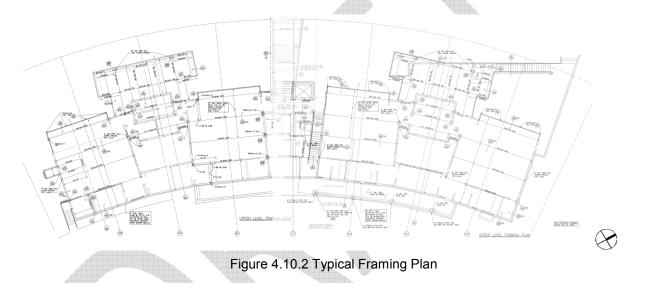
Both the floors and roof of the building form rigid diaphragms framed with lightweight concrete over metal deck. The diaphragms span between exterior and interior reinforced masonry shear walls. The masonry shear walls are fully grouted and 12" thick below the lower level and 8" thick above. Typical framing of the building is shown in Figure 4.10.2.

Per ASCE 41-13, the building is classified as Building Type RM2.

4.10.2 Seismic Rating: No Tier 1 deficiencies were observed in this building, and it qualifies for a Seismic Rating of III, as it meets the CBC requirements for a new building.
