INDEPENDENT SEISMIC REVIEW

**Occidental Petroleum Building & Hammer Museum**

10889 & 10899 Wilshire Boulevard  
Los Angeles, CA

**Nabih Youssef Associates**  
*Structural Engineers*  
550 South Hope Street, Suite 1700  
Los Angeles, California 90071  
NYA Job #14265-00

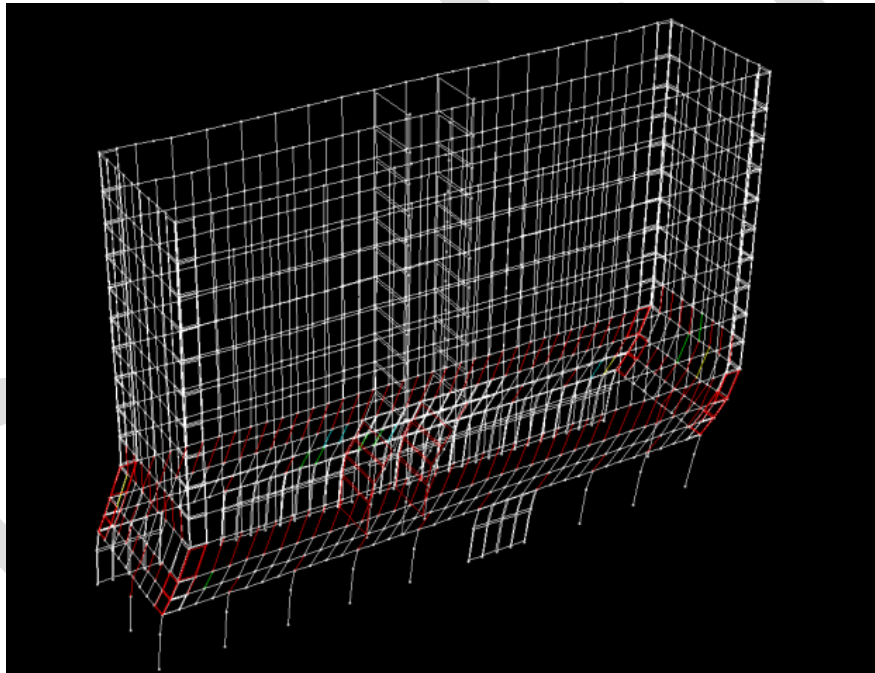
**Figure 5.12 - Plot of deformed shape for Sylmar record (BSE-2)**

The results of the nonlinear history response analyses indicate formation of story mechanisms at the 3<sup>rd</sup> through 7<sup>th</sup> floors due to excessive overstress of the concrete shear walls resulting in excessive inter-story drifts. The average maximum inter-story drift in the north-south direction at the 4<sup>th</sup> floor is approximately 6% with maximum inter-story drift of approximately 10%. Generally accepted drift limits for collapse prevention performance at the 2,475-year seismic hazard is average maximum inter-story drift less than 3%, maximum inter-story drift less than 4.5%.

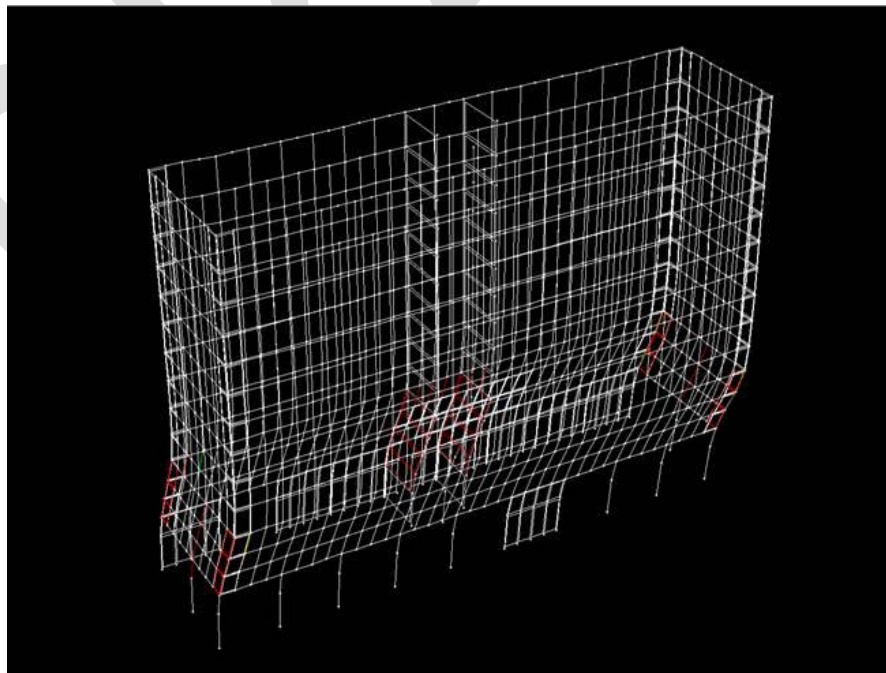
Figure 5.14 - Plot of deformed shape for Sylmar record (BSE-C)

The results of the 975-year seismic hazard analyses indicate slight overstress of the interior shear walls in the north-south direction, average maximum demand-to-capacity ratio of 1.1; and average maximum inter-story drift less than 2% with a maximum inter-story drift of 5.4% for the Sylmar Earthquake record and maximum residual drift of 1.2%. Figure 5.14 shows a plot of the deformed shape for the Sylmar record. Figure 5.15 shows a plot of the maximum inter-story drifts for all BSE-C records.

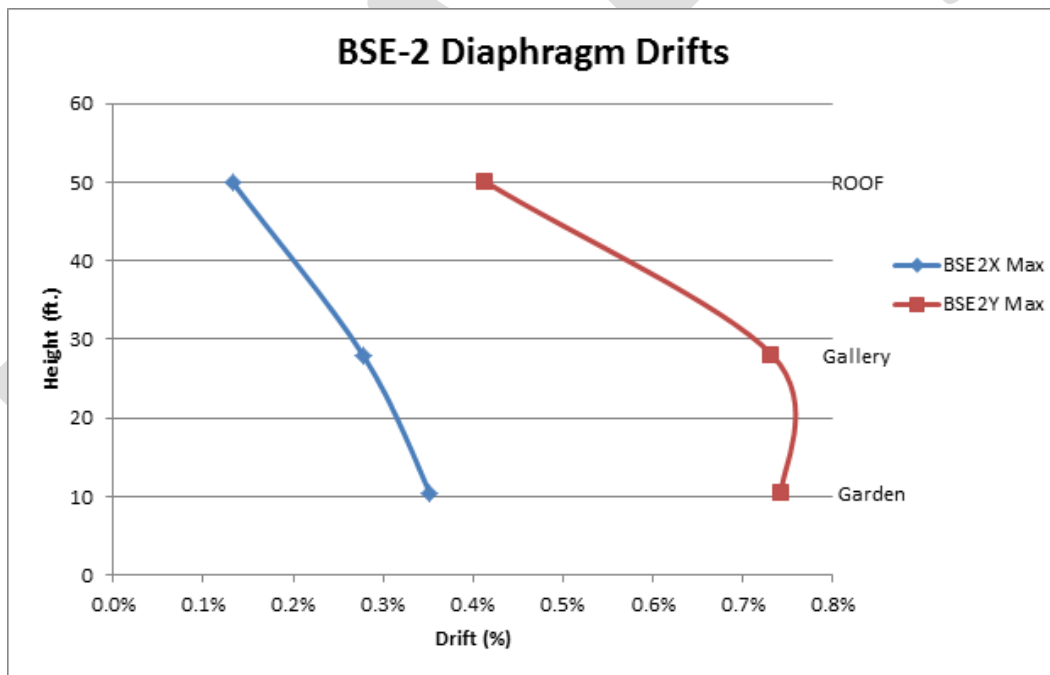
Figure 5.16 - Plot of Maximum BSE-2 Inter-story Drifts for Hammer Museum

Figure 5.16 shows a plot of the maximum inter-story drift ratios from the dynamic analysis at each story for the BSE-2 earthquake hazard level. As can be seen, the maximum inter-story drifts are well within acceptable levels at all floors.

- Pre-Northridge welded moment connections with limited ductility.
- Beams and columns of moment frame do not satisfy strong column/weak beam configuration. Strong column/weak beam configuration promotes yielding of the beam – a preferred behavior.
- The moment frame beams are connected to the weak axis of the column at many locations.

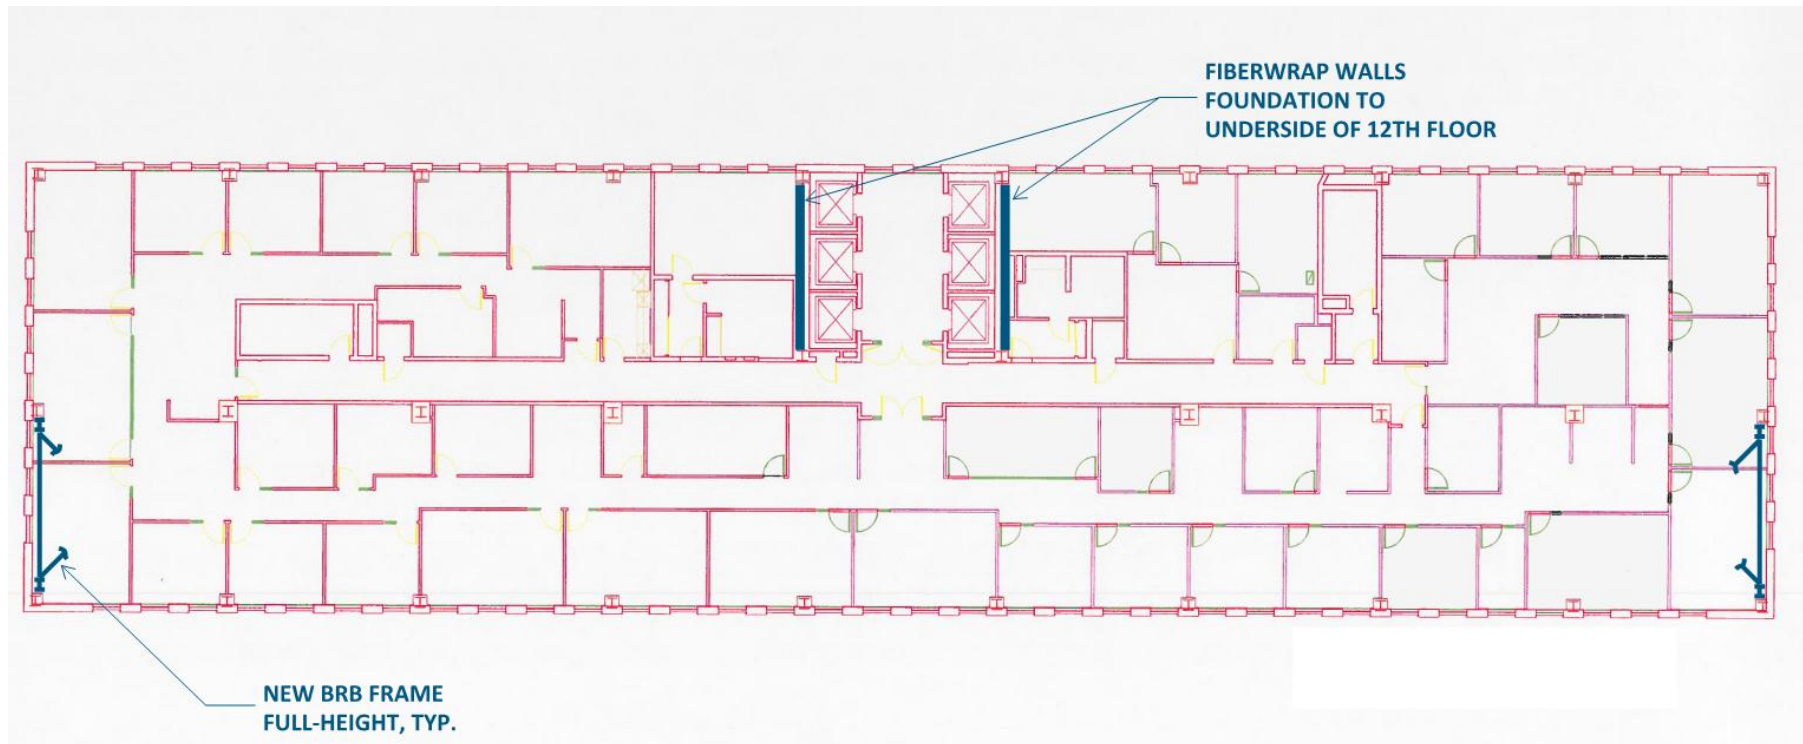
Figure 6.1 - Typical floor plan of proposed seismic strengthening

The evaluation of the Occidental Tower identified inadequate shear strength of concrete walls in north-south direction as the principal structural deficiency.

- Strengthening existing interior concrete walls, located adjacent to the elevator banks, with fiber reinforced mesh from the foundation to the underside of the 12<sup>th</sup> floor; and
- Add new single-bay interior buckling restrained brace (BRB) frames at the east and west perimeter of the building from the foundation to the roof.

Figure 6.1 shows the location of the proposed strengthening on a typical floor plan. Figure 6.2 shows an isometric view of the computer model with the proposed strengthening indicated.

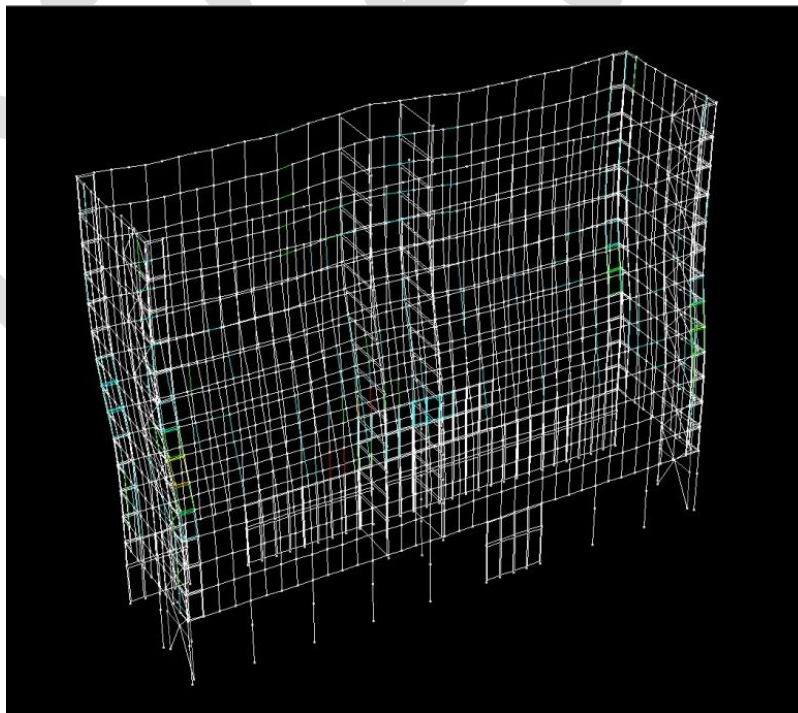
Figure 6.3 – Plot of deformed shape for Sylmar record (BSE-2)

The results of the analyses indicate no overstress and average maximum inter-story drift less than 2% with a maximum inter-story drift less than 3%. Figure 6.3 shows a plot of the deformed shape. Figure 6.4 shows a plot of the maximum inter-story drifts for all BSE-2 records.
