FORM 1
CERTIFICATE OF SEISMIC PERFORMANCE LEVEL

UCLA – Vending Machine Building - ATM

FEMA 154 Rapid Visual Screening

Building Name: Vending Machine Buildings - ATM

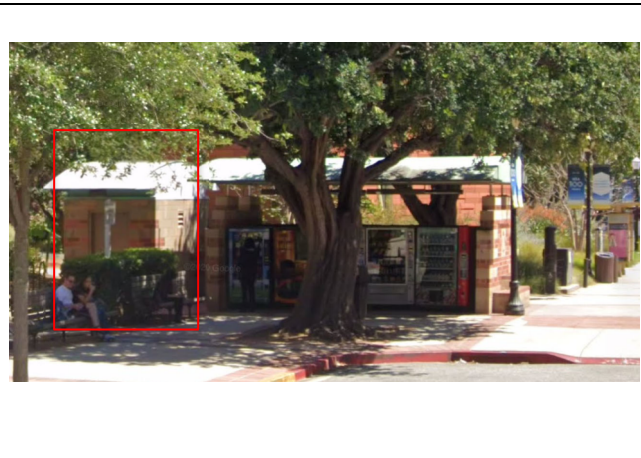
Exterior Elevation

COMMENTS:
 Building has reinforced masonry walls in both directions, has redundancy.
