Campus: [UCLA](#)
Building Name: [Vending Machine Buildings - Vending](#)
CAAN ID: [4518](#)
Auxiliary Building ID:

FORM 1
CERTIFICATE OF SEISMIC PERFORMANCE LEVEL

UCLA – Vending Machine Building - Vending

FEMA 154 Rapid Visual Screening

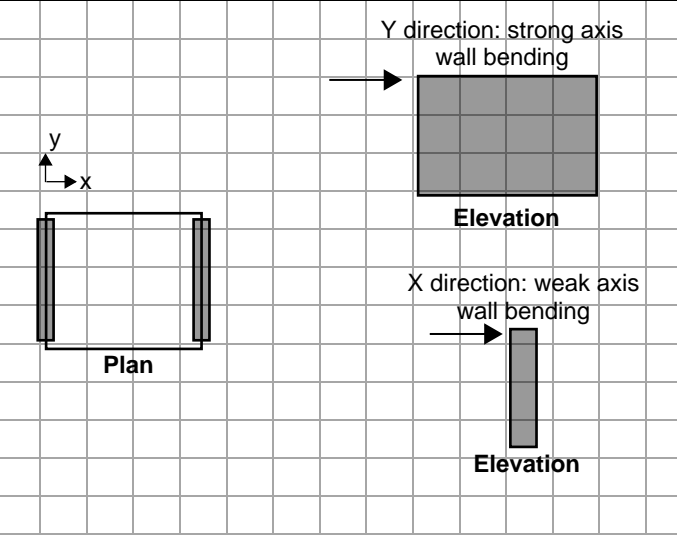
SKETCH

COMMENTS:
 Building has reinforced masonry walls in one direction, and cantilever columns in the other direction.
